REPORT OF INVESTIGATION

Surface Metal Mine  
(Mill)

Fatal Electrical Accident  
October 12 2006

United Taconite, LLC  
United Plant  
Eveleth, St. Louis County, MN  
Mine I.D. No. 21-03404

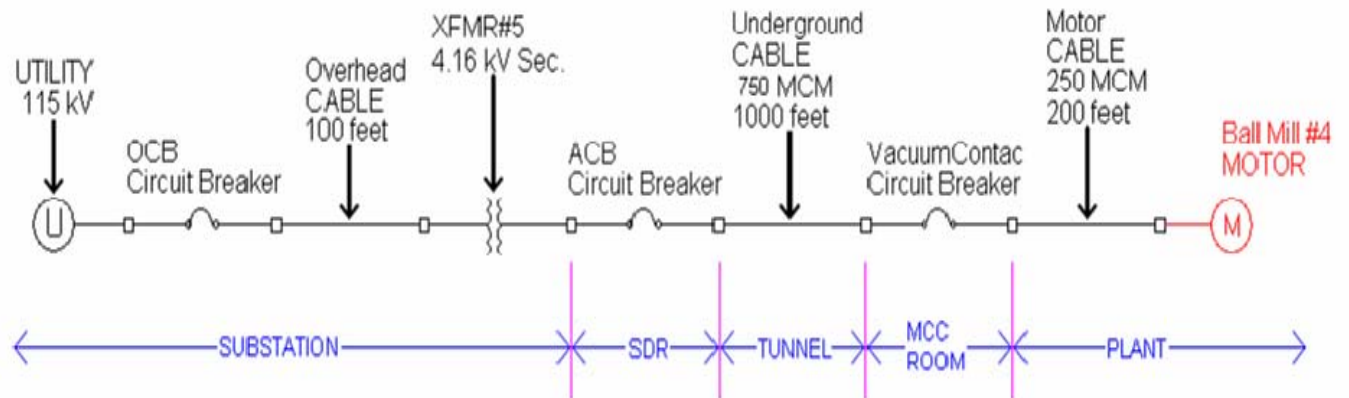
**Figure 1: Simple single line diagram of circuits involved in accident**

Electrical power was provided to the concentrator building new side ball mill motor control center (MCC) room by approximately 1000 feet of 750 MCM cables (Appendix B).

The electrical circuits that supplied power to ball mills Nos. 3, 4, and 5 were protected by an Allis-Chalmers ACB. This breaker was located in the SDR and was found in the closed (on) position after the accident. Electrical power continued to be supplied to the MCC room through the ACB and was only interrupted when the cables feeding Nos. 3, 4, and 5 ball mills melted, causing a physical break in electrical connection.

Approximately 3.5 minutes after the initial fault occurred, the OCB tripped, interrupting electrical power to the entire plant. The OCB was equipped with an under-voltage relay device. The device was designed to open when incoming voltage dropped below a certain percentage of the original line voltage (usually 5 to 10 percent). When the incoming 115kV voltage dropped, the under-voltage relay opened and cut power. The OCB was equipped with an over-current relay; however, this over-current relay was not functional and failed to protect the load side electrical circuit.
