Coal Mine Fatal Accident 2007-04

Operator:	Double E Augering Inc.
Mine:	No. 3
Accident Date:	March 12, 2007
Classification:	Machinery
Location:	Dist. 6, Pike County, Kentucky
Mine Type:	Surface Coal Mine
Employment:	5
Production:	200 Tons/Day

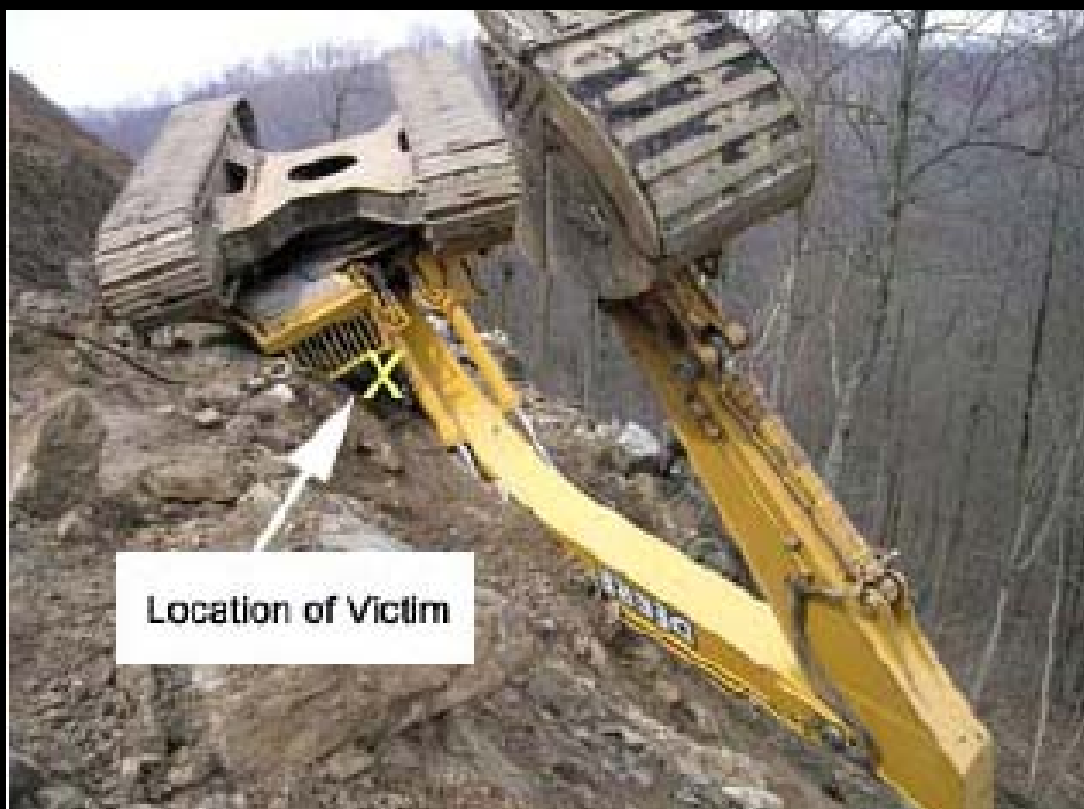
At approximately 4:00 p.m. on March 12, 2007 a 47-year old foreman/excavator operator with 29 years mining experience received fatal injuries when the track-mounted excavator which he had been operating overturned from an elevated mine bench. The victim had been loading and moving shot rock overburden while positioned on the narrow

bench, digging toward the excavator. The excavator was positioned with the left (operator's) side track on the edge of the upper bench, when he began trying to reposition the machine away from the edge by using the boom. When down pressure was applied to the boom, the rear portion of the track went over the edge of the bench and the excavator began to roll over onto the lower bench. As the excavator continued rolling over, the cab was crushed and the victim was fatally injured. The accident occurred because the width of the elevated mine bench was not sufficient to insure safe operation of the excavator.

Root Cause: The standards, policies and procedures used by the mine operator did not ensure that safe working conditions were provided for the employees at all times. The width of the elevated mine bench was not sufficient to provide safe working conditions for the equipment being used and the operation being performed.

"The width of the mine bench was not sufficient to insure safe operation of the John Deere 330C LC excavator.

The mine bench was measured to be 13 feet wide and the excavator tracks are 11 feet, 2 inches wide. The excavator was being operated on the edge of the bench in order to allow rotation of the deck.

Corrective Action: The mine operator developed a plan to prevent a similar occurrence of this accident. The ground control plan was revised to show when track-mounted equipment is being operated parallel to the outslope from an elevated bench on in-place shot material, the width of the bench will be a minimum of 1.5 times wider than the distance between the outside edges of the equipment tracks. The plan also requires training to be provided to the employees concerning the revised ground control plan and hazards associated with operating equipment from a mine bench.
