Coal Mine Fatal Accident 2007-11

Operator:	Rockhouse Creek Development, LLC
Mine:	No. 8
Accident Date:	August 4, 2007
Classification:	Machinery
Location:	Dist. 4, Mingo County, West Virginia
Mine Type:	Underground Coal Mine
Employment:	132
Production:	3,000 Tons/Day

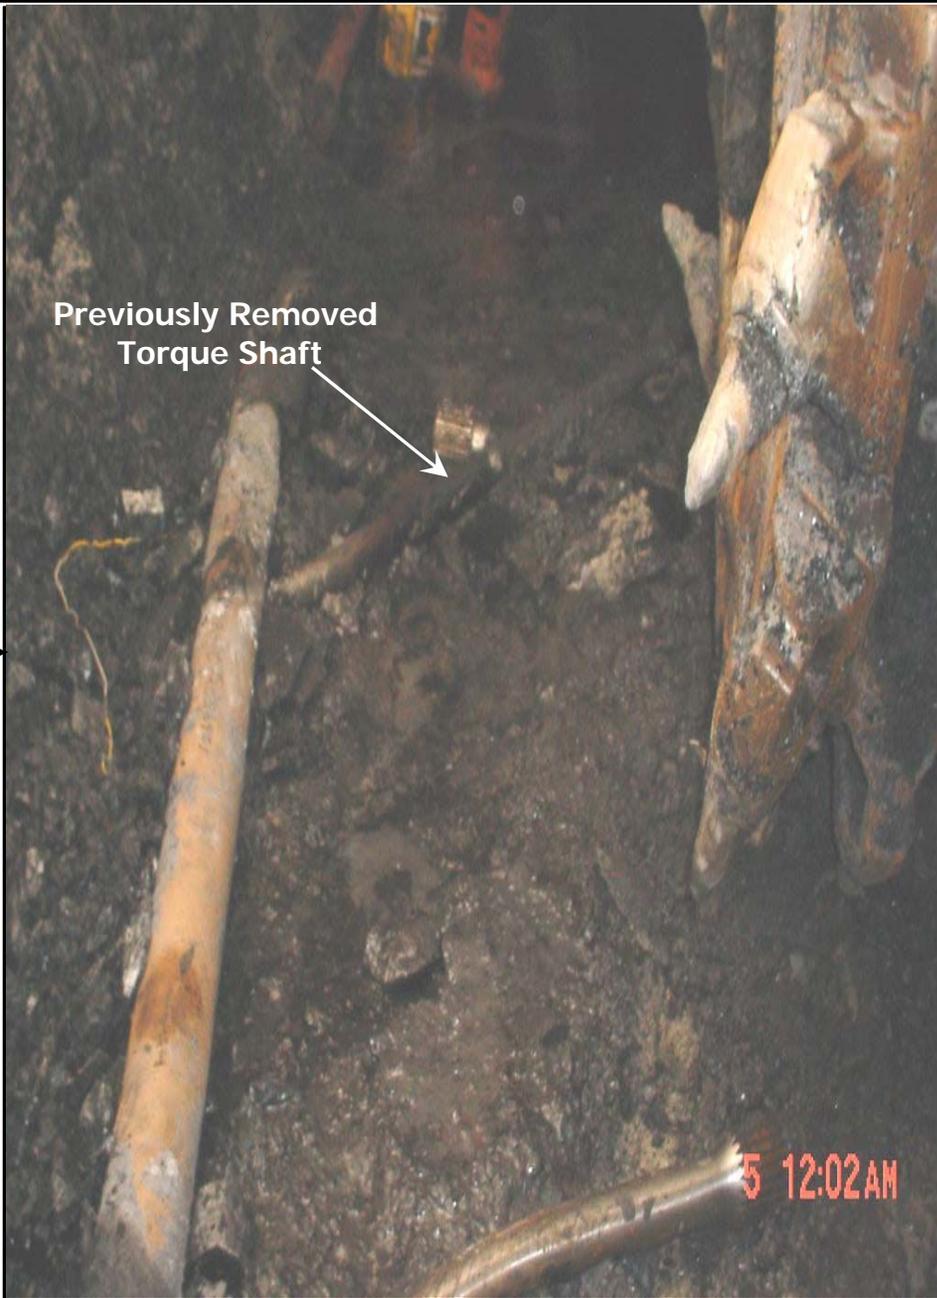
At 6:15 p.m. on Saturday, August 4, 2007, a 25-year old foreman was fatally injured while assisting a mechanic in the replacement of a cutter motor torque shaft on a continuous mining machine. During the installation of the new torque shaft, the shaft became stuck in the operator's side of the cutting head motor. In an attempt to remove the shaft, as the motor was turning after being shut off, the shaft contacted the turning motor and rotated, striking the victim in the head and face..

Root Cause: Improper procedures and unsafe work practices were used. The manufacturer's recommended procedure was not followed for the replacement of the continuous mining machine torque shafts. Electrical power was not disconnected, the torque shafts were not greased, and the torque shaft cap, snap ring, O-ring, clutch cover cap, and the cutter motor/clutch access door or cover were not replaced prior to the restoration of electrical power to the machine.

Root Cause: A miner was in close proximity to an unguarded, unsecured, rotating machine part while the continuous mining machine was energized.

Although electrical power was interrupted from the cutter motor moments prior to the accident, electrical power remained on the machine, and the cutter motor continued to rotate. The cutter motor was not blocked against motion and machinery motion was not necessary to complete the repair.

Corrective Action: Maintenance personnel were retrained in the proper procedures for replacing a cutter motor torque shaft. In addition, the mine operator established a policy where repairs or maintenance cannot be performed until all persons are in a safe location, and machine power is disconnected.

Corrective Action: The mine operator established a policy where repairs or maintenance cannot be performed until all persons are in a safe location, and machine power is disconnected. All miners were trained in the new policy.
