MNMM Fatal 2007-19

- Fall of Person Accident
- July 29, 2007 (Tennessee)
- Zinc Operation
- Contract Miner/Driller
- 29 years old
- 3 years experience

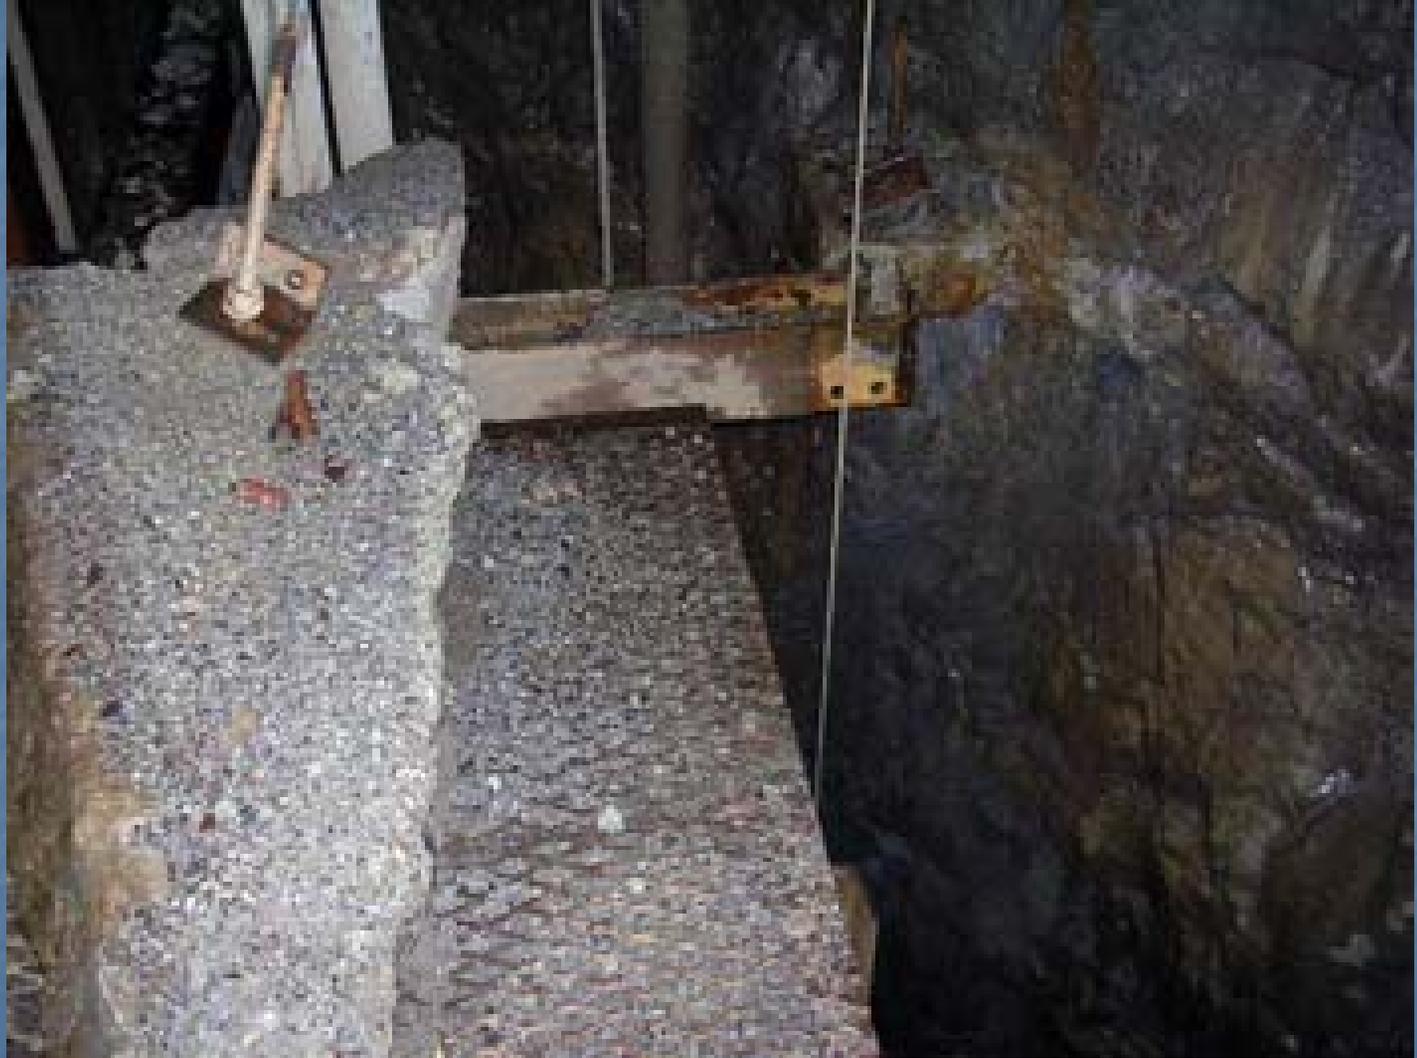
The victim was fatally injured while working from the top of a shaft conveyance (cage) in the main shaft compartment. The victim and a coworker were positioned on a beam removing concrete from steel shaft sets. One end of the beam broke loose and both men fell. They were wearing fall protection but the victim's lanyard was not secured and he fell approximately 1,000 feet to the shaft bottom.

- Management policies and controls were inadequate and failed to ensure that persons could safely work at elevated positions where there was a danger of falling. Management failed to conduct an assessment of the risk when performing these tasks and had not identified procedures to ensure the work could be completed safely.
- Management policies and work procedures failed to ensure that fall protection was properly used by persons working where there was a danger of falling.

- Ensure workers are trained and understand that safety lanyards are not permitted to be unfastened while working at elevated locations.
- Provide self retracting lanyard mechanisms when workers are required to reposition themselves to perform tasks.
- Ensure safety lanyards are securely fastened at all times when workers are positioned at elevated locations.
