MNMM Fatal 2007-20

- Fall of Ground Accident
- July 30, 2007 (Montana)
- Copper Operation
- Underground Mechanic
- 55 years old
- 2 years 10 months experience

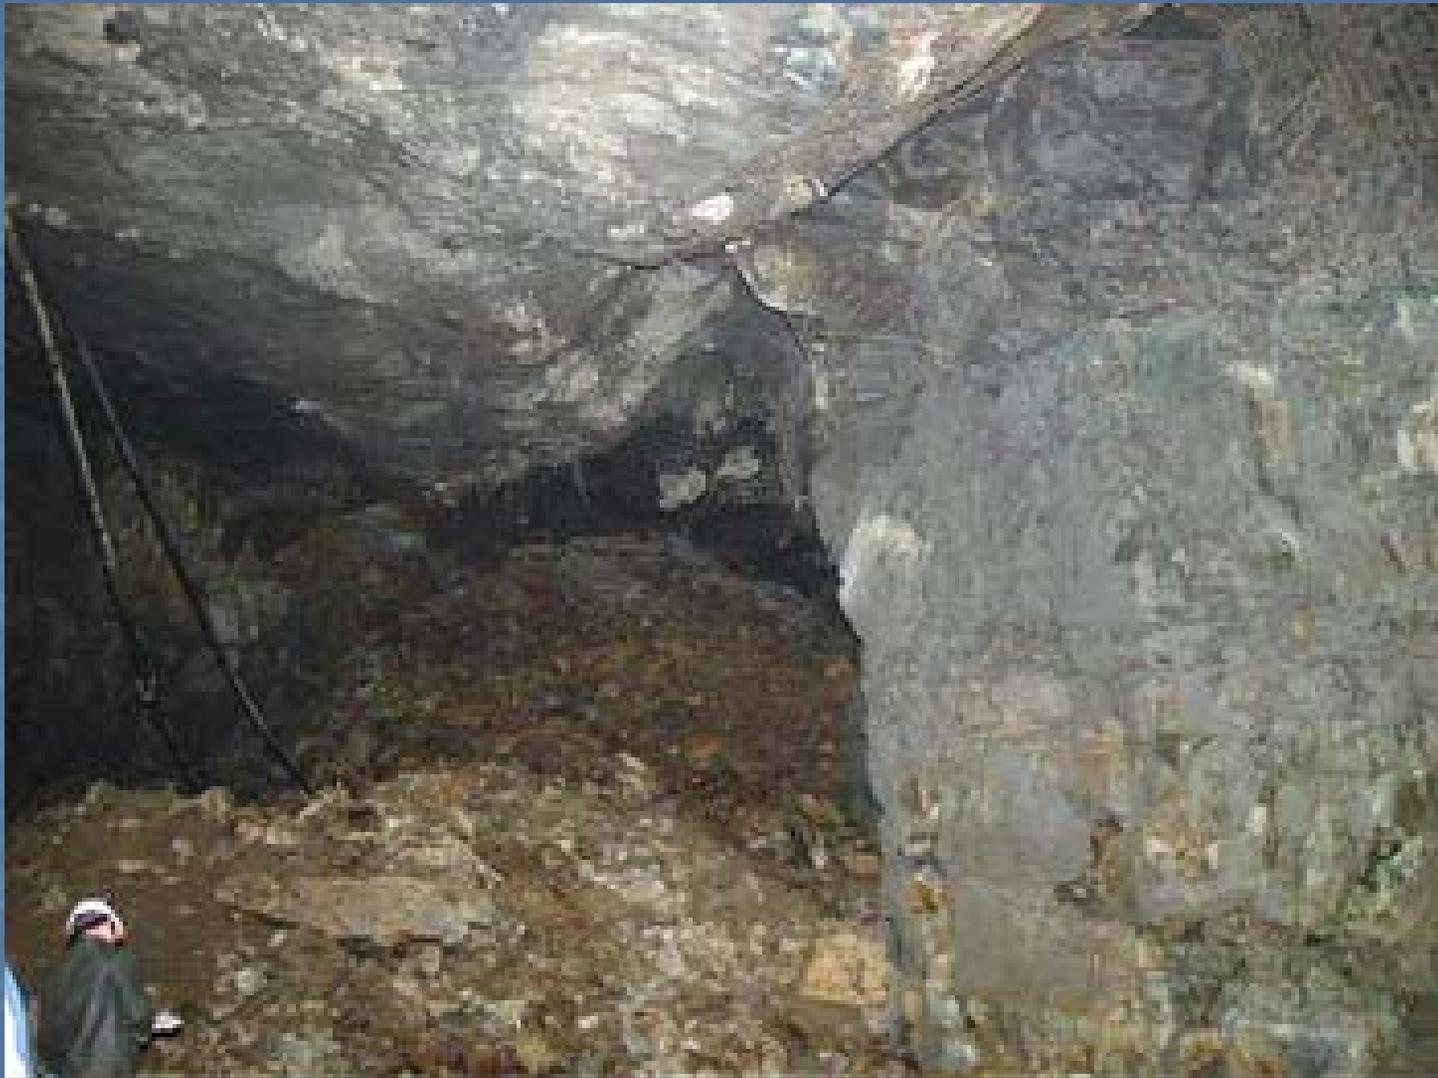
The victim was fatally injured when a fall of ground occurred, entrapping him in the cab of a service truck. He had completed repairs to a roof bolter and was waiting for another truck to move when three separate falls of ground occurred. The first fall covered the bed of his truck, the second covered the cab, and the third covered the remainder of the truck.

- Management policies, procedures, and controls were inadequate and did not ensure that persons were protected from fall of ground hazards where they worked or traveled. Management failed to follow the ground support plan they had established and did not require additional ground support to be installed in the location where the fault existed.
- Management failed to address adverse ground conditions identified and reported during work place examinations. Persons conducting the examinations failed to require additional roof support materials be installed to control the ground where the fault was visible.

- Design, install, and maintain a support system to control ground in places where persons work or travel.
- Examine and test ground conditions where persons work or travel.
- Promptly initiate action to install additional support when ground faults are identified.
- Install barriers to impede entry when ground conditions may create a hazard.
