# MNMM Fatal 2007-33

- Electrical Accident
- September 14, 2007 (Arizona)
- Copper Operation
- Assistant Electrical Superintendent (Contractor)
- 46 years old
- 20 years experience

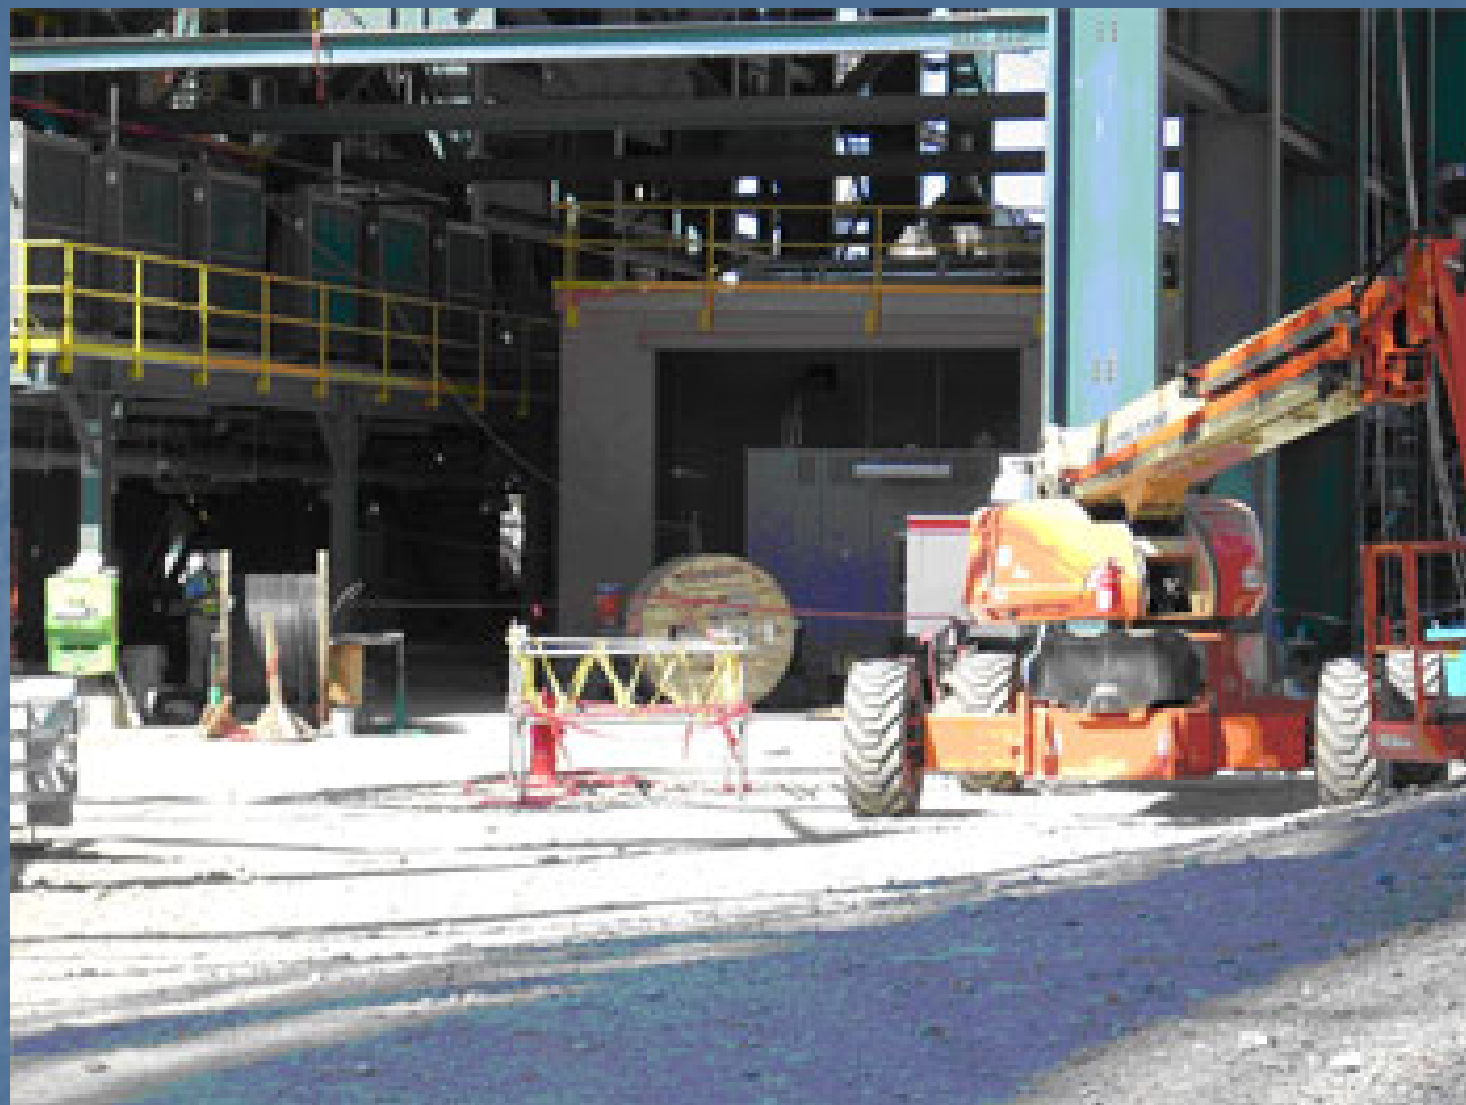
The victim was seriously injured on September 14, 2007, when a ground fault occurred in the 5.2 motor control center (MCC). He was troubleshooting an electrical problem in the 5.2 MCC when he contacted an energized fuse and the switch gear handle, resulting in a ground fault condition and arc flash. The victim was hospitalized and died as a result of his injuries on July 7, 2008.

Management policies and controls were inadequate and failed to ensure that the electrical circuit was de-energized, locked out, tagged, and tested before work was performed on the circuit.

- Positively identify the circuit on which work is to be conducted and the corresponding disconnecting device.
- De-energize power from the circuit and place YOUR lock and tag on the switch.
- Ground all phase conductors to the equipment grounding medium with grounding equipment that is properly rated.
- Verify that the circuit is de-energized by testing the circuit for voltage using properly rated test equipment.
- Utilize properly rated Personal Protective Equipment including Arc Flash Protection such as a hood, gloves, shirt, and pants.
