Fatality #4 - March 23, 2007
Machinery - Ohio - Sandstone (C&B)
Oglebay Norton Industrial Sands, Inc. - Glass Rock Plant

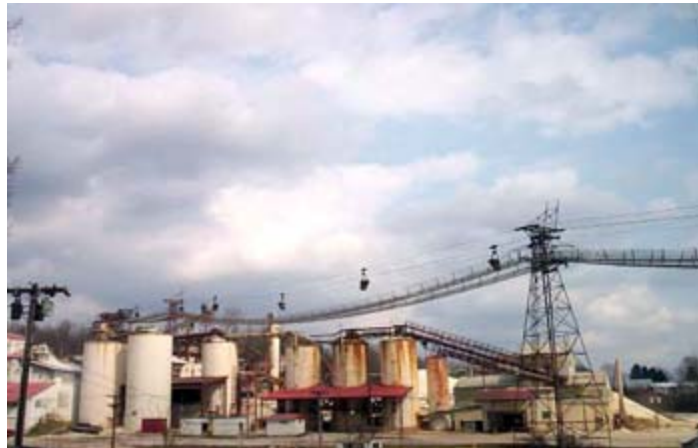
METAL/NONMETAL MINE FATALITY - On March 23, 2007, a 44 year-old tramway maintenance man, with 26 years mining experience, was fatally injured at an industrial sand operation. A maintenance crew was adjusting a cable for an aerial tram. A tension jack was being used to tighten the cable when the cable anchorage point failed. The victim was in a man basket, looking down the cable line, and was struck by the tension jack or cable. A co-worker was also injured.

- Identify inspection criteria and maintenance procedures for carriers (including loading and unloading mechanisms), ropes and supports, and brakes according to the recommendations of the manufacturer.

- Identify potential hazards for each step of the task, establish written procedures, and train persons conducting the task of aligning cable lines.
- Ensure that competent persons address hazards associated with and the uncontrolled release of stored energy.

- Ensure that persons are not positioned within the recoil zone of tensioned cables.
- When using hydraulic systems, ensure that the maximum allowed pressures and the settings of the relief valves are established by a qualified individual.

- Before any work is performed on a tension linkage assemblage, ensure that all connection points of the linkage assemblies have been examined for signs of excessive deformation, signs of distress such as cracking, distortion of holes, warping, out of plan lateral movements.
