**UNITED STATES
DEPARTMENT OF LABOR
MINE SAFETY AND HEALTH ADMINISTRATION**

REPORT OF INVESTIGATION

**Fatal Machinery Accident
November 5, 2007**

**San Miguel Lignite Mine
The North American Coal Corporation
Jourdanton, Atascosa County, Texas
ID No. 41-02840**

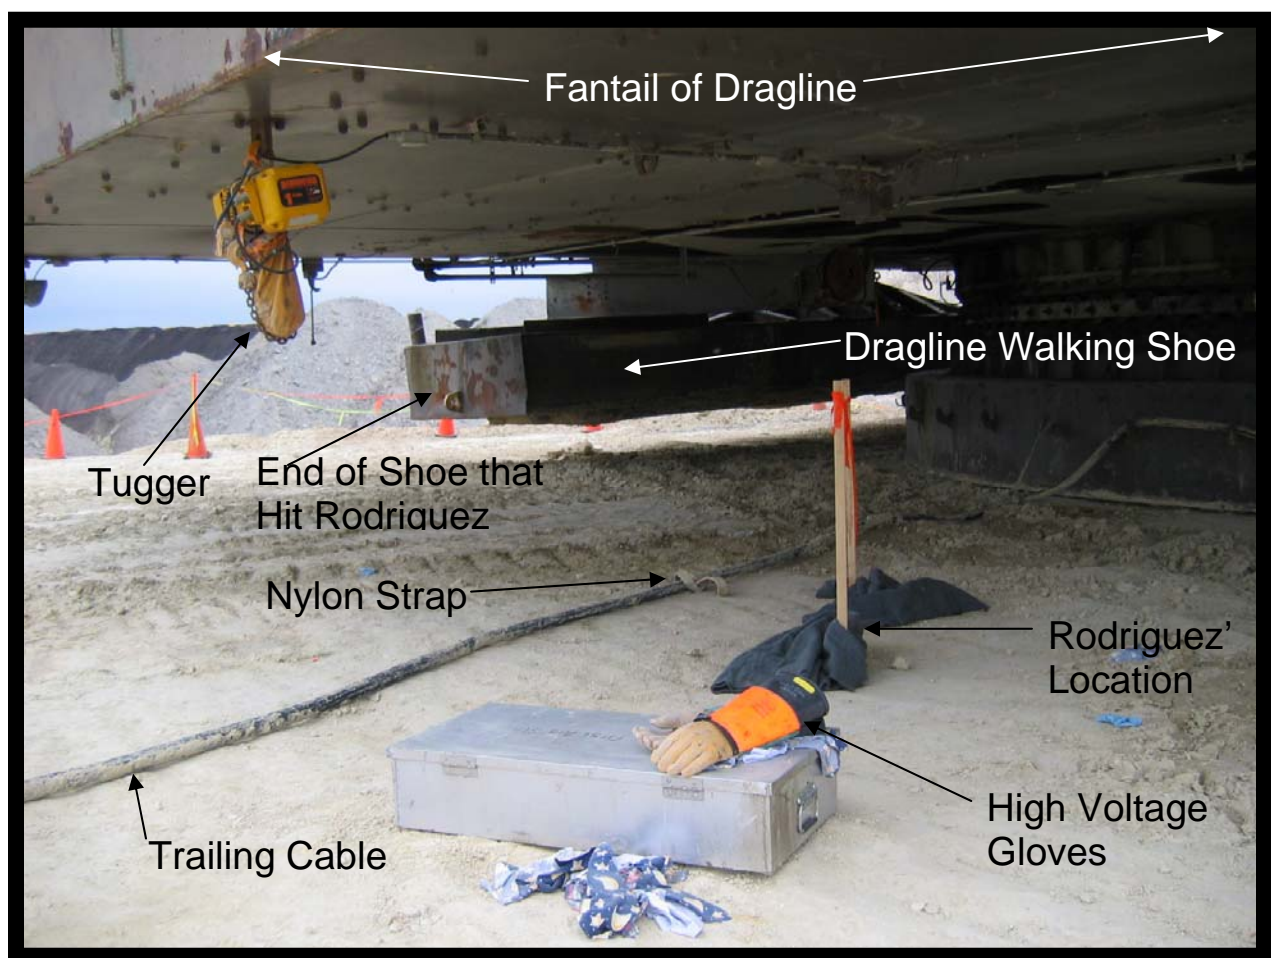
**VIEW OF ACCIDENT SCENE WITH WALKING SHOE IN
LOCATION PRIOR TO THE ACCIDENT WHILE DRAGLINE IN
DIGGING POSITION**

The dragline walking shoe was 8 feet wide, 34.5 inches thick, and 40 feet long. The bottom of the walking shoe in the raised position was approximately 22 to 24 inches off the ground. Rodriguez was struck by the end panel of the shoe which was 8 feet by 34.5 inches in dimension. The bottom of the fantail/rear housing of the dragline was approximately 7 feet off the ground.

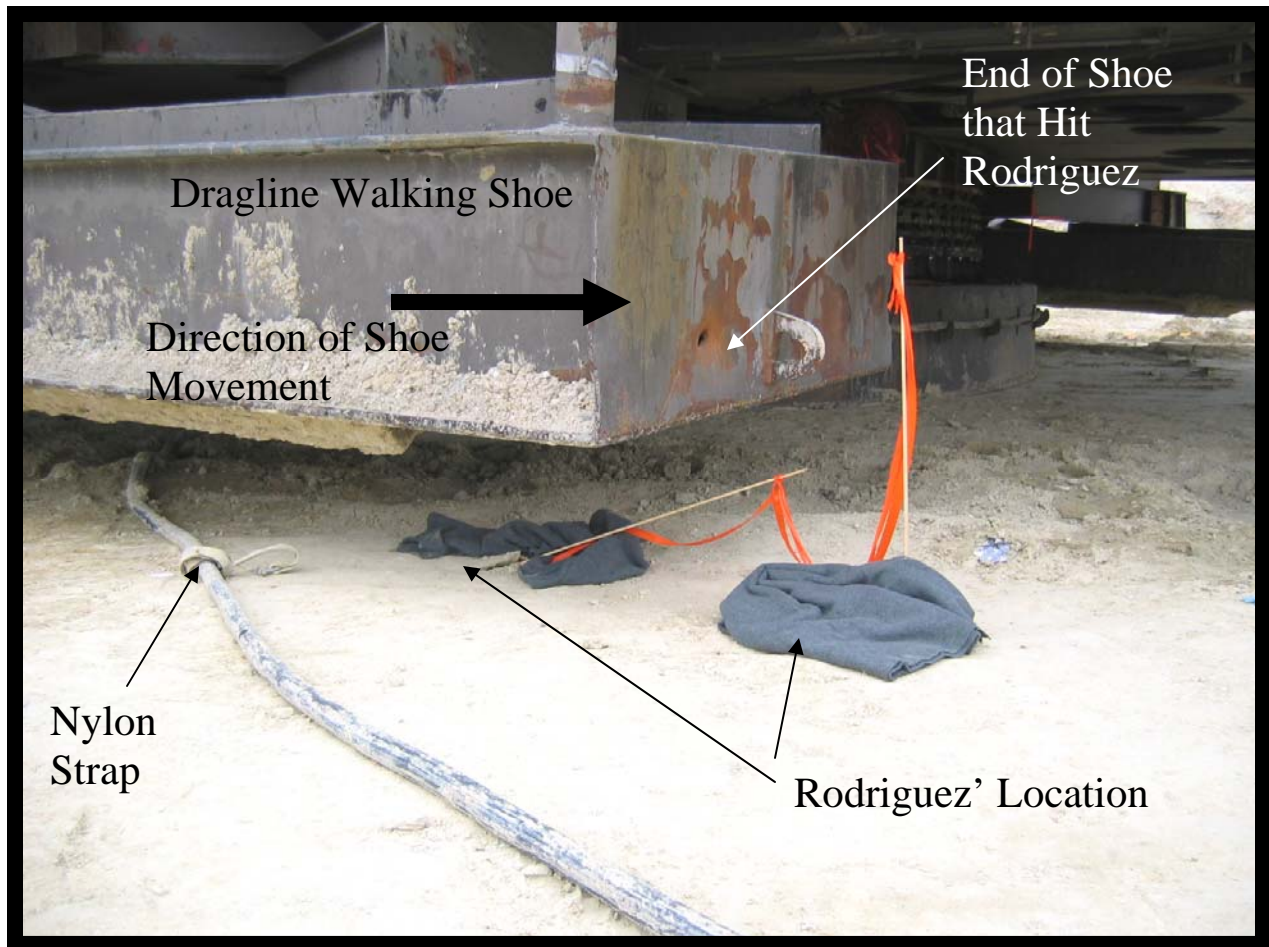
Appendix B

Root Cause: Management did not ensure consistent compliance with the job procedure of notifying the dragline operator and stopping operation before entering the shoe swing radius of the dragline. The victim entered the active shoe swing radius of the dragline while the dragline was in operation without notifying the dragline operator to cease operations.

Dragline Walking Shoe in Location where It Rotated and Struck Rodriguez

Corrective Action: Following the accident, management conducted safety meetings to train employees on procedures of not allowing anyone to work under the fantail section while draglines are in motion and to contact the dragline operator to stop the machine prior to entering the fantail swing area.

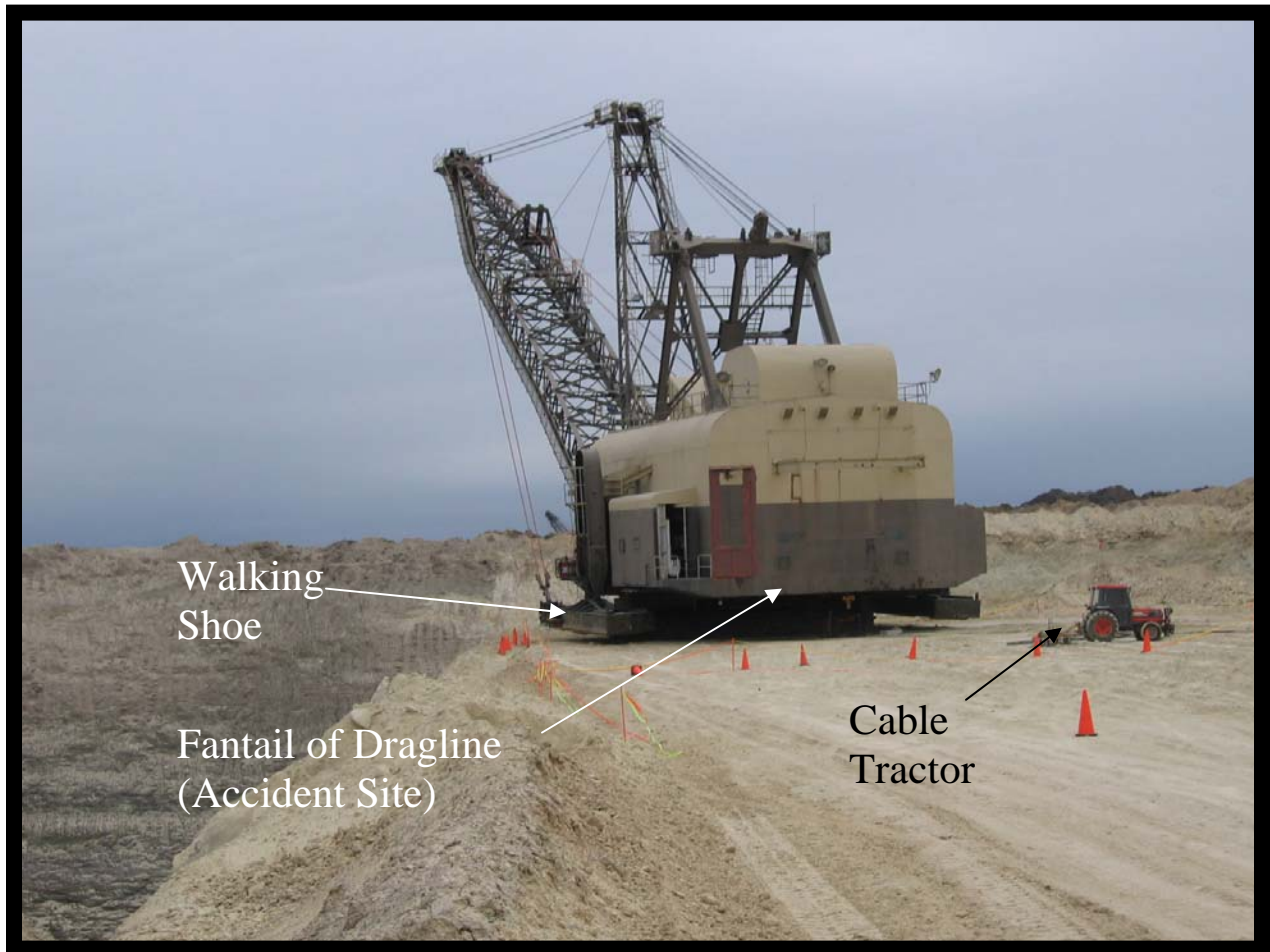
Appendix C

View of Page Model 740 Dragline and Cable Tractor

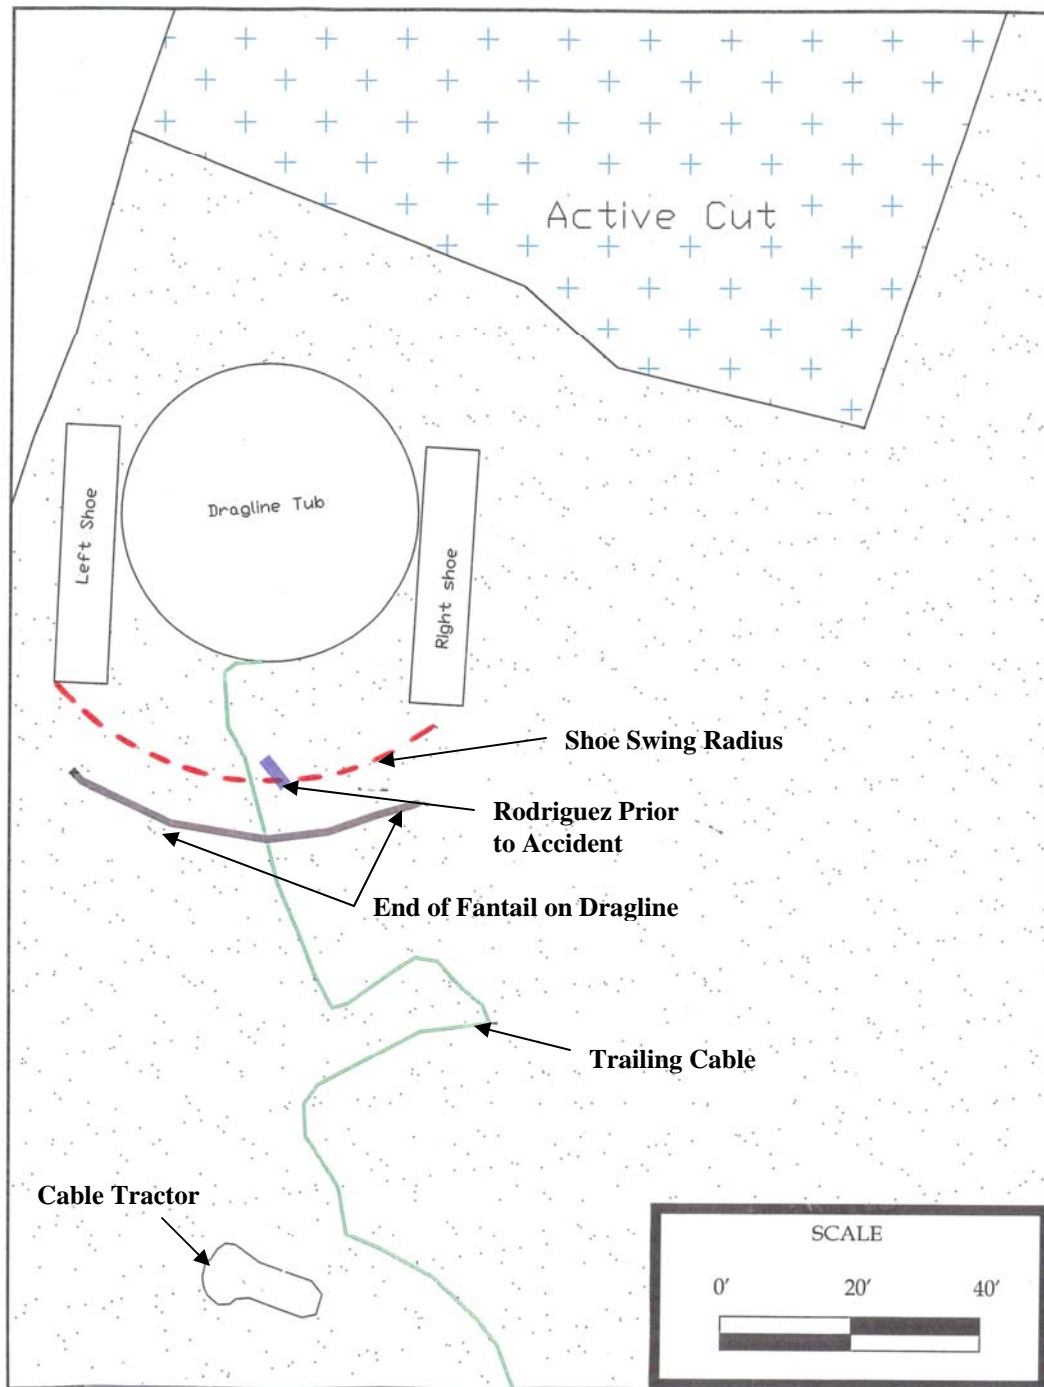
Appendix D

Plan View of Dragline in Digging Position Prior to Accident

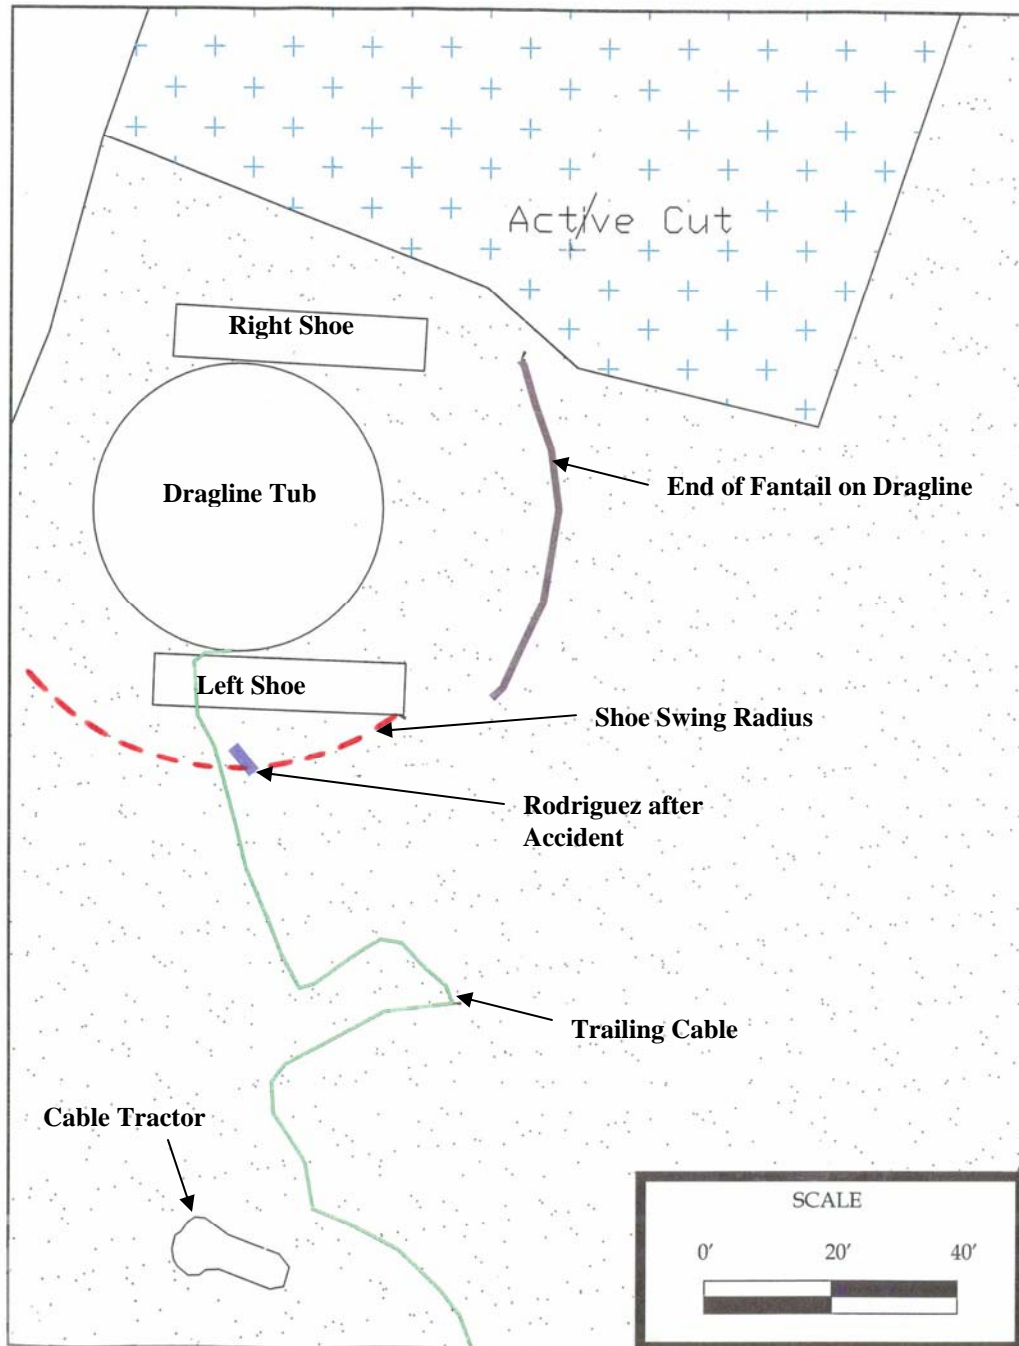
Appendix E

Plan View of Dragline in Dumping Position after Rodriguez Was Hit
