REPORT OF INVESTIGATION

Surface Facility  
Fatal Powered Haulage Accident  
December 12, 2007

Trimac Transportation Service, Inc.  
ID No. H5P  
at

Bear Canyon  
C.W. Mining Company  
Huntington, Emery County, Utah  
ID No. 42-02395

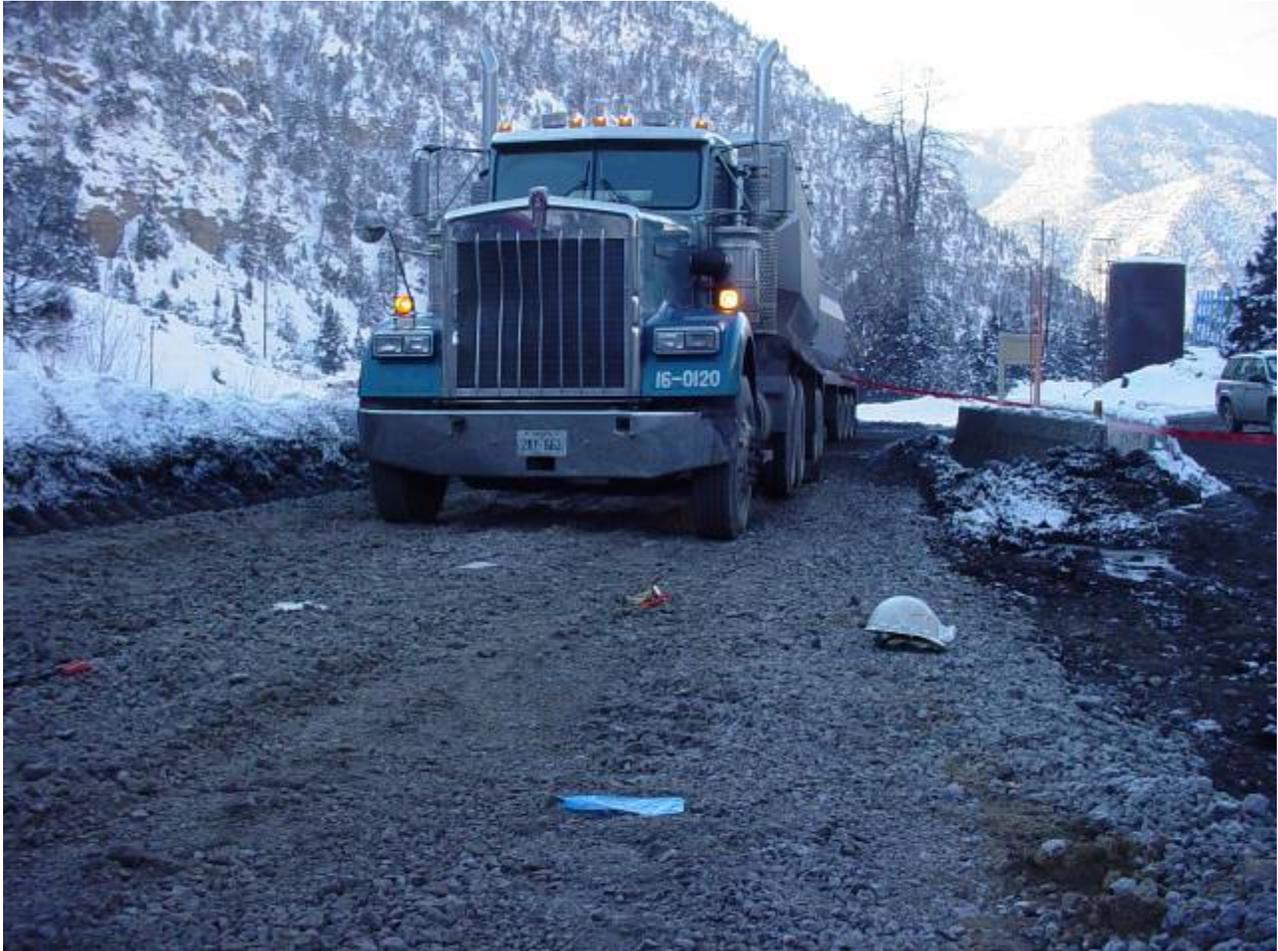
**VIEW OF ACCIDENT SCENE**

**VICTIM WAS CRUSHED AGAINST FRONT OF TRUCK BY  
FRONT-END LOADER**

**TRUCK WAS ON 8-9% UPHILL GRADE**

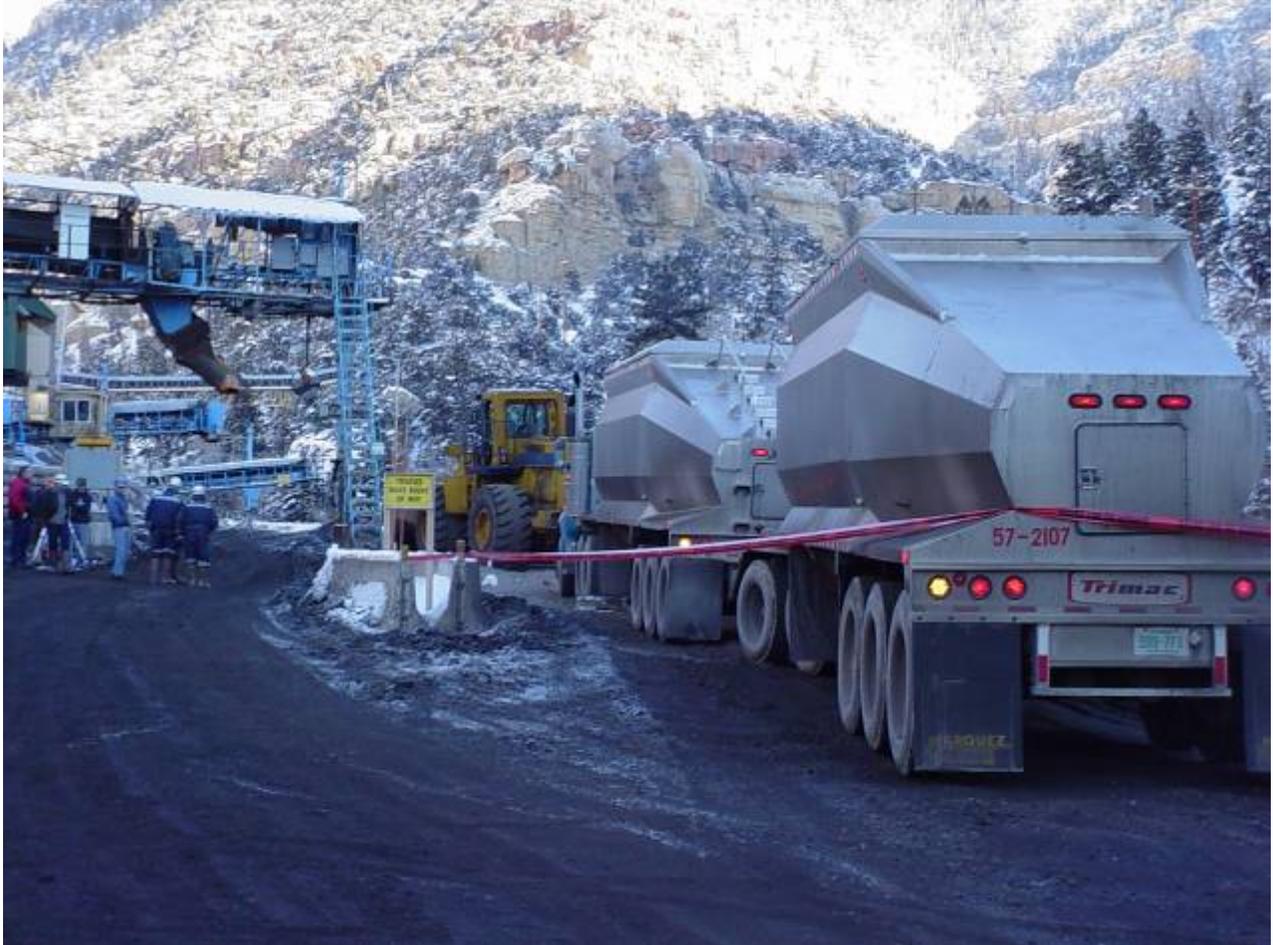
### View of Truck and Loader on Access Road

*Accident Location and Conditions:* The accident occurred just beyond the scales and weigh building on the unimproved roadway leading to the loadout. The area had received snowfall and inclement weather for several days preceding the accident. The snow, freezing and thawing made travel for the coal trucks very difficult and the loader operators stated that during a 12-hour shift, they assisted the tractor/trailers to the loadout 15 to 16 times. The roadway at the accident site was sloped approximately 8 to 9 percent uphill where Whiting's truck became stuck. A layer of loose gravel had recently been placed on the roadway in the accident location.
