REPORT OF INVESTIGATION

Fatal Machinery Accident  
April 18, 2007

United Mine  
United Taconite, LLC  
Eveleth, St. Louis County, Minnesota  
Mine I.D. No. 21-03403

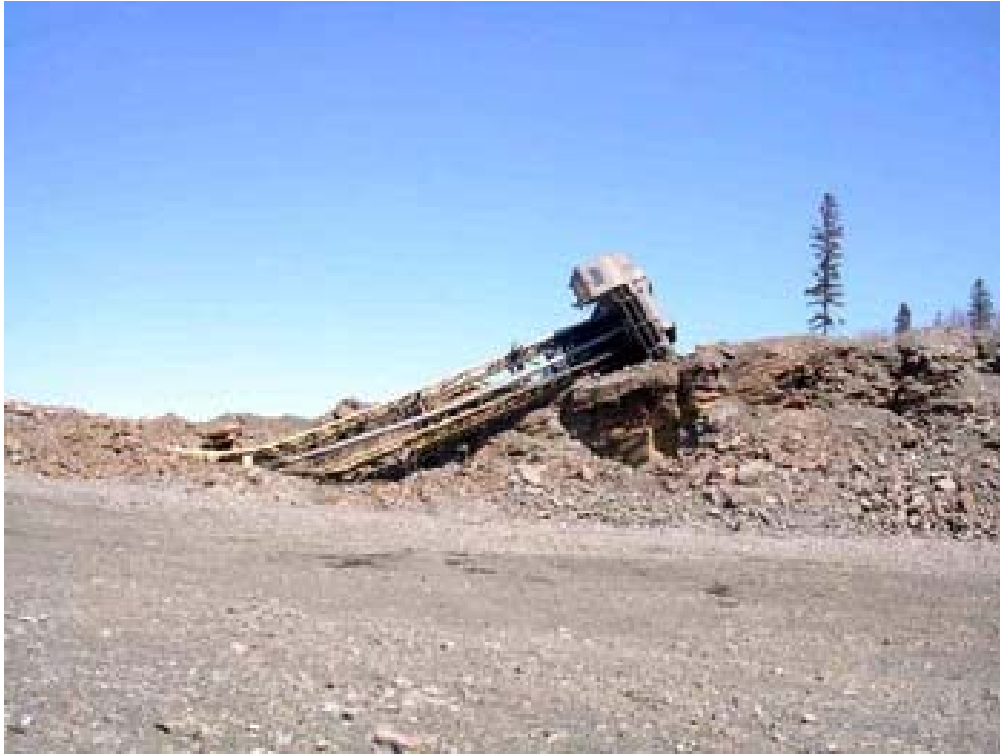
Post-Accident Position of Drill

At the time of the accident, the main tower of the drill was found fully elevated and locked in position, resting on the non-cab side, near the edge of a bench. The drill end of the machine had a surveyed side slope of 7.8 degrees with the non-cab side at the lower elevation. The ground at the opposite end of the machine (the non-drill end) had a side slope of 11.8 degrees with the non-cab side at the lower elevation.

The accident occurred on the next shift (day shift) when the leveling jack assembly at the drill end, non-cab side corner of the machine collapsed as a result of the failure of the remaining three bolts holding the cap plate to the jack assembly cylinder sleeve.

Corrective Action: Management should provide a stability/gradeability chart and train all persons operating the drill to ensure the machine is operated as specified by the manufacturer.

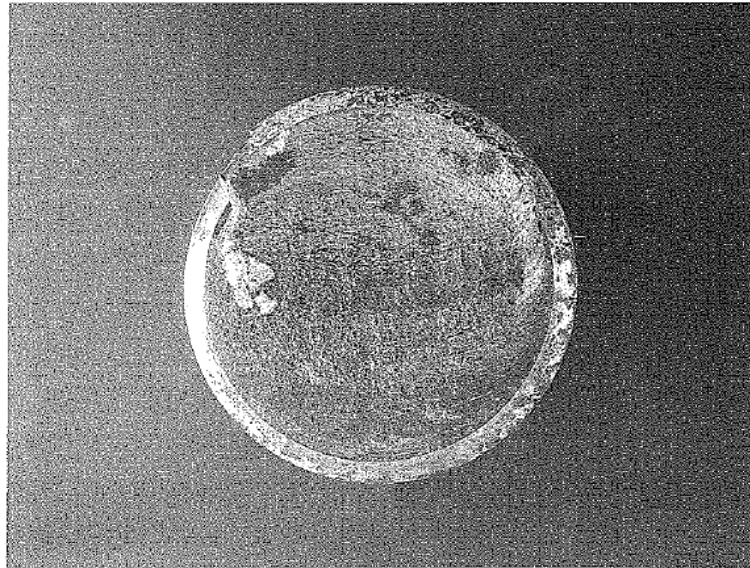
**Figure 1 Fracture Surface of Bolt Specimen 1**

Based on examination of the four bolts, three showed signs of fatigue where a small initial crack continually became larger over time due to a fluctuating load. The remaining bolt failed in a more sudden fracture with no signs of fatigue. After the four bolts failed, the cap plate separated from the cylinder sleeve. When this occurred, the load bearing capacity of the leveling jack assembly was lost, allowing the leveling jack assembly to collapse. As a result, the machine tipped over onto the non-cab side of the machine.

The purpose of this investigation was to evaluate four grade 8 bolts provided by Mine Safety and Health Administration to determine hardness, chemistry and microstructure. Bolts with identification 1, 3 and C all showed signs of fatigue by the presence of beachmarks on the fracture surface. The bolt that had a more sudden fracture with no signs of fatigue will be used for SEM analysis to find evidence of a ductile failure. The bolts were removed from the scene of a drilling rig accident and were delivered to Touchstone Research for analysis.

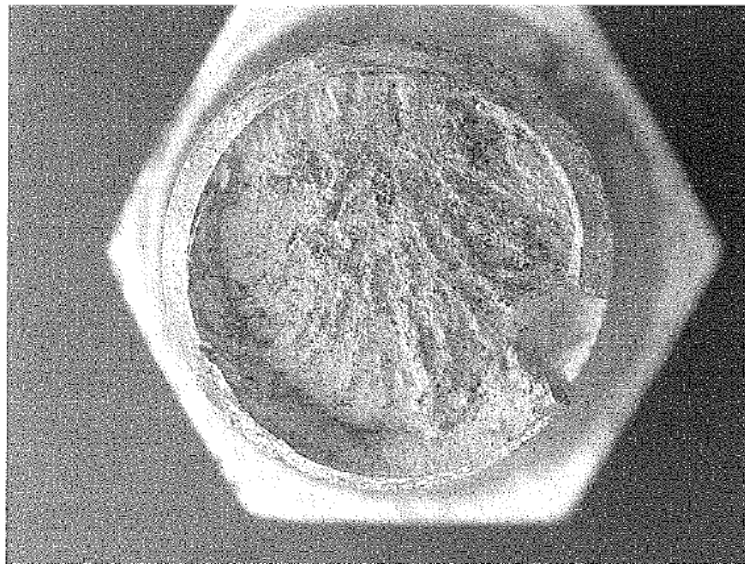
**Figure 4 Fracture Surface of Bolt Specimen X5**

The fracture surface from the bolt with identification 'X5' was removed by bandsawing. The cut was made approximately one-quarter of an inch from and parallel to the fracture surface. This section was cleaned in an ultrasonic bath with acetone for several minutes. Images were taken (Figures 5 and 6) and it was determined that dimples were present in the fracture surface that are a characteristic of ductile fracture, Metals Handbook, Volume 12 pg 220.

The analysis of the bolts and bolt sections found that the material used was within specifications for hardness and elemental composition. These values correspond to those obtained by manufacturer. The microstructure analysis concluded that the material was quenched and tempered. Dimples were discovered in the fracture surface of bolt with identification 'X5' which is characteristic of ductile failure.

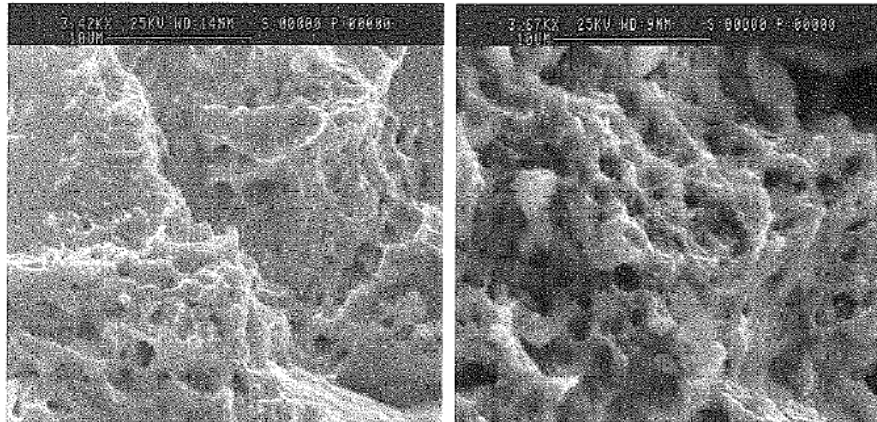
Figures 5, 6 Typical SEM micrographs Showing Characteristic Dimpled Rupture

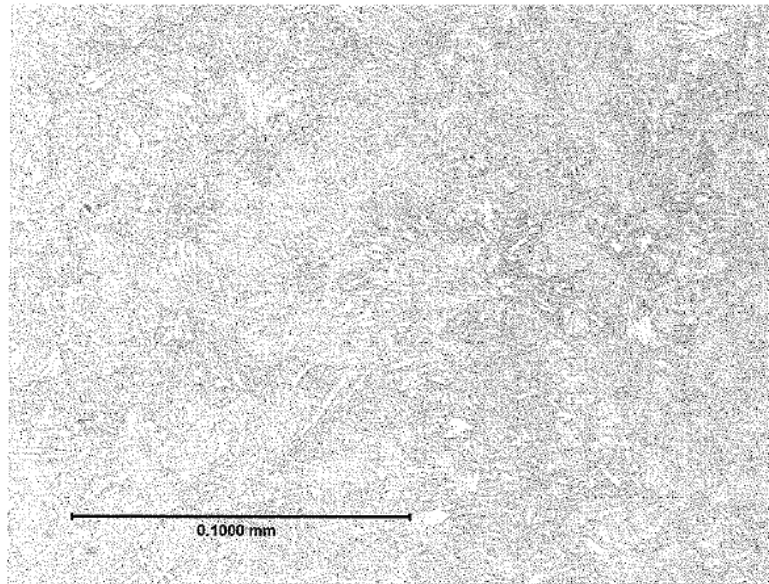
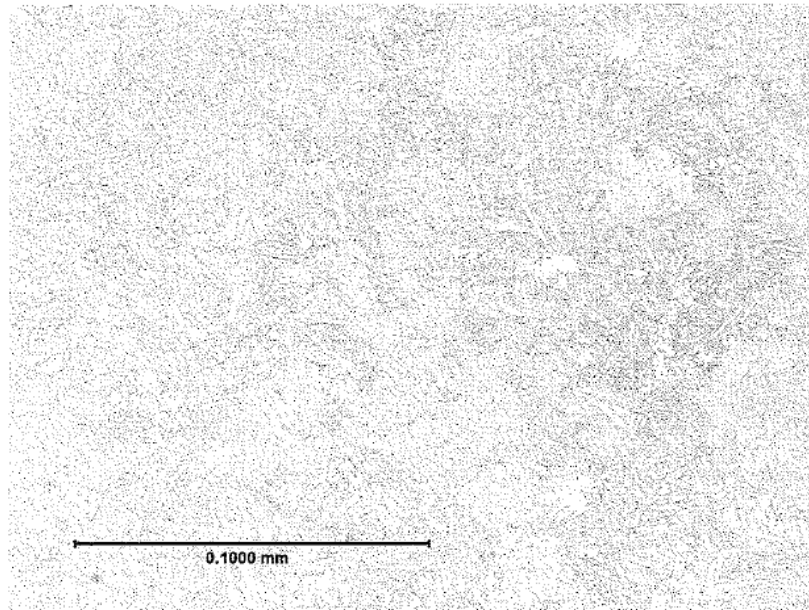
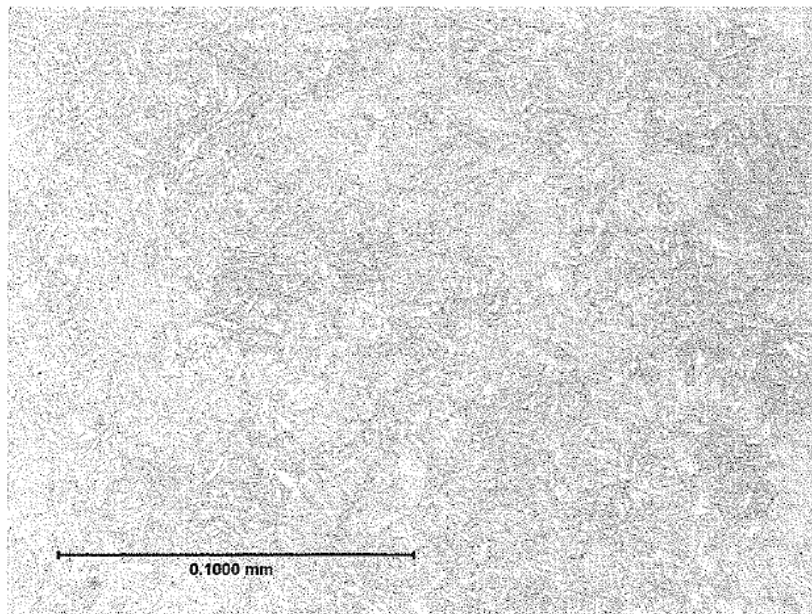
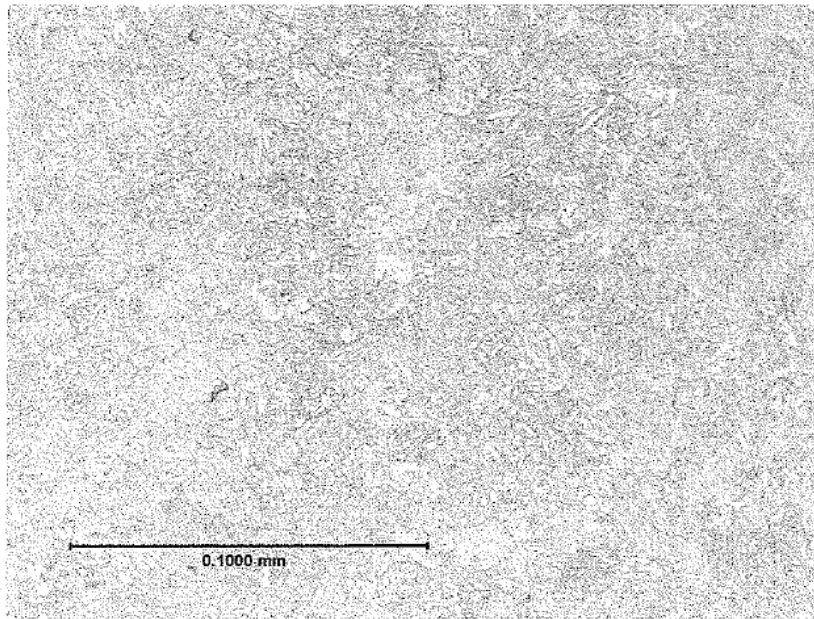
Pieces cut from the bolt head, as described in the Elemental Composition section, were also used for the microstructural analysis. A piece from each bolt was mounted in epoxy, polished and etched with 1% Nital. The specimens were then analyzed and photographed using a metallograph. It was determined that the bolts contained tempered martensite with small amounts of ferrite. (Figures 7-10) This indicated the bolts were quenched and tempered, Metals Handbook Vol. 7 8<sup>th</sup> Edition pg 30.
