REPORT OF INVESTIGATION

Fatal Powered Haulage Accident

April 25, 2007

Essroc Cement Corp.
Riverton Investment Corp.
Martinsburg, Berkeley County, West Virginia
Mine I.D. No. 46-00007

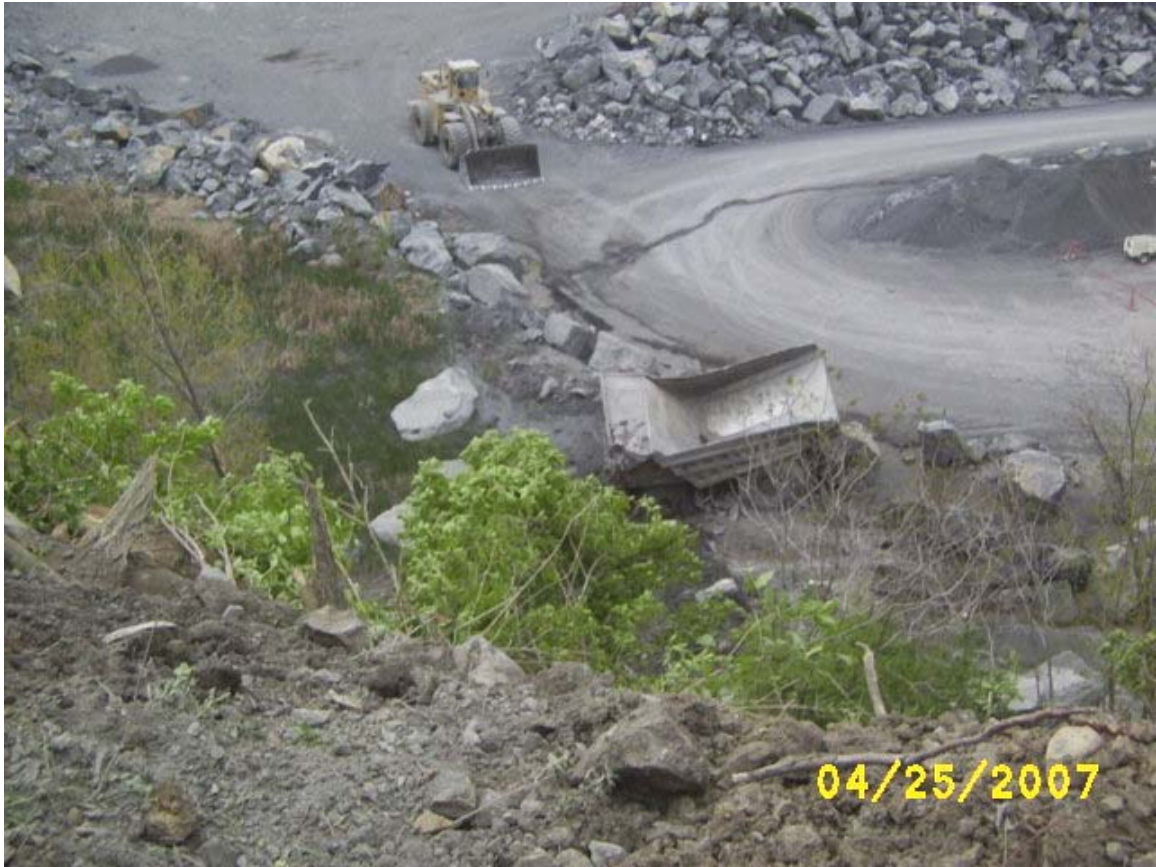
View of haul truck on the 740 Level where it landed after rolling from roadway above.

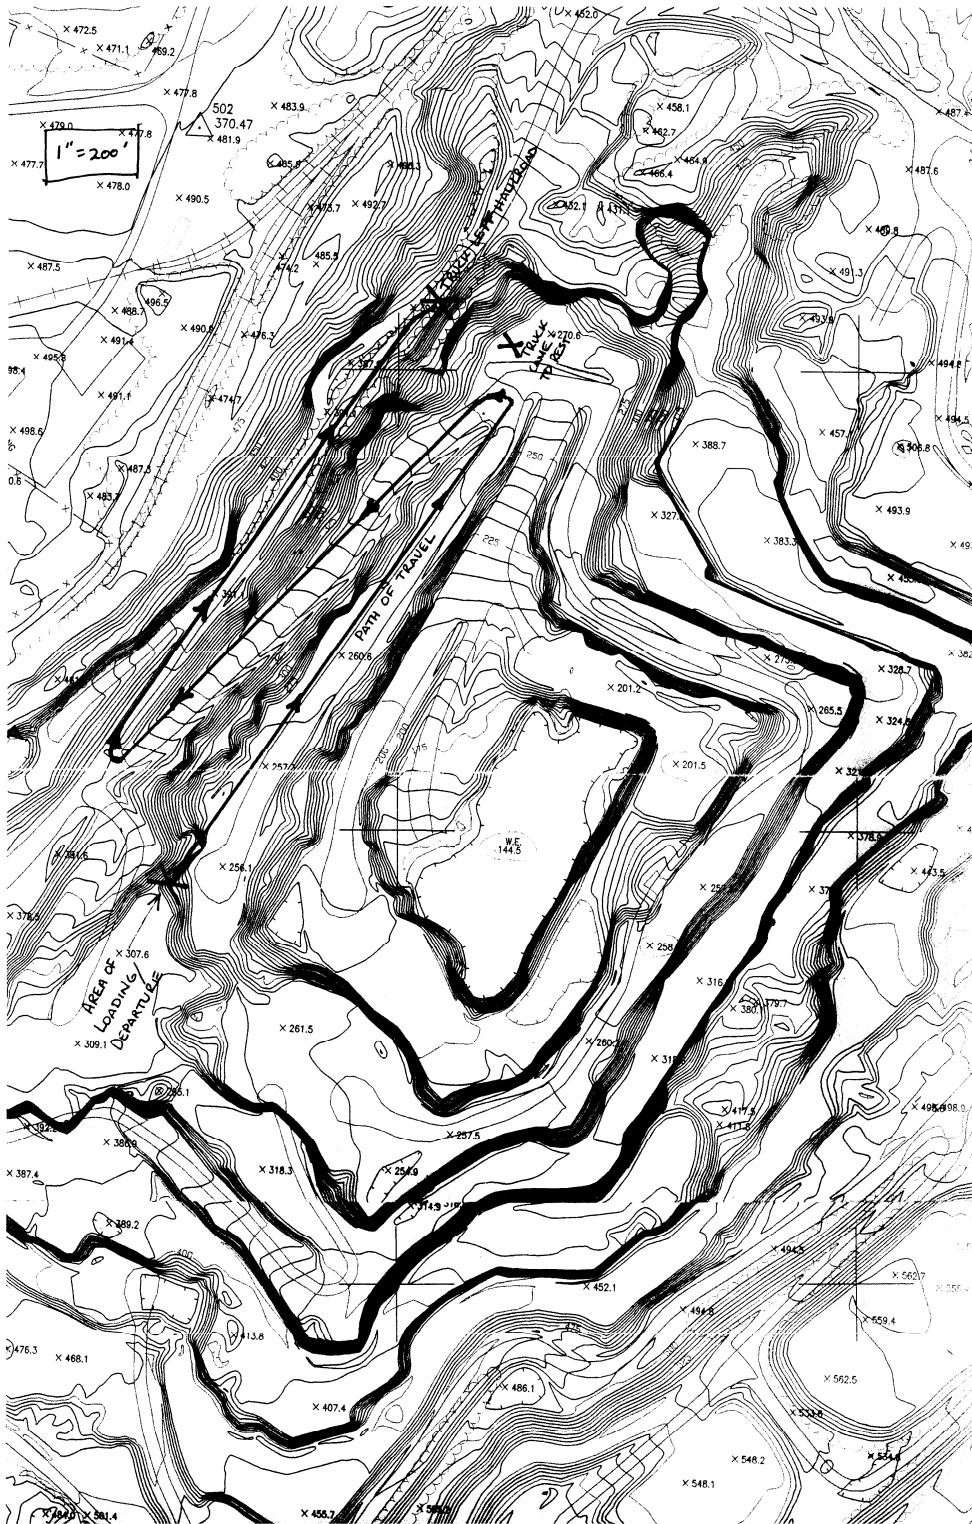
After the turn, tire tracks showed that the truck drifted to the right in a straight line for approximately 50 feet and then contacted and climbed the berm, traveled in a straight line for 30 feet, slid and rolled approximately 120 feet to the 740 level below. The waste dump was located approximately 1,000 feet from where the truck contacted the berm.

Figure 1 – Map showing the path of travel for the haul truck

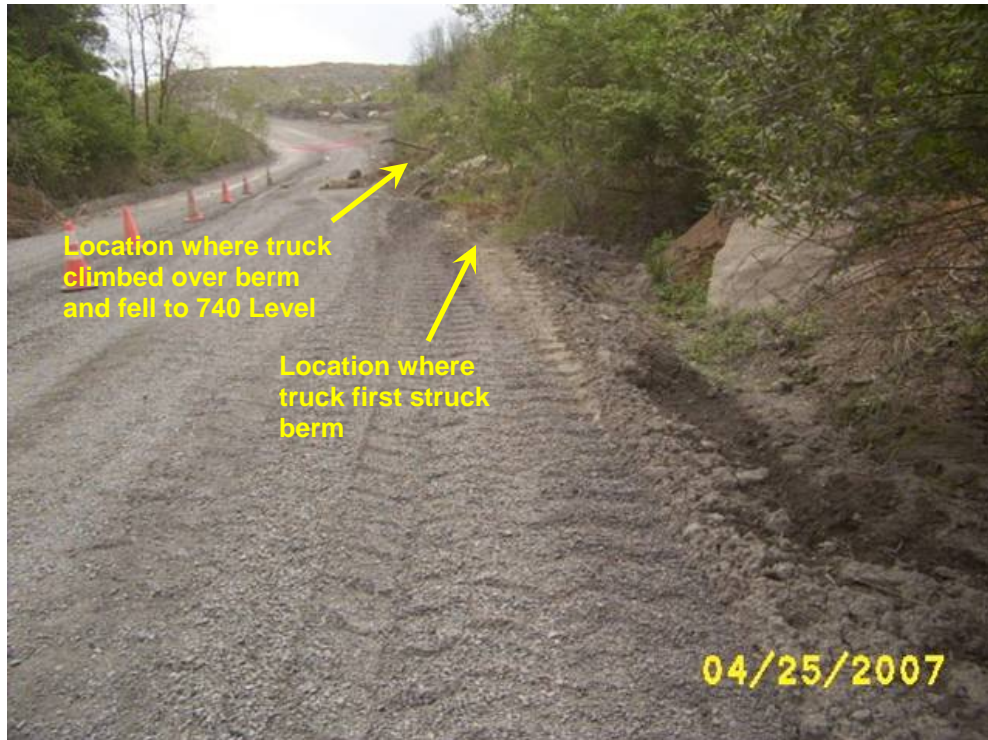
Figure 2 - Photo showing locations where truck left the haul road.

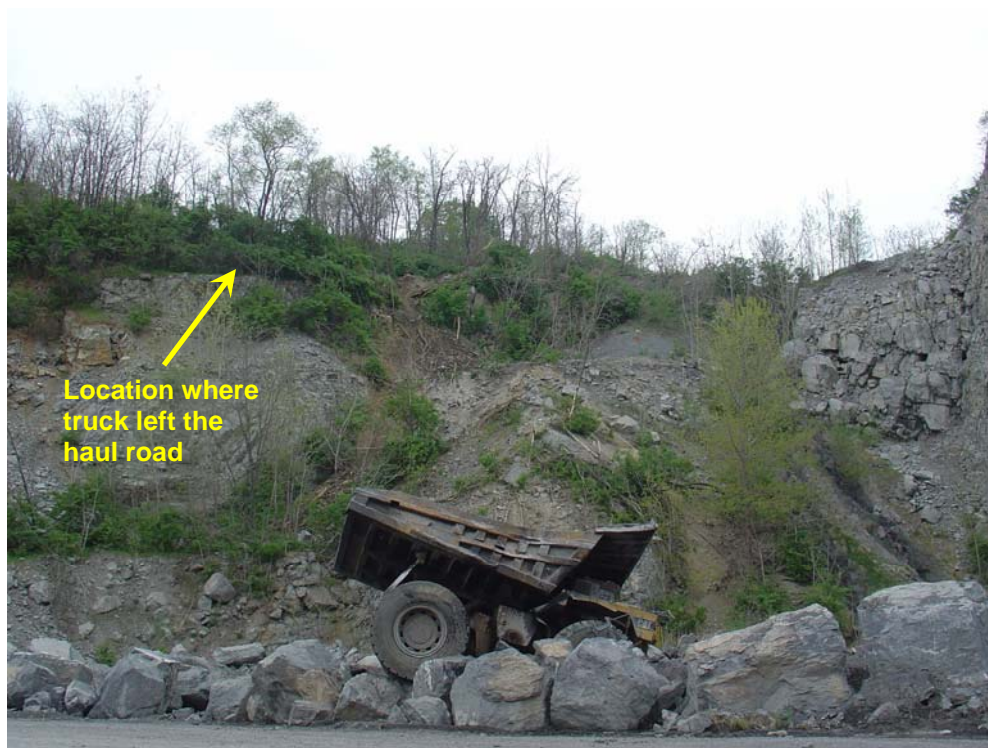
Charles A. Wroe, truck driver, age 65, was fatally injured on April 25, 2007, when the truck he was driving drifted off a road, climbed over a berm, slid on its side, and rolled over a highwall onto a bench approximately 120 feet below. The victim was ejected and found 60 feet from the truck on an adjacent haul road.

Figure 3 - Photo showing where truck came to rest on the 740 Level
