REPORT OF INVESTIGATION

**Underground Metal Mine
(Gold)**

**Fatal Powered Haulage Accident
June 19, 2007**

**Midas Mine
Newmont Midas Operations
Midas, Elko County, Nevada
Mine I.D. No. 26-02314**

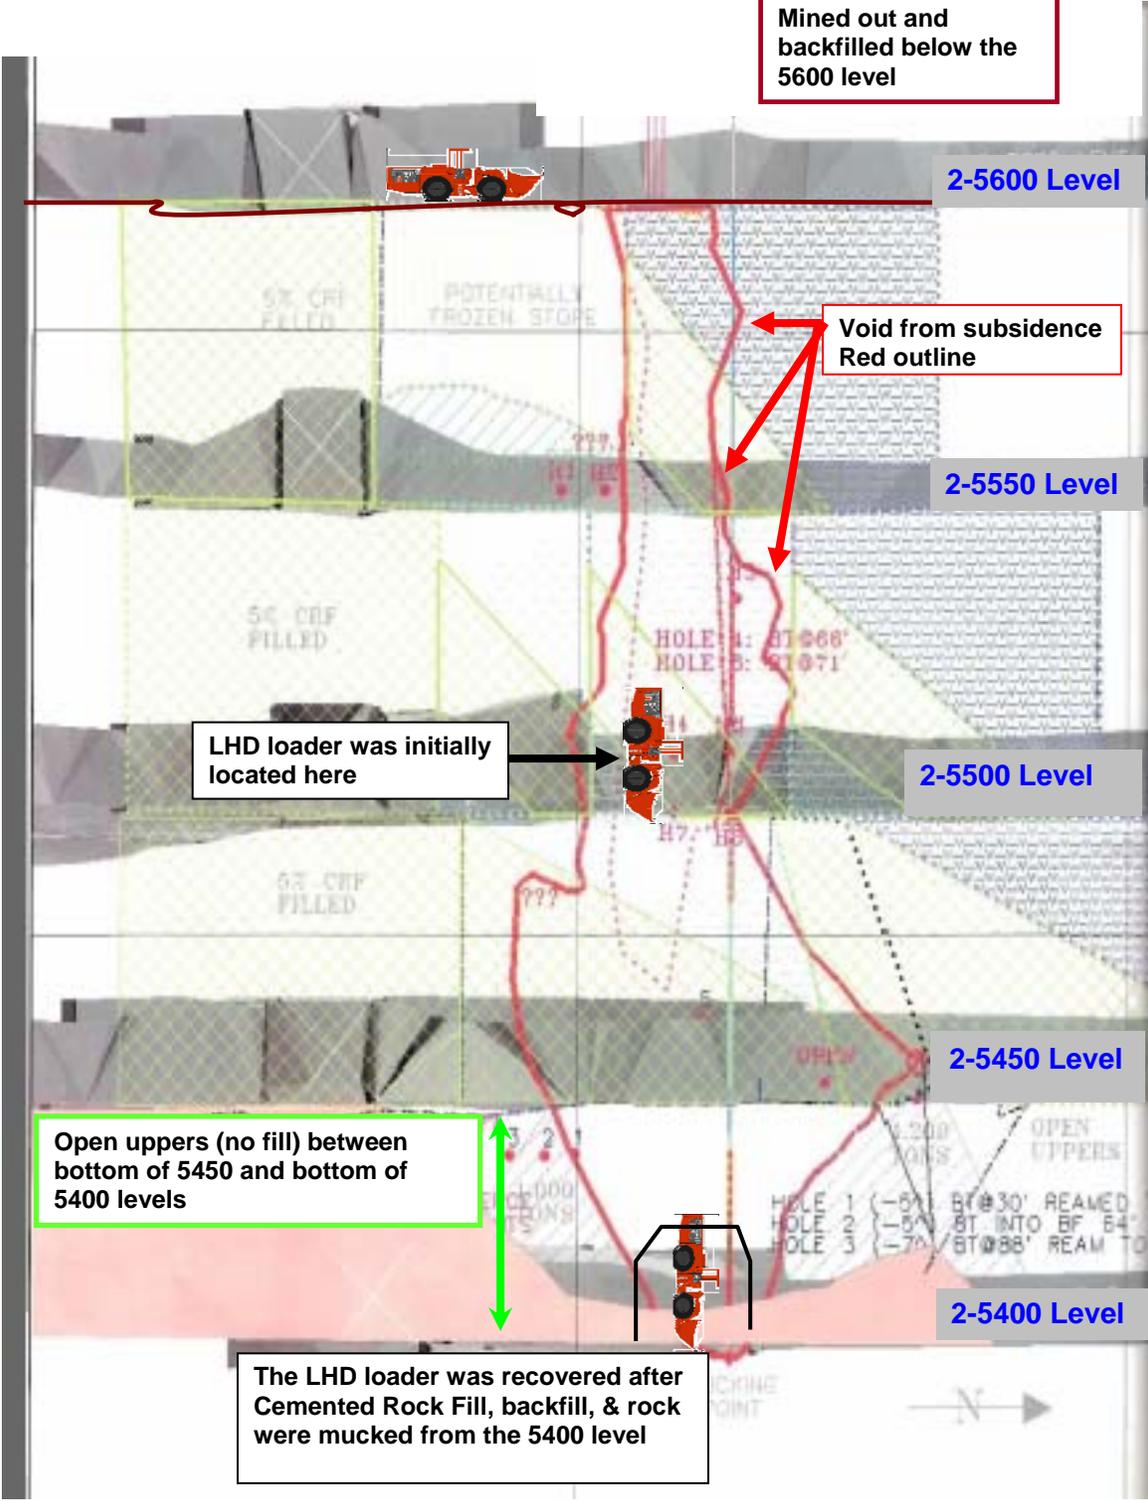
Mined out and backfilled below the 5600 level

Void from subsidence Red outline

LHD loader was initially located here

Open uppers (no fill) between bottom of 5450 and bottom of 5400 levels

The LHD loader was recovered after Cemented Rock Fill, backfill, & rock were mucked from the 5400 level
