REPORT OF INVESTIGATION

**Fatal Machinery Accident
July 19, 2007**

**Alaska Mechanical, Incorporated
Contractor I.D. No. LWI**

**Nome Operations
Alaska Gold Company
Nome, Nome County, Alaska
Mine I.D. No. 50-01850**

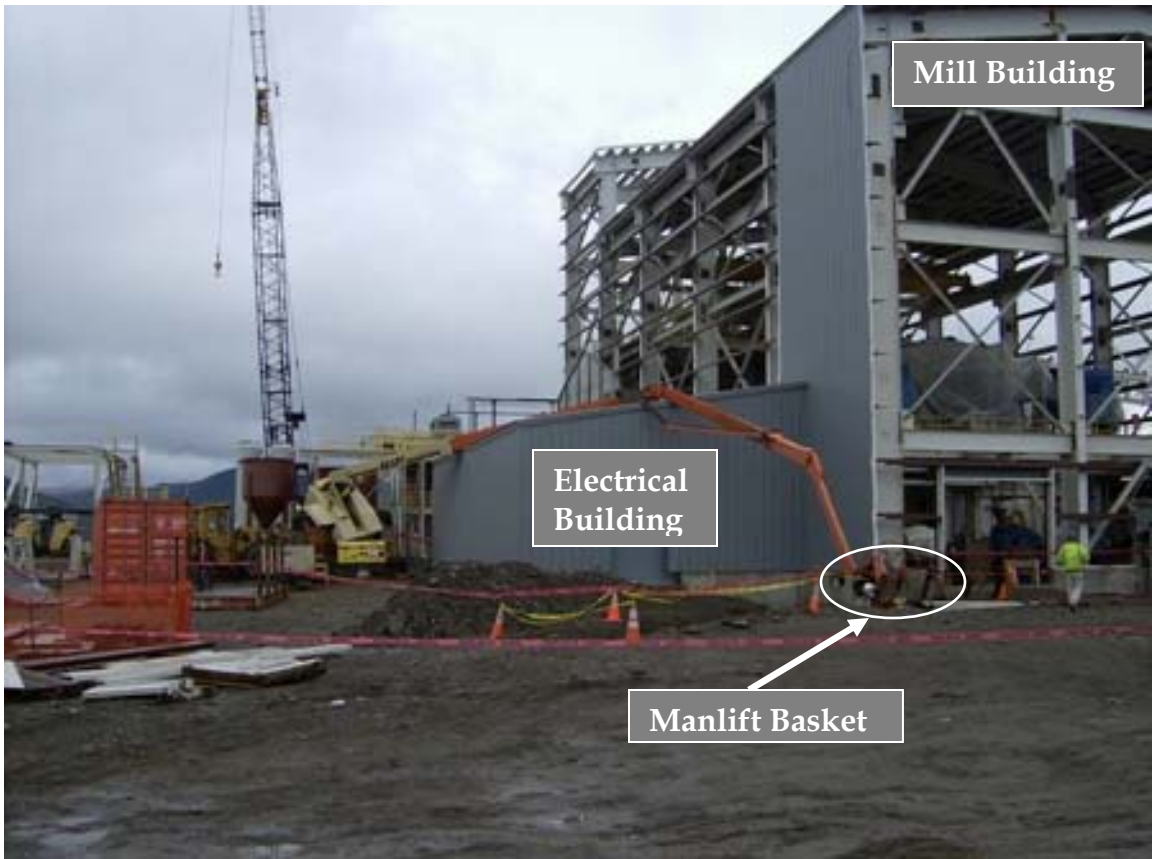
Mill Building

Electrical Building

Manlift Basket

During the accident, the JLG tipped over and the JLG's boom came to rest on the roof of the electrical main control building for the mill, which had prevented the JLG's chassis from tipping all the way onto its side.
