REPORT OF INVESTIGATION

**Fatal Powered Haulage Accident
July 24, 2007**

**Delta Pit & Plant
Delta Sand & Gravel Company
Eugene, Lane County, Oregon
Mine ID No. 35-00481**

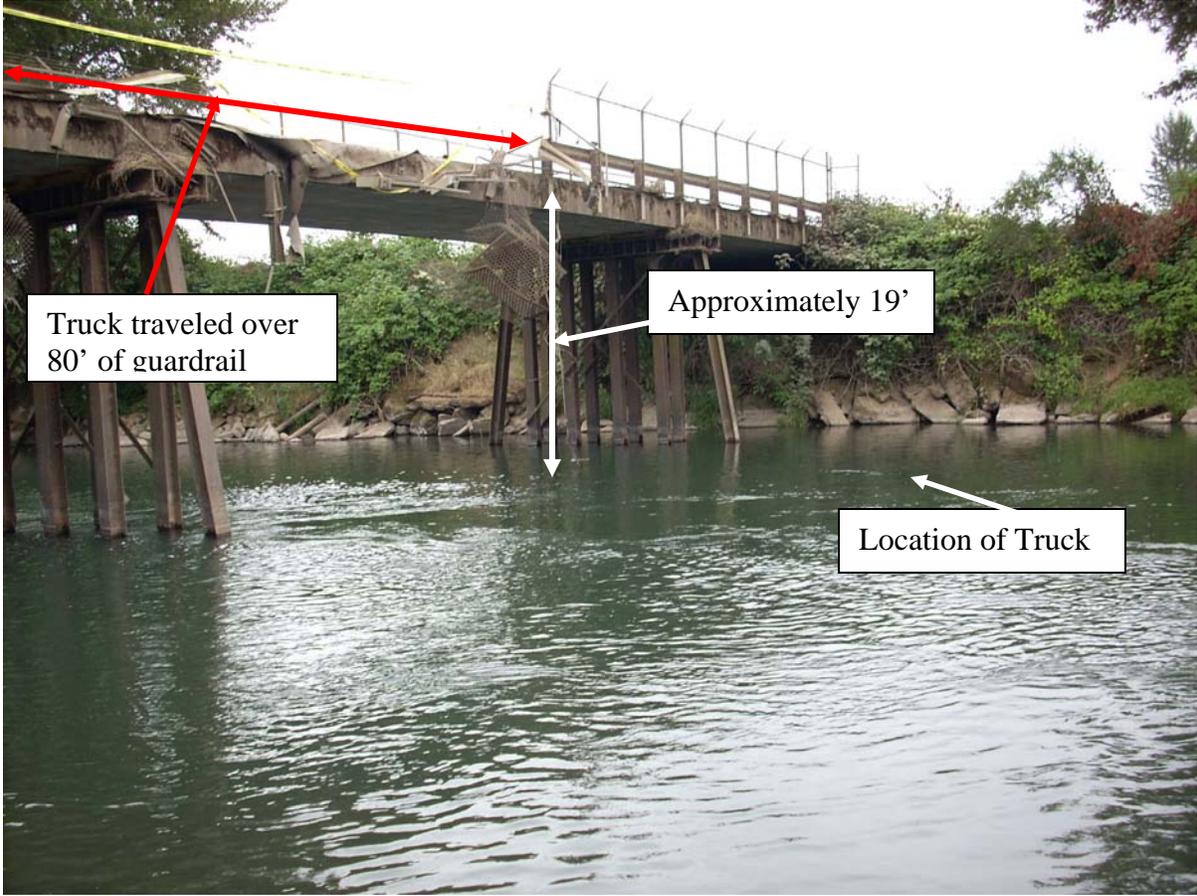
Mark T. Slinker, plant superintendent, age 57, was fatally injured on July 24, 2007, when the haul truck he was operating crossed a bridge, struck a guard rail, and landed in the river below. The victim was wearing a seat belt at the time of the accident.

The accident occurred because the truck driver did not maintain control of the truck. The investigation determined that the right front tire struck the guard rail. The impact damaged the tire causing it to lose air and adversely affect the victim's ability to steer the truck.
