METAL AND NONMETAL MINE SAFETY AND HEALTH
REPORT OF INVESTIGATION

Surface Nonmetal Mine
(Sand and Gravel)

Fatal Fall of Person Accident
August 29, 2007

Evans Gravel, Inc.
Evans Gravel, Inc.
Milford, Clermont County, Ohio
Mine I.D. No. 33-04358

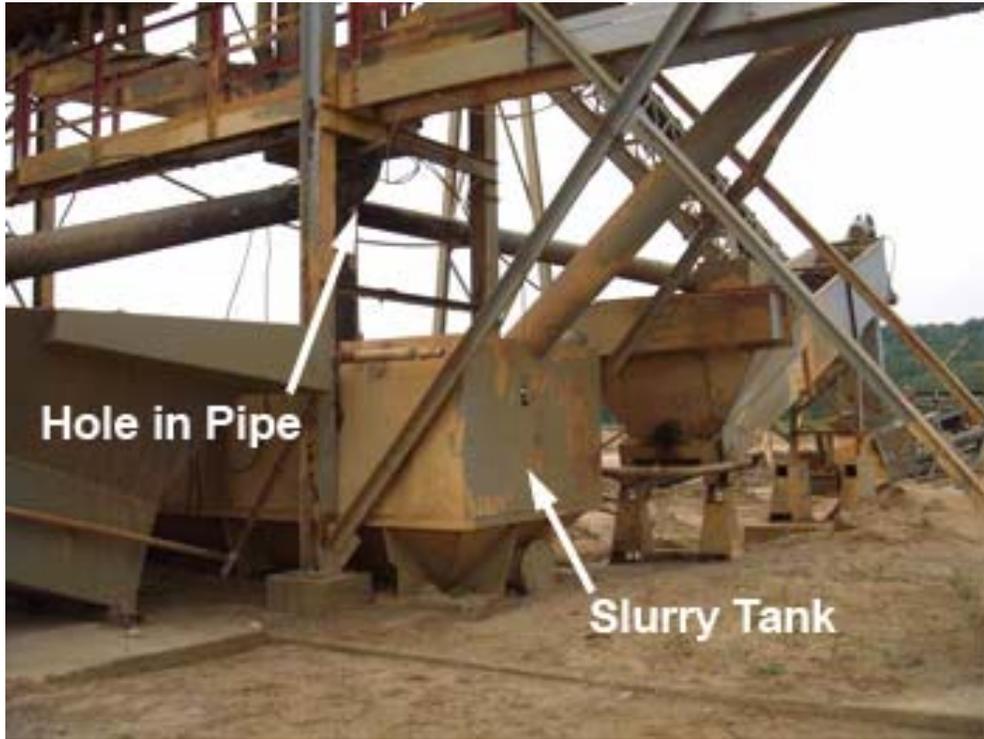
Hole in Pipe

Slurry Tank

The accident occurred at the sand plant's steel slurry tank positioned under a sand classifier. The tank was approximately 7 feet wide, 7 feet high, and 17 feet long. It contained a 12-inch pipe that ran along the bottom. The slurry tank was empty at the time and the plant was not operating.

A 12 inch diameter pipe discharged water and sand from the sand classifier into a sand screw for further conveyance. This pipe dropped out of the bottom of the classifier, made a right angle turn, and emptied into a sand screw. A 2- inch hole had worn through the steel pipe where the pipe made a right angle turn (elbow) allowing leakage into the slurry tank.

The pipe's elbow was located about 6 feet above the top middle of the slurry tank and 13 feet above ground.

The wooden plank involved in the accident was approximately 2-inches by 8-inches by 7 feet long. The plank had been placed over the sides of the tank to provide a work platform to weld a patch on a pipe. The same plank had been used as a work platform previously. The plank was rotted and decayed from age and exposure to weather. It broke into 4 larger pieces and numerous smaller portions.

Corrective Action: Management should establish policies, procedures, and controls to ensure that persons can safely perform tasks when working at elevated locations of the plant. A work platform should be substantially constructed. Persons should be monitored to ensure hazards from falling are discussed and safe work procedures are established before beginning work.
