REPORT OF INVESTIGATION

Fatal Fall of Person Accident
October 25, 2007

Oro Grande Constructors-Amec-Zachry Joint Venture
Contractor I.D. No. M255

Oro Grande Quarry
Riverside Cement Company
Oro Grande, San Bernardino County, California
Mine I.D. No. 04-00011

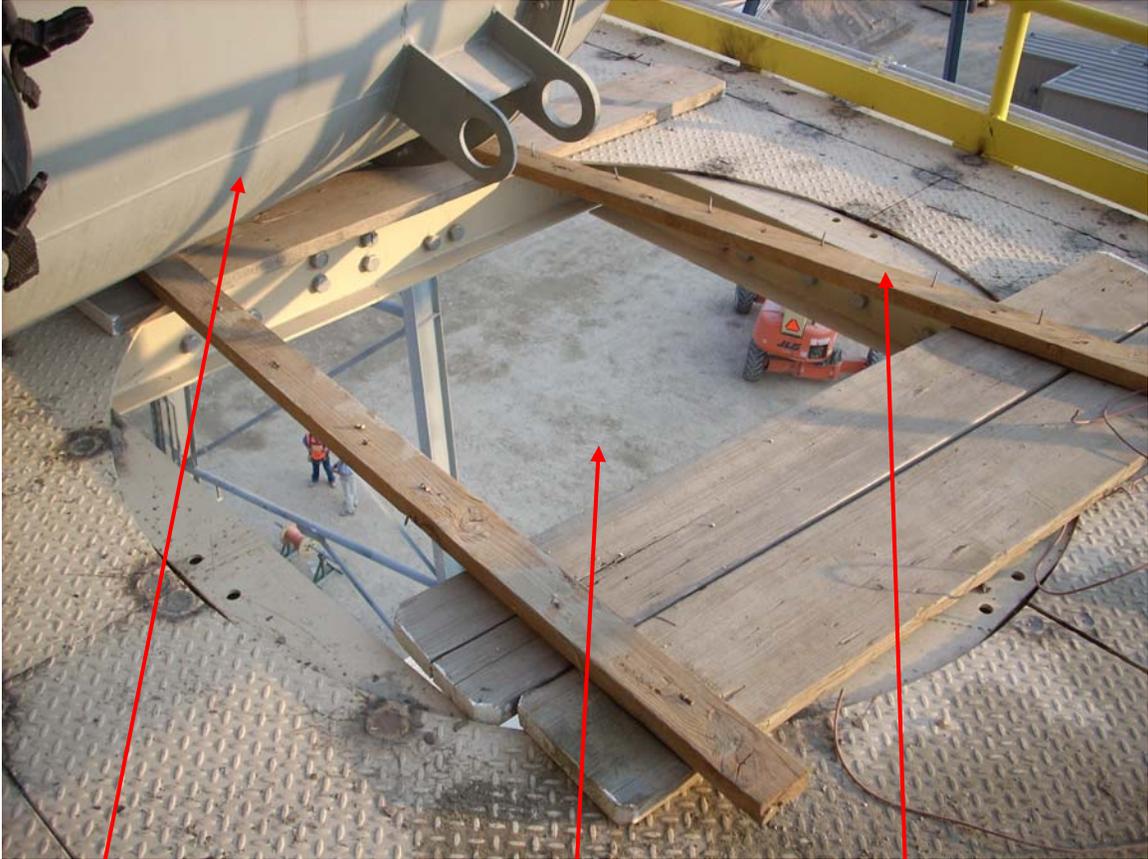
Photo of accident scene

Air receiver tank

Opening in deck

Overturned 2-inch by 4-inch platform board

After the accident, investigators found that only three planks were across the opening on the deck. The planks came loose when some of the nails used in construction failed to hold the planks and boards together as the victim stepped on the platform. One of the boards was still nailed to the planks. The other board

was lying upside down with the nails sticking up across the three remaining planks.

Corrective Actions: Contractor management should establish policies and procedures to ensure that persons are trained to substantially construct and maintain platforms in good condition. Prior to beginning work, potential risks should be discussed and procedures established to safely complete the task.

This citation was terminated on February 5, 2008. A substantially constructed platform was provided to cover the opening. A square barricade was also placed around the area of the covered opening.
