REPORT OF INVESTIGATION

Surface Nonmetal Mine
(Limestone)

Fatal Handtools Accident
October 24, 2007

Delphi Limestone Company
US Aggregates, Inc.
Delphi, Carroll County, Indiana
Mine I.D. No. 12-00023

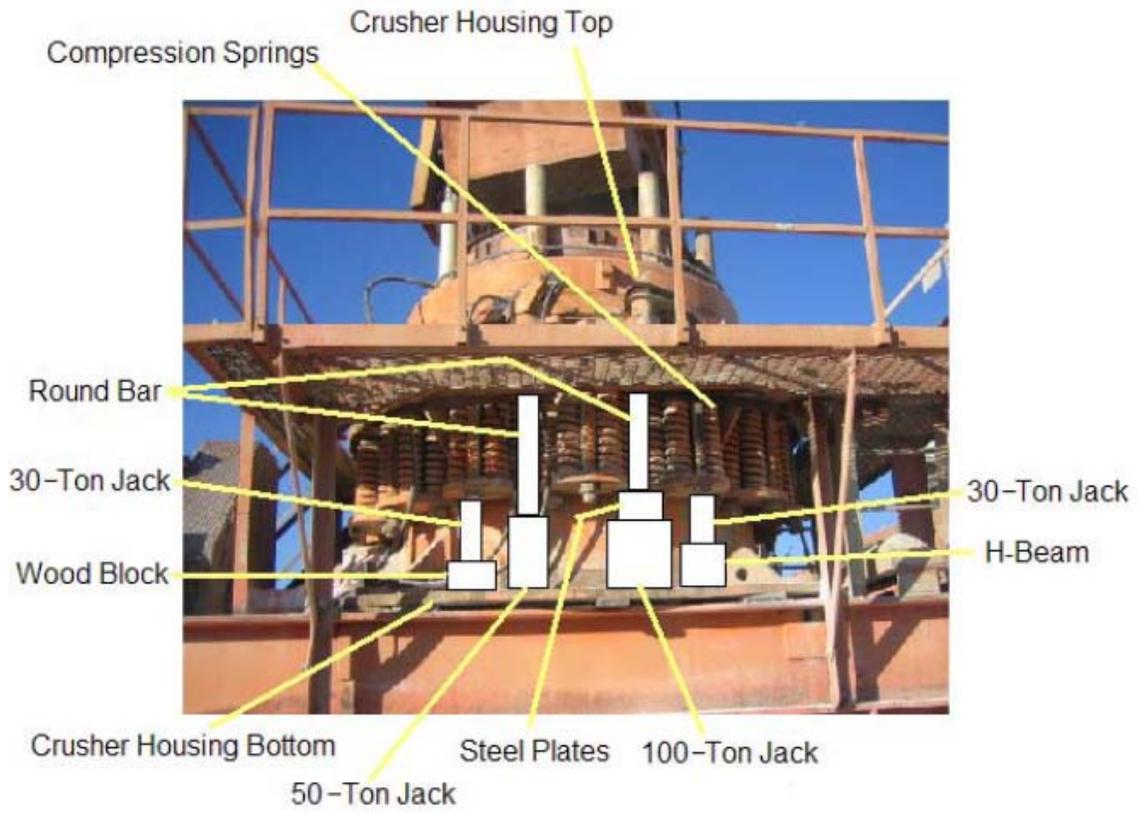
APPENDIX B

Material was placed above and under the jacks to extend their reach because they had short ram heights.

A 30-ton jack was resting on a wooden block with the ram pressing against the crusher's lower spring segment. A 50-ton jack was positioned to rest on the main crusher frame with a round steel tail pulley shaft on top of the ram pressing against a lug on the upper section of the crusher. A 100-ton jack was resting on the main frame with a stack of various steel plates on the jack's ram. A round steel tail pulley shaft was positioned on top of the plates to press against a lug on the crusher's upper section. Another 30-ton jack was resting on a steel H-beam with the ram pressing against the crusher's lower spring segment. A ¼-inch steel chain had been placed in front of the round steel tail pulley shafts to prevent movement.

The jacks were not designed to be used in conjunction with steel plates and shafts as extensions. The following citation was issued:

Approximate arrangement of the jacks and supports.

Corrective Action: Management should develop and implement procedures to ensure that persons can safely remove objects lodged in the crusher. The manufacturer's procedures should be followed to clear a blocked crusher. Analyze and manage each task to evaluate possible hazards and ensure steps are taken to safely perform the task.

This citation was terminated on February 26, 2008, after the mine operator installed an electrically operated hydraulic system to raise the crusher's upper section to remove tramp steel blocking the crusher. This system eliminates the former procedure of using portable hydraulic bottle jacks to raise the upper section. Training was provided to persons using the new hydraulic system.
