REPORT OF INVESTIGATION

Surface Metal Mine
(Copper)

Fatal Fall of Person Accident
October 11, 2007

Pinto Valley Operations
BHP Copper Inc.
Miami, Gila County, Arizona
Mine I.D. No. 02-01049

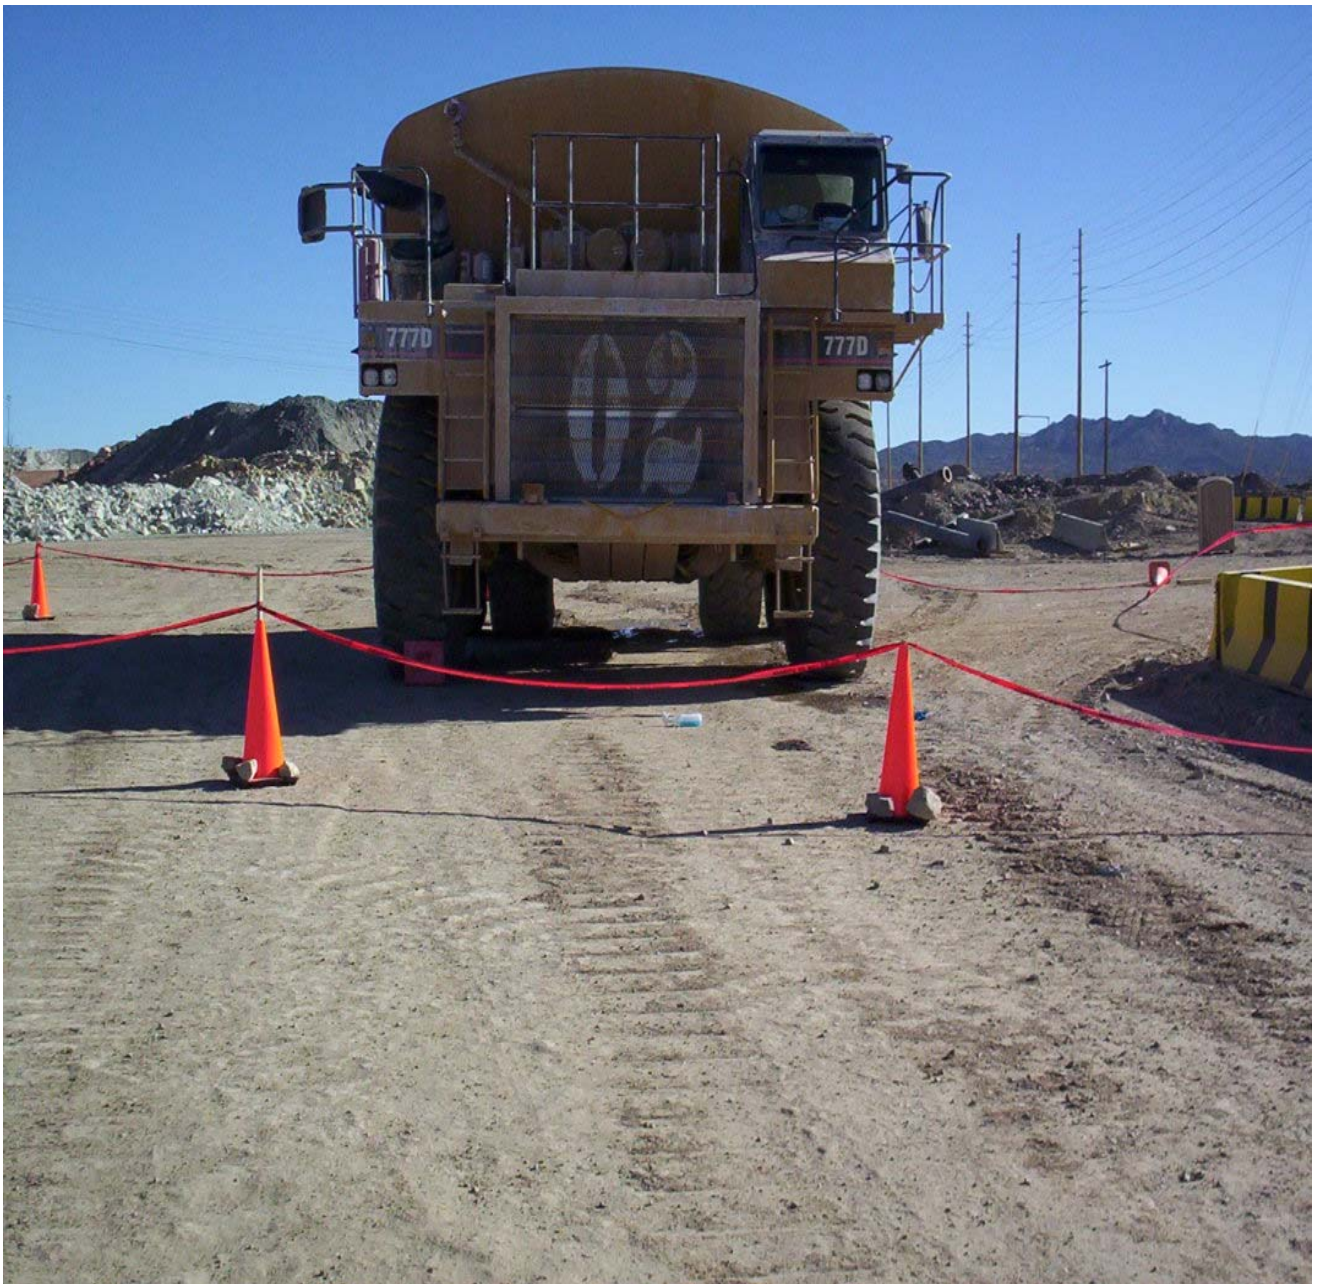
The victim was found on dry ground in front of a ladder that provided access to the cab of the water truck.

The vehicle involved at the accident was a Caterpillar, Model 777D haul truck converted into a water truck. The capacity of the water tank was 10,000 gallons. A ladder was positioned to the left of the truck allowing persons to access the deck to the right or left side of the cab. The deck was 10 feet above the ground. The ladder was 8 feet 6 inches and the first step was 18 inches above the ground. The opening at the top of the ladder and deck measured 2 feet 5 inches.
