REPORT OF INVESTIGATION

Fatal Electrical Accident
September 14, 2007

Aker Kvaerner Industrial Constructors, Inc.
Contractor ID No. 1PL

Freeport-McMoRan Safford Inc.
Freeport-McMoRan Safford Inc.
Safford, Graham County, Arizona
Mine ID No. 02-03131

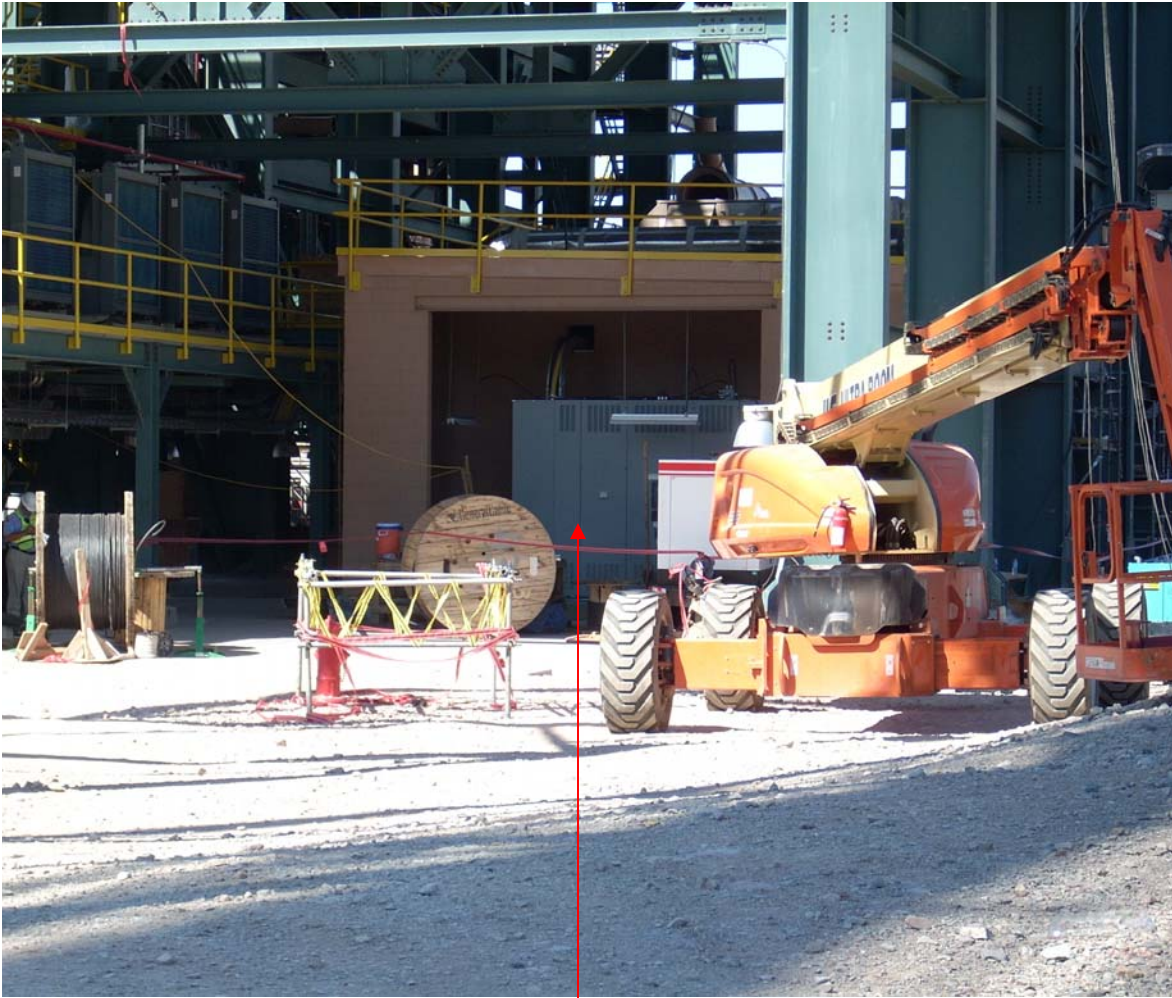
5.2 Motor Control Center building

The accident occurred at the switchgear located in the new 5.2 MCC building near the secondary crusher.
