REPORT OF INVESTIGATION

**Underground Metal Mine
(Uranium)**

**Fatal Fall of Rib Accident
May 26, 2010**

**Pandora Complex
Denison Mines (USA) Corporation
La Sal, San Juan County, Utah
Mine ID No. 42-00470**

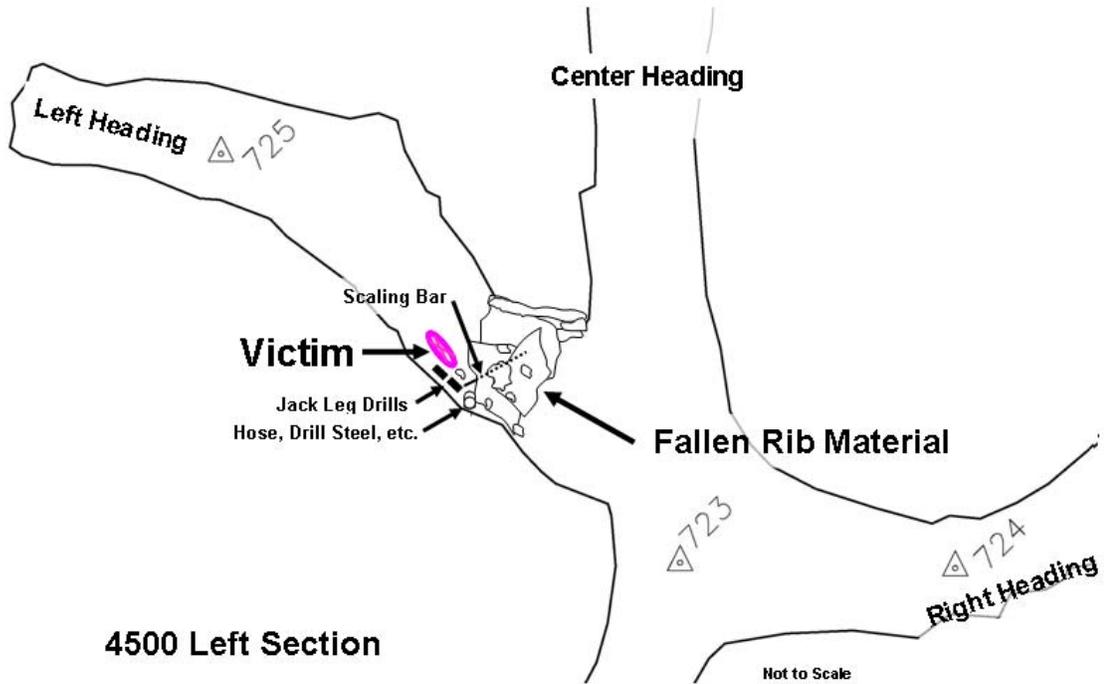
APPENDIX C

The accident occurred in the entrance of the drift accessing the left heading of the 4500 left section of the mine. The face of the drift was approximately 51 feet from the victim's location. The drift was approximately 12 feet wide and 12 feet high. Two days before the accident, this area was scaled and cleaned up in preparation for driving a ventilation drift from this area to another section of the mine on the 5000 level. This area had been inactive during the previous 18 months.

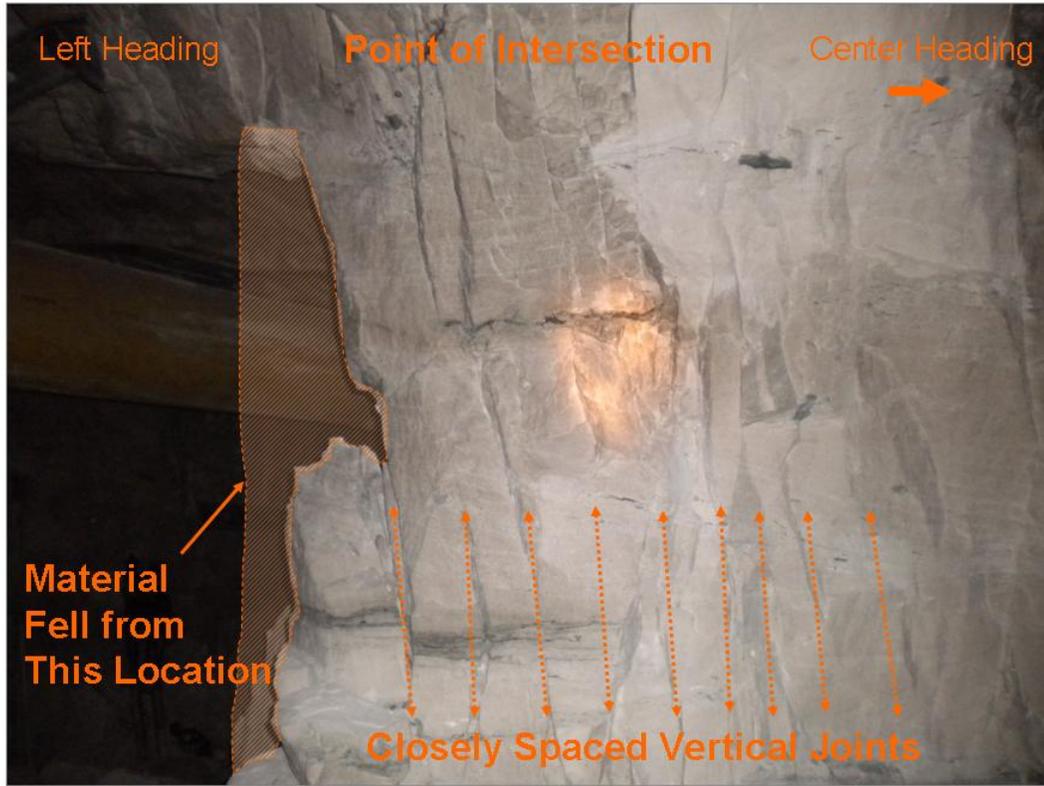
APPENDIX D

The mined sandstone had a distinct vertical joint set. Joints were naturally occurring fractures where there had been no lateral movement in the plane of the

fracture of one side relative to the other. Joints generally occurred as sets, with each set consisting of joints roughly parallel to each other. Joint sets were formed when the rock layers were compressed and stretched as they were being uplifted. The mine's dominate joint set had a direction of approximately North 110 degrees East. The joints at the mine had a random spacing of several inches to several feet. Numerous closely spaced joints, between 3 and 8 inches apart, over a distance of 12 feet, were observed in the right rib at the intersection of 4500 left, center heading and 4500 left section, left heading (See Appendix D).

These closely spaced joints were observed in the roof crossing the intersection and intersecting the mine rib between the left and center headings at what is commonly referred to as the point (or nose) of the intersection. These joints at the point of the intersection ran parallel to the left rib in the 4500 left section, left heading. The orientation of both the left heading and the closely spaced joint set contributed directly to the rib failure.
