REPORT OF INVESTIGATION

Fatal Powered Haulage Accident
July 11, 2011

Voyager #7
Martin County Coal
Inez, Martin County, Kentucky
ID No. 15-19193

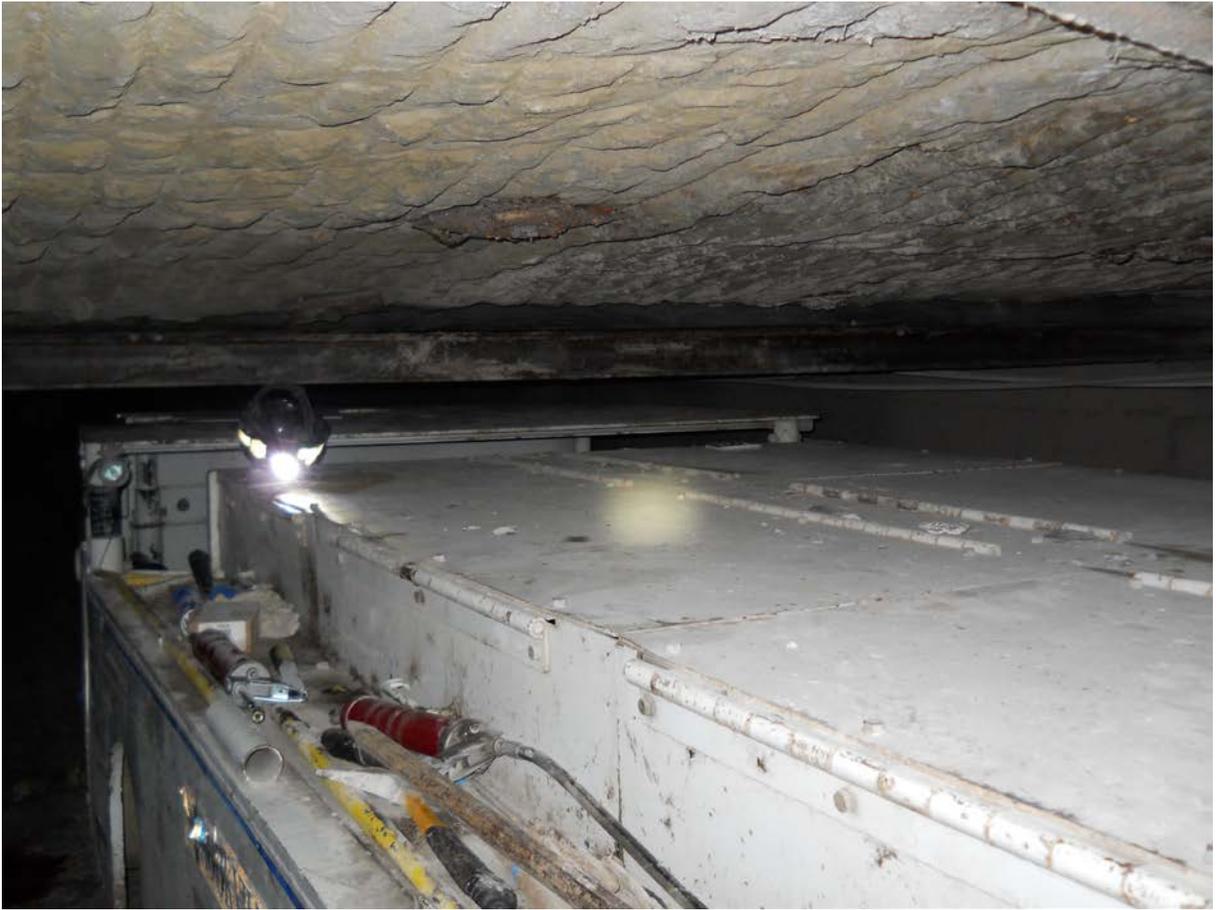
ACCIDENT SITE

On Monday, July 11, 2011, at approximately 6:45 p.m., Ryan K. Thatcher was fatally injured while operating a 15-ton supply locomotive or motor. Mr. Thatcher was 26-years-old and had six years of mining experience. The locomotive he was operating was pulling two loaded supply cars into the mine to an area of low, overhead clearance at a return overcast. The compartment where the operator is located in the locomotive is covered by a retractable cover which had been left open. This allowed the victim to place his body outside the protective compartment in order to get a better view of the load he was pulling. The victim's fatal injuries were a result of his body being caught between the return overcast and the locomotive operator's compartment cover.

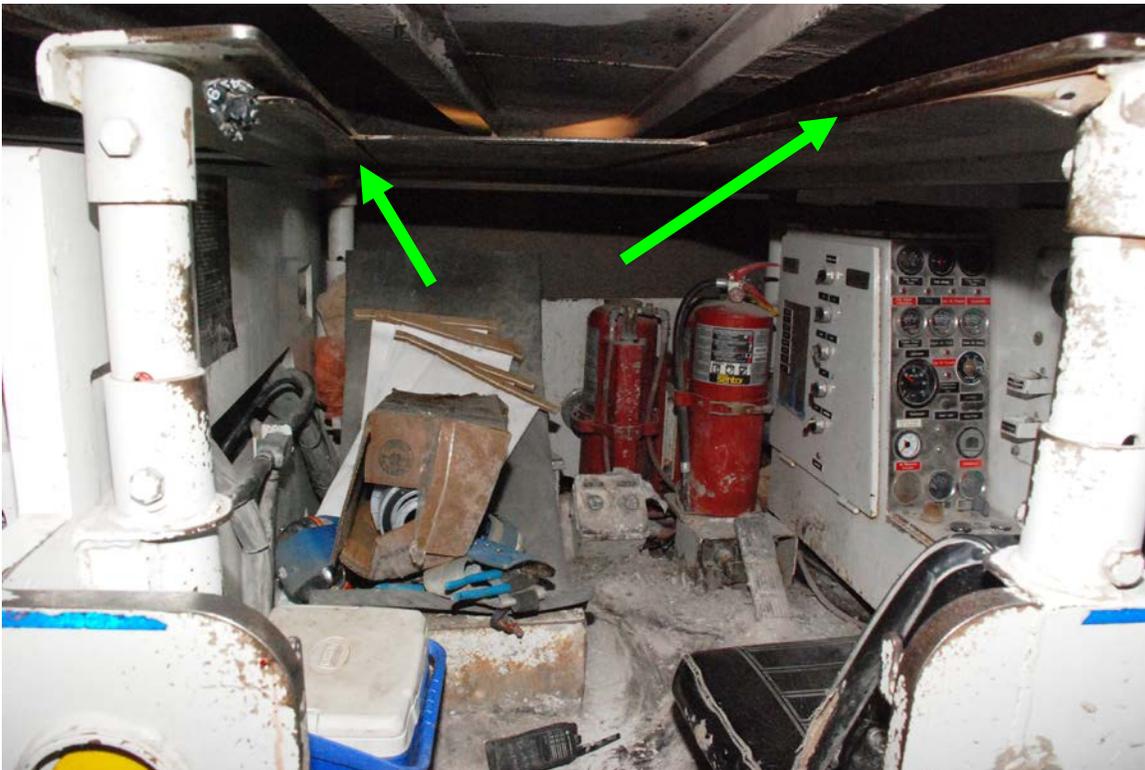
The retractable canopy was in the "Open" position allowing the equipment operator to extend his head through the opening.

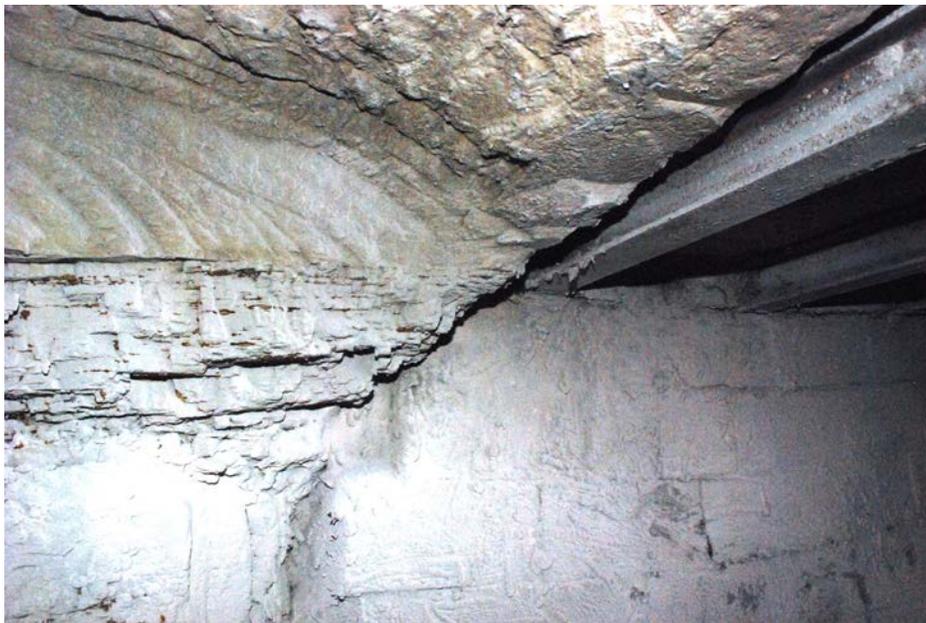
The accident occurred in an area where a return overcast had been built near the No. 1A Belt Drive. The mine roof at this location is predominately sandstone. This influenced the amount of roof that was cut out for this overcast. The lower than usual height has been determined to have contributed to the accident.

The overall mining height was lower in the accident area due to sandstone roof.

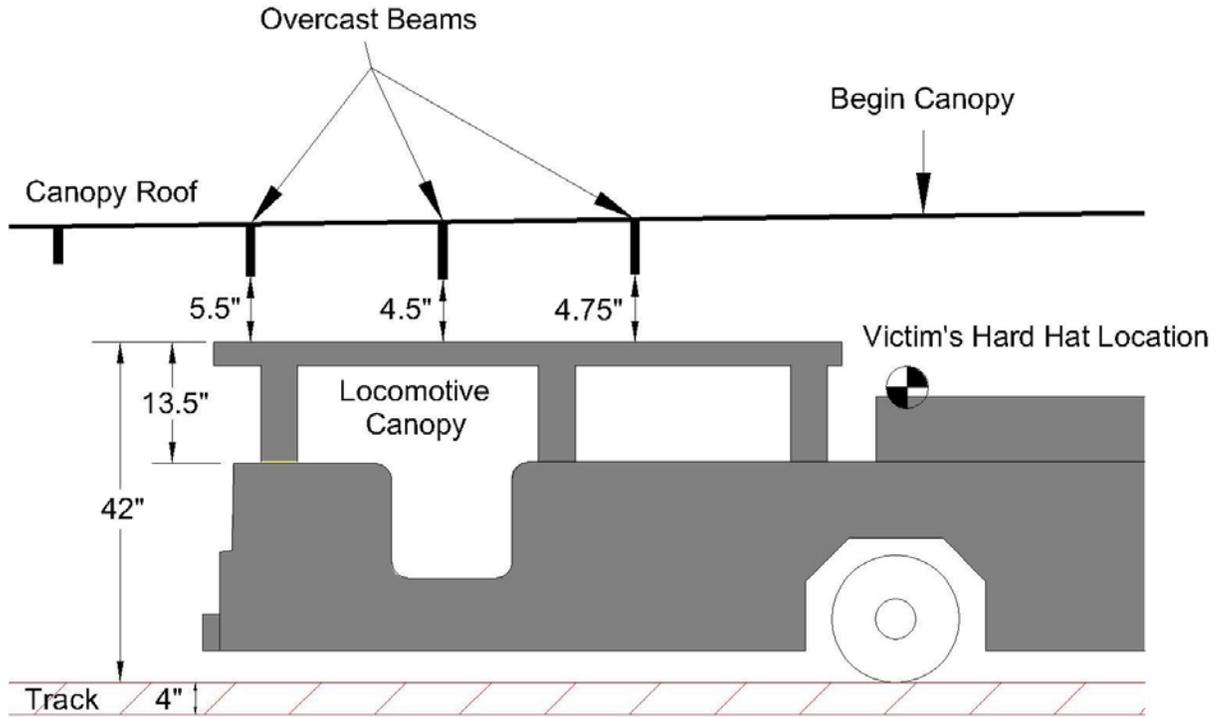
Enlargement View of Locomotive/Overcast Area

Measurements were taken to determine the height of mine roof in the track travelways from the surface to each underground working section to determine if any abrupt changes were present that would create a hazard. The overcast

where the accident occurred had the lowest clearance and measured 46.5 inches at the lowest horizontal beam to the top of the ball of the rail. (See appendix F)

Following the accident, the operator was required to increase the rail equipment visibility or increase the height beneath this overcast. The operator decided to do both by removing the first overcast beam, raising the second and exchanging the 15-ton locomotive with a smaller, 12-ton locomotive, which resulted in a 7-inch height gain in the area of the accident.
