REPORT OF INVESTIGATION

Fatal Rib Fall Accident
March 16, 2015

Deep Mine 41

Paramont Coal Company Virginia, LLC
McClure, Dickenson County, Virginia
ID No. 44-07223

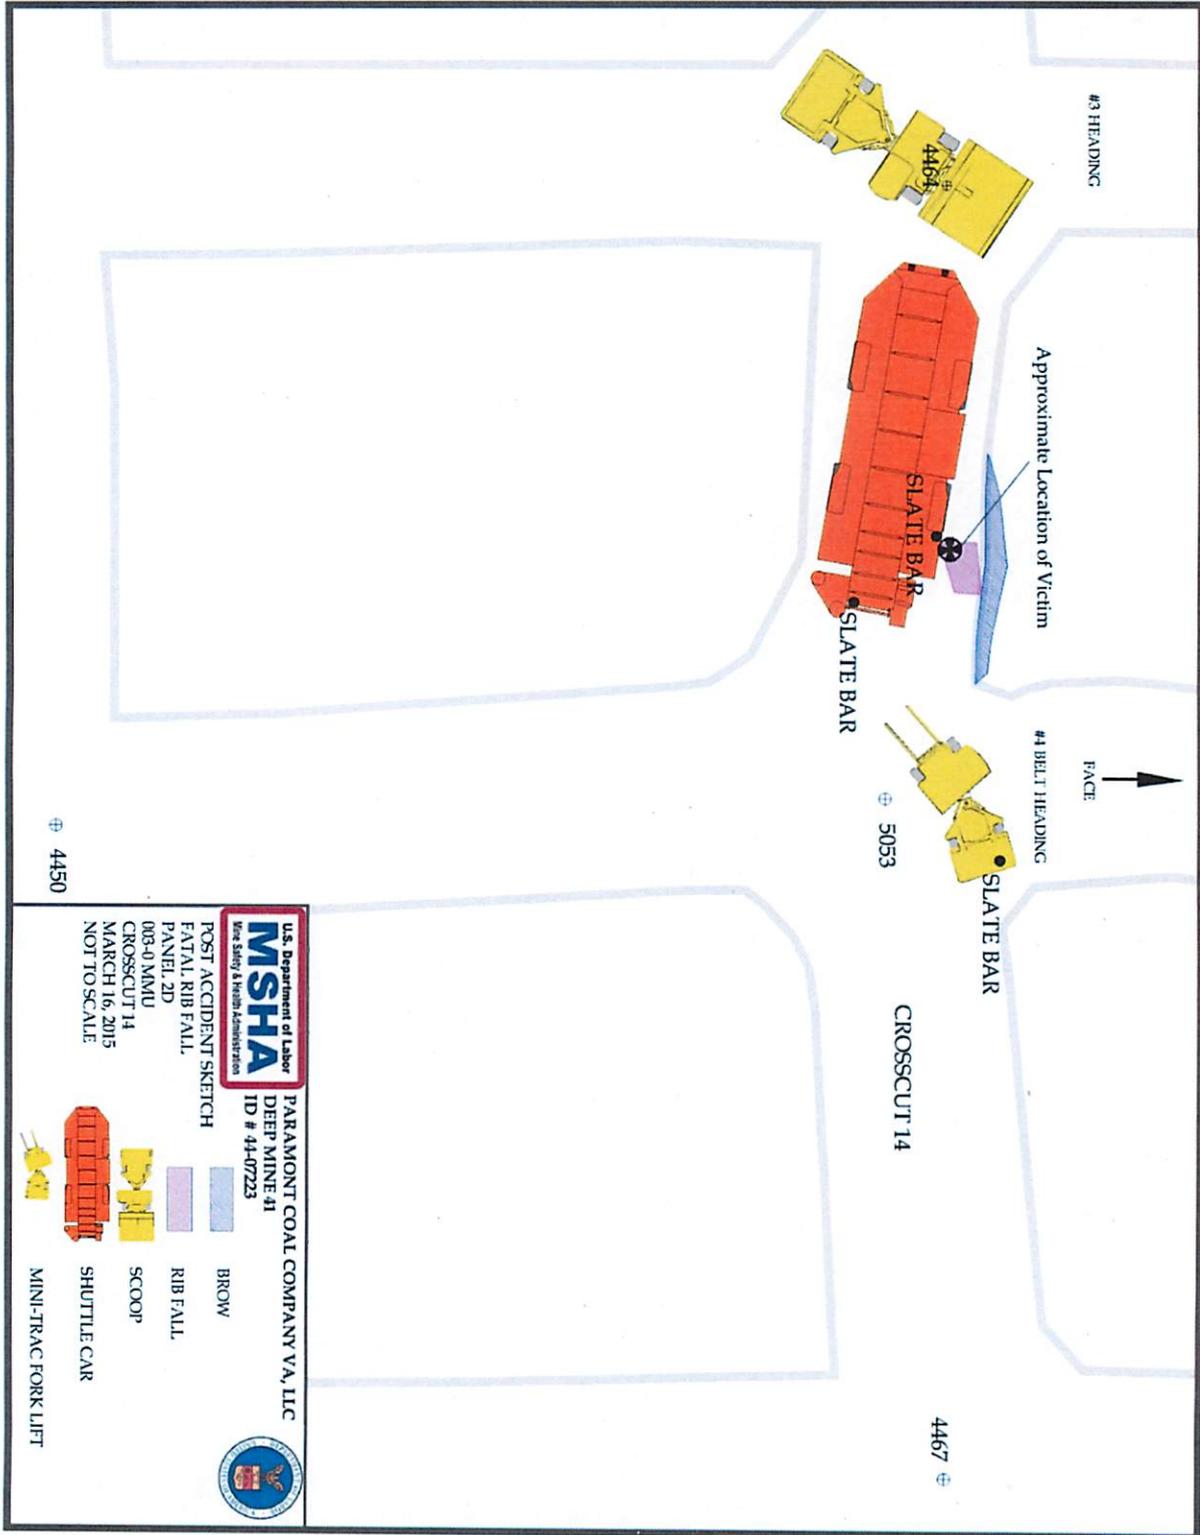
APPENDIX B - Post Accident Sketch

The accident occurred in the crosscut between the No. 3 and No. 4 entries of the 003-0 MMU retreat mining section. The accident occurred on the inby side of crosscut 14 approximately 90 feet inby Survey Station 4450 and approximately 50 feet to the right of Survey Station 4464 (See Appendix B).

The mining height at the location of the accident was 78 to 90 inches high. The coal/rock rib fall which fell on the victim was lying on the mine floor between the shuttle car and the base of the coal pillar. The fallen material was approximately 90 inches long, 45 inches high and 15 to 18 inches thick. Smaller pieces of coal/rock rib material had also fallen on the mine floor surrounding the large section. These smaller pieces ranged in sizes up to approximately 1 to 2 feet with the thicknesses, up to approximately 1 foot. These pieces appeared to have broken off from the larger section of rib, either during the initial rib failure or during the process of moving the rib to free the victim. A measurement of the cavity in the pillar, which resulted from the

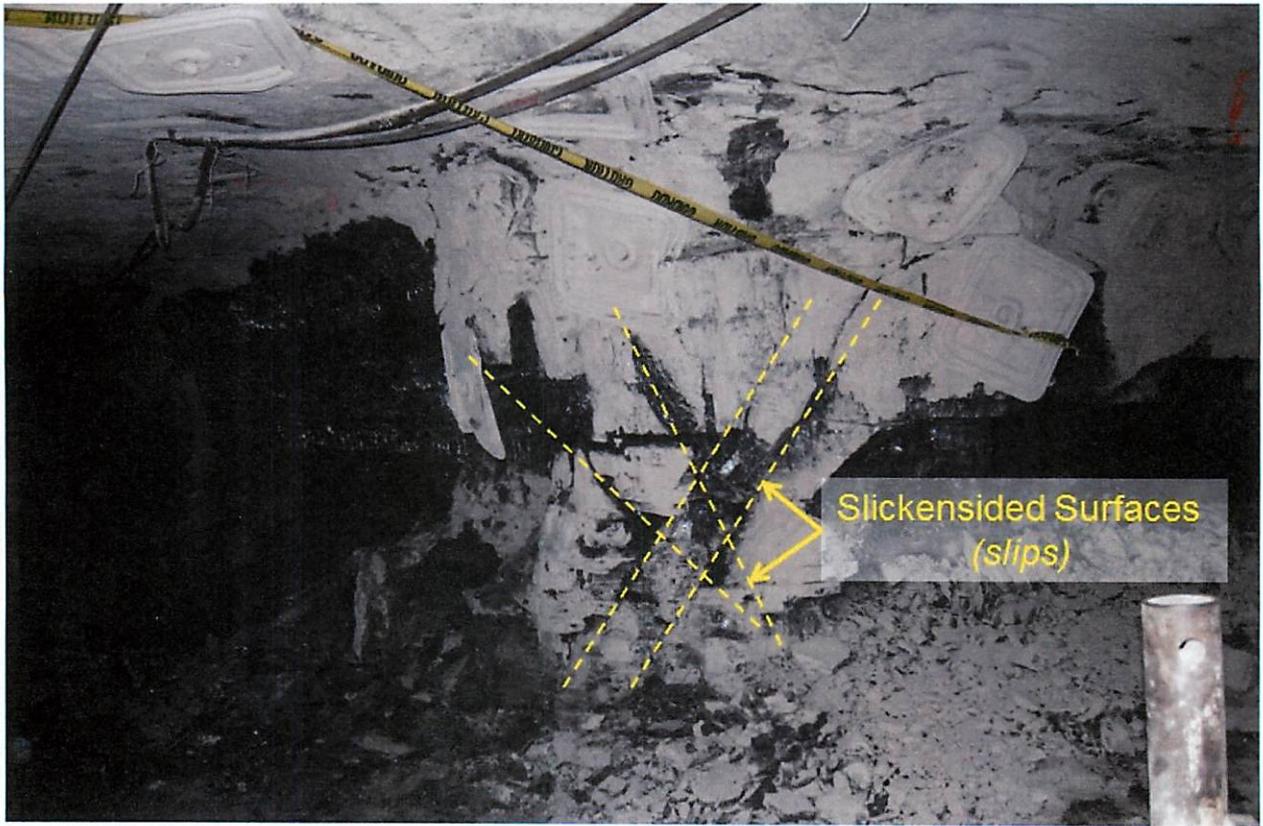
APPENDIX D – Slickenside Surfaces in Rib at Accident Site

The local geology of the 2D Panel of this mine, as well as throughout the majority of this entire mine, has geological fracture features called “drag folds” and “slickensides” that caused the ribs of the pillars to become loose and unstable.

Only a small area at the lower right of the coal that fell during the fatal accident was slickensided. However, the slickensides in the vicinity of the accident contributed to the instability in the rib (See Appendix D).

Corrective Action: The mine operator revised the approved Roof Control Plan for this mine to include a mandatory rib bolting pattern to support the mine ribs to ensure the miners working in the underground portions of this mine are not exposed to the hazards of loose mine ribs. The operator implemented the provisions of this plan revision by installing rib support bolts in all mine ribs on the active 003-0 MMU prior to resuming production. Because of this, the ribs were effectively controlled while retreat mining was completed on the 2D panel. All miners were trained in the provisions of the revised roof control plan.
