Appendix S - Executive Summary of "Inspection of Sago Mine Voice Communication Equipment"  
U.S. Department of Labor

December 21, 2006

Executive Summary of Inspection of Sago Mine Voice  
Communications Equipment

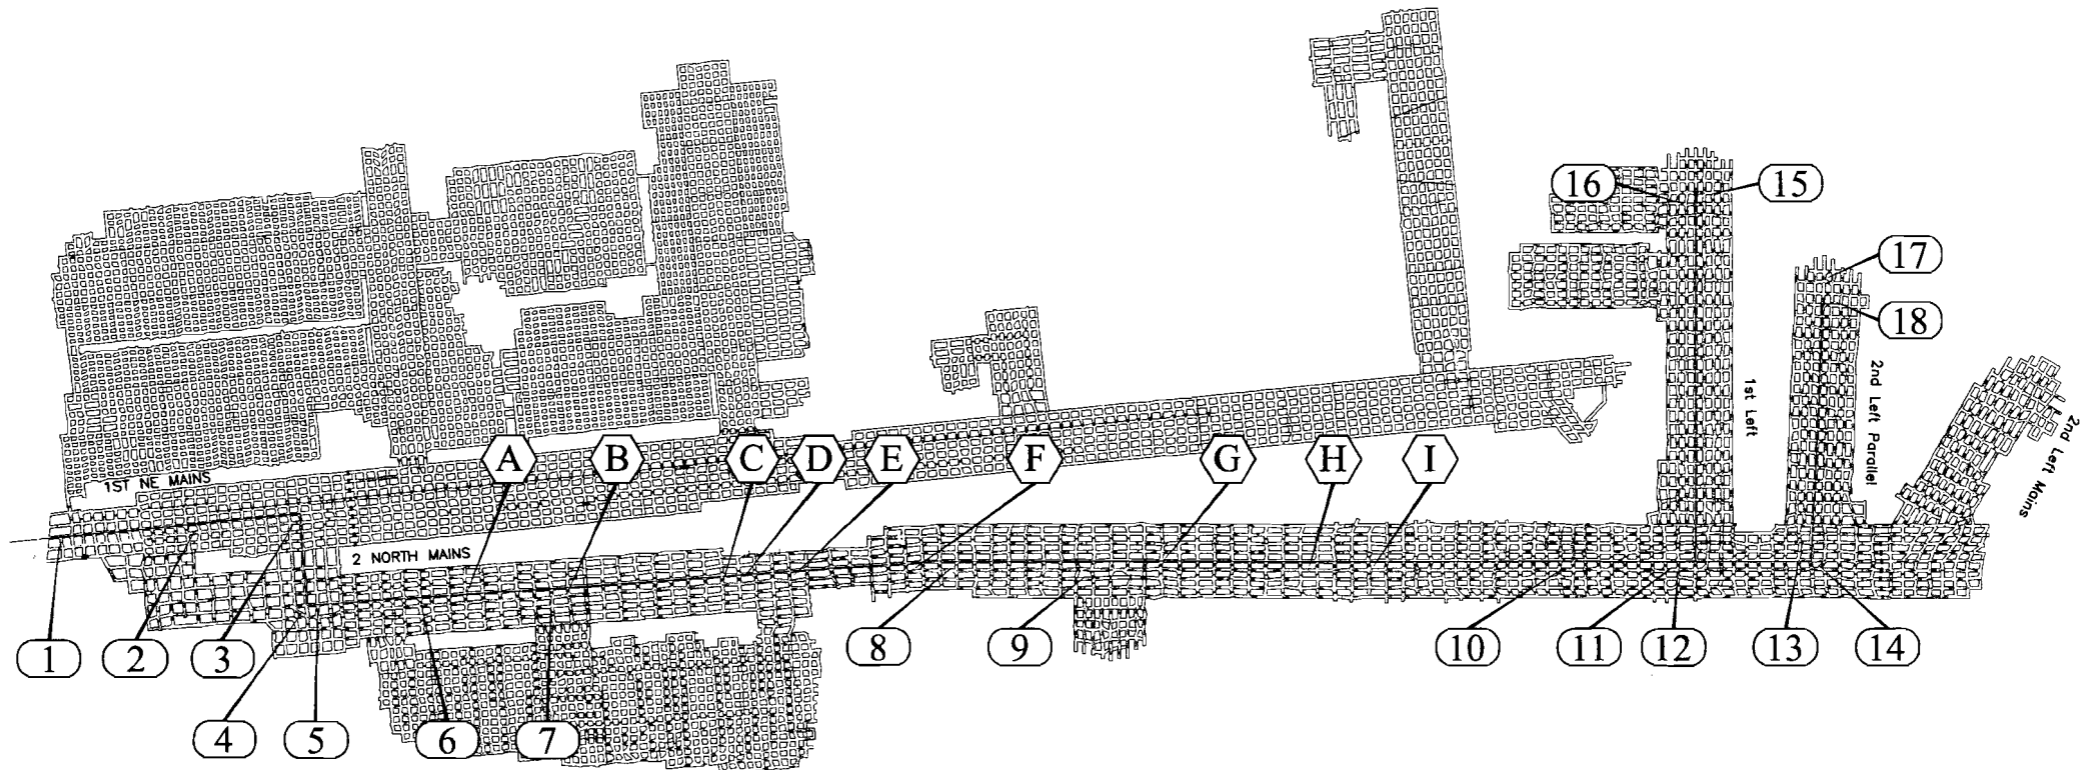
⑩ Pager locations as defined in Table 1

Ⓘ Unused pager connections as defined in Table 2
