Inspection Report - Special

Inspection Number: SWF110404

Mine Name: Genwal
Mine Owner: Andalex/IPA
Inspector: Steve Falk
Operator: Genwal
Operator Rep: /

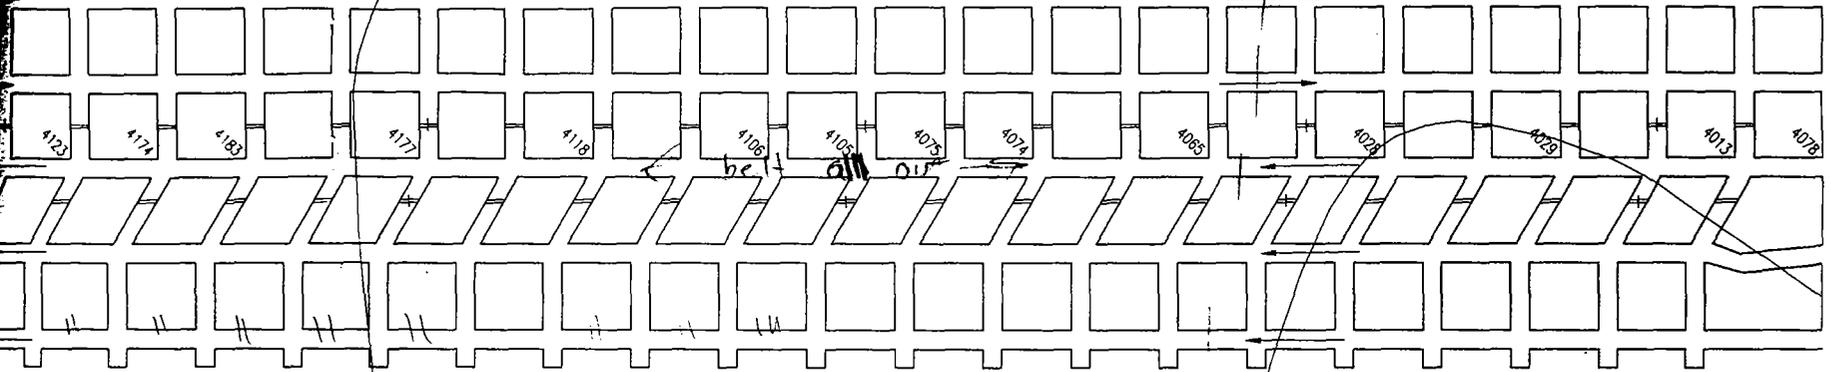
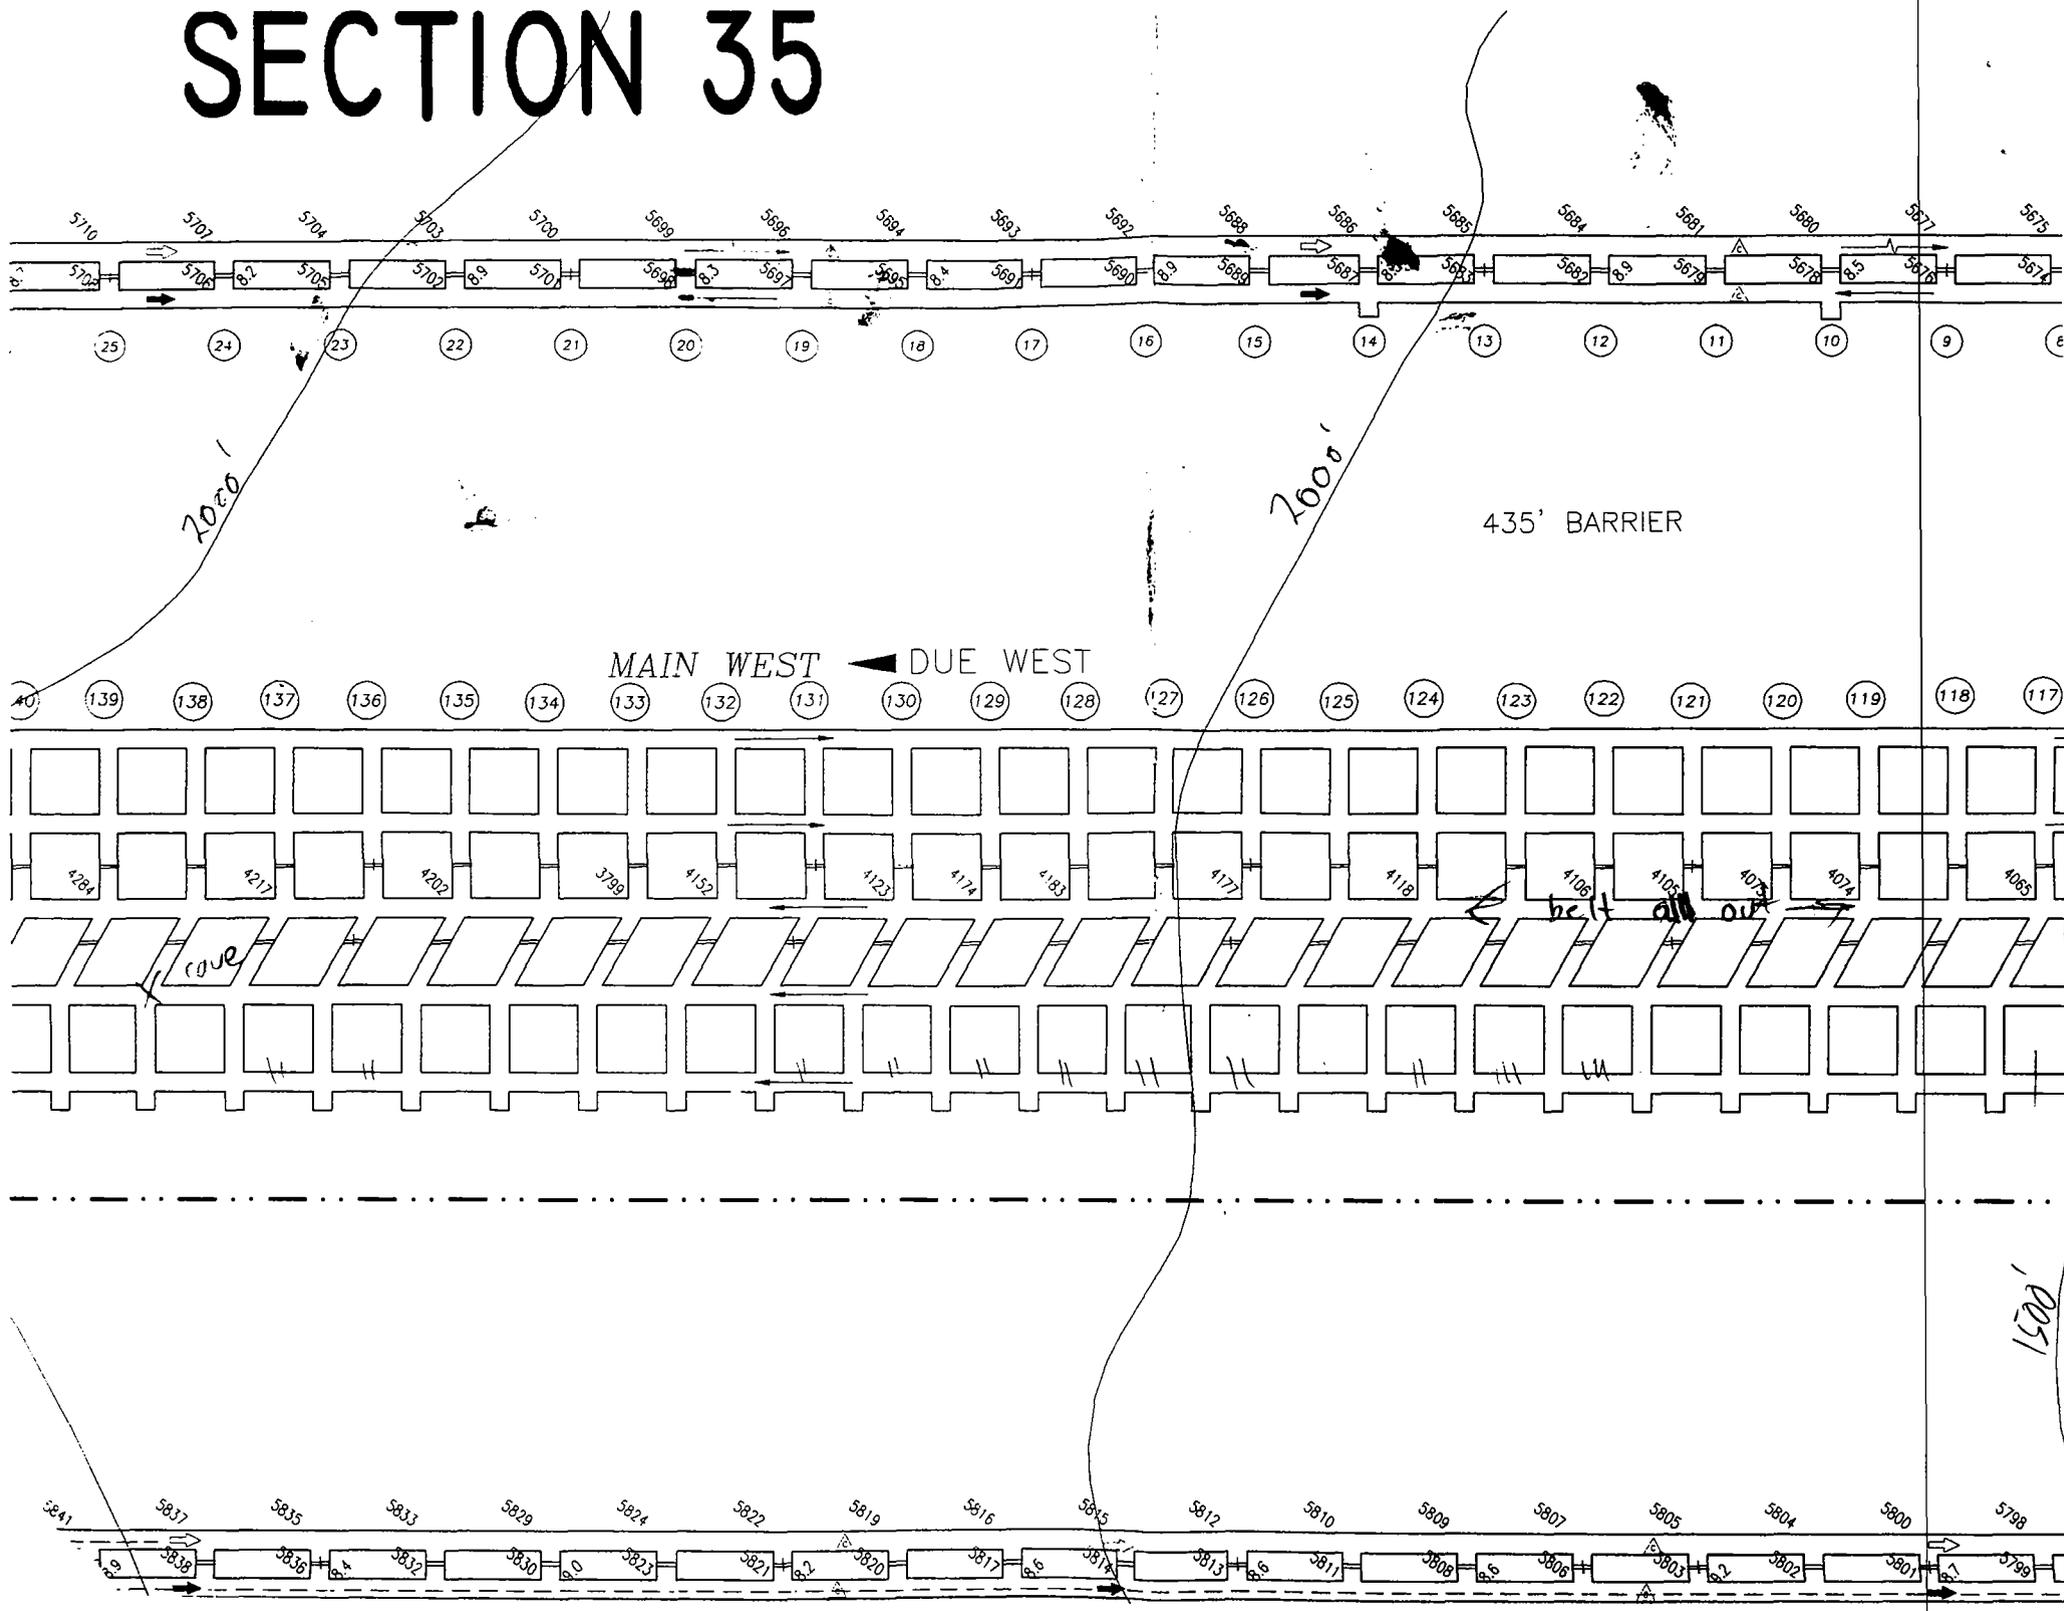
Main West is in use up to crosscut 92 where South Mains intersects and accesses 6th East pillar area. Main West continues back west from crosscut 92 to 105 where 1st Right submains drove north to access longwall panels 7-12. This is sealed off. From crosscut 107 to the Joe's Valley Fault at 167, Main West was used as access to the bleeder for longwall panels 13-18. Now this bank of panels is sealed off and use is no longer needed. A number of years ago, BLM inspected Main West after the north longwall block was mined out and the first few panels to the south were mined out. The barrier planned on both sides looked like it was designed to only hold up for only a short while. The north entry was taking weight and extra roof supports and rebolting had to be done. Now the situation is even worse. Genwal plans to seal at 116. At 116, the depth of cover is about 1500 feet and rises to 2000 feet by crosscut 127 and stays 2000+ feet to 143. The depth is between 1500 and 2000 feet from 143 to 154 and drops off to 1000 feet at the fault, 167. It was apparent from traveling down the intake that the area is taking unacceptable weight. Main West is a 5 entry main entry system that was mined to the Joe's Valley Fault back in 1995. The entries were on 90 foot entry and crosscut centers, leaving a 80 x 80 foot pillar. However, the crosscuts from the belt (middle) entry to the left intake (number 2) entry, were driven on an angle off of 90 degrees due to the need for the continuous haulage system then in use to have a easier turn for gathering the track mounted belt. The end result of cutting this crosscut on an angle is that the intersections have tended to be wider and irregular and they are caving in under the pressure. I traveled down the number 1 or left most intake entry and noted the inside pillar rib rash that was occurring past crosscut 123. I peeked past check currents at crosscut 141, 142 and 149 and noted large intersection caves. Genwal is maintaining the left intake but is being told by MSHA that if Main West is to be used in the near future for access, then all travel ways need to be cleaned up and supported against any future caves. It is very apparent that pressure arches from both side gobs are sitting right down on the main entry pillars. At this depth, the pillars are failing. Genwal tried to split a pillar around an intersection cave and could not hold the top and side pillar failures were occurring.

After the inspection, the following items were noted and agreed on. First, Main West past crosscut 116 is no longer of any use and sealing off would release the extra ventilation air for other use. Second, the pillars in Main West are failing over time with greater than 1700 feet of cover. Caves are occurring at intersects compounded by irregular intersection dimensions. Third, attempts to split pillars under this depth could not hold the top and prevent pillar outbursts.

Conclusions: Main West was designed only to hold up until longwall panels were mined out on both sides. Depth of cover precludes pillar recover even if there were no mined out sections next door. Weight on the pillars is substantial and dangerous conditions are present. Mining any of the coal in the pillars will result in hazardous mining conditions such as pillar bursts and roof falls. Original mine plans called for pillar recovery only in general sense and recent plans conditioned recovery on favorable geologic conditions. If any further mining is to be in this area, MSHA will require making both intake entries travelable and some of the belt and structure would have to be replaced. I agree that further mining in this area would be dangerous and most likely too expensive to rehabilitate. The reserves left in the pillars and the two barriers were never included in the recoverable reserve base as far as I can determine and Genwal not required for further coal recovery in this area. The sealing should go forth and revisions to the R2P2 for this area will be covered in an approval for mine-wide revisions recently submitted.
