Inspection Report - IE/PV

Inspection Number: SWF022707

Mine Name: Genwal
Mine Owner: Andalex/IPA
Inspector: Steve Falk *SWF*
Operator: Genwal
Operator Rep: *4*

North Barrier Section, West Mains, Hiawatha Seam, Federal Lease UTU-68082

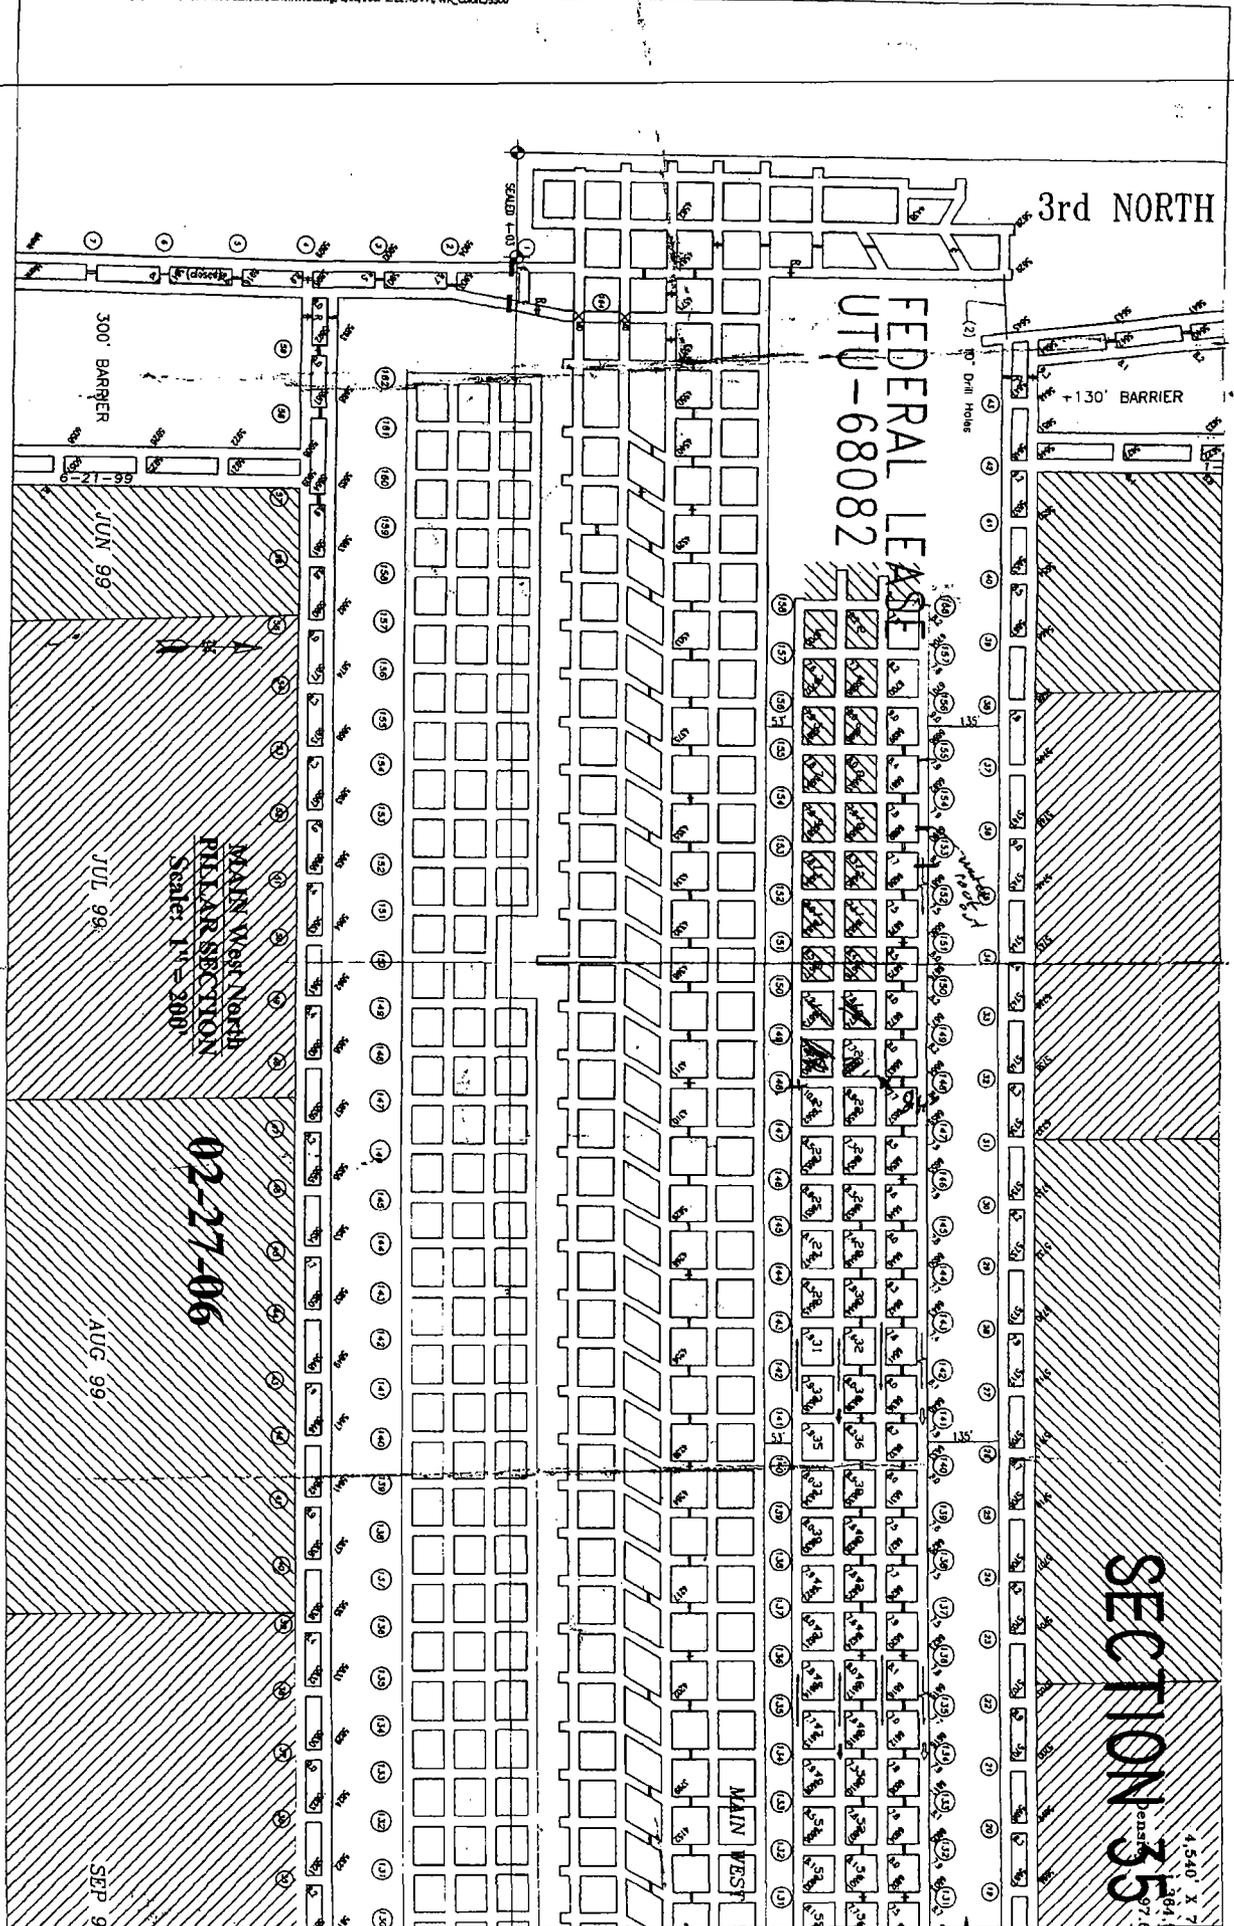
MAIN WEST NORTH
PILLAR SECTION
Scale: 1" = 200'

The one mining section was visited. Conditions were noted and spot measurements were taken of the section working faces. These measurements will be compared with the submitted monthly production maps to verify volumes from monthly production verification. These spot measurements are shown on the attached maps to this report and will be transferred to the monthly production maps. Genwal is mining according to the approved mine plan and no incidents of non-compliance were noted. The section visited follows below:

This section finished driving 4 entries on 92 foot entry centers and 80 foot crosscut centers. These were driven in the north barrier pillar between Main West and mined out longwall panel # 12. The barrier pillar is 450 foot wide which accommodates the 4 entries. This leaves only 130 foot barrier to the north longwall panel. This section started out back at Main West crosscuts 108 - 110 and drove out to crosscut 158. Here the section starts to dip down to the west before the Joe's Valley Fault. At this place, the section experienced large inflows of water. They could not control it enough with pumps. We think this is water flowing through fractures close to the fault, draining the gob to the north. Crosscut 158 is about 400 feet short of the bleeder entries along the fault. With the water coming in too fast, the company stopped advance at this point and began pulling pillars back. They got a special pillar plan approved by MSHA to pull the south two of three pillars and have the return out the north most entry. So far, the crews have pulled 18 pillars or 9 rows. Currently they are pulling the pillars between crosscut 149 and 150. I have been concerned about pulling pillars in this environment with mining a narrow block with little coal barriers to mined out blocks on both sides. Fortunately, the beginning depth on the west end toward the Joe's Valley Fault is somewhat shallow starting at 1300 feet. So far no inordinate pillar stresses have been noted, though thing should get interesting soon. The face is under 1600 feet of cover now and will increase to over 2000 feet by crosscut 139. The working face looks ok and coal is good. There is some cap rock in the roof that is not holding up during mining. Coal height is running about 9 feet. The rate of retreat mining is well ahead of water build up as the seam has a incline down to the west fault starting with pillar row 144, so the water is running down to the end of the entries. Measurements are noted on the attached map.
