REPORT OF INVESTIGATION

**Underground Coal Mine
Inundation of Water
Resulting in Entrapment of Miners
May 9, 2009**

**Alpha Natural Resources
Cobra Natural Resources, LLC
Mountaineer Alma A Mine
Wharncliffe, Mingo County, West Virginia
ID No. 46-08730**

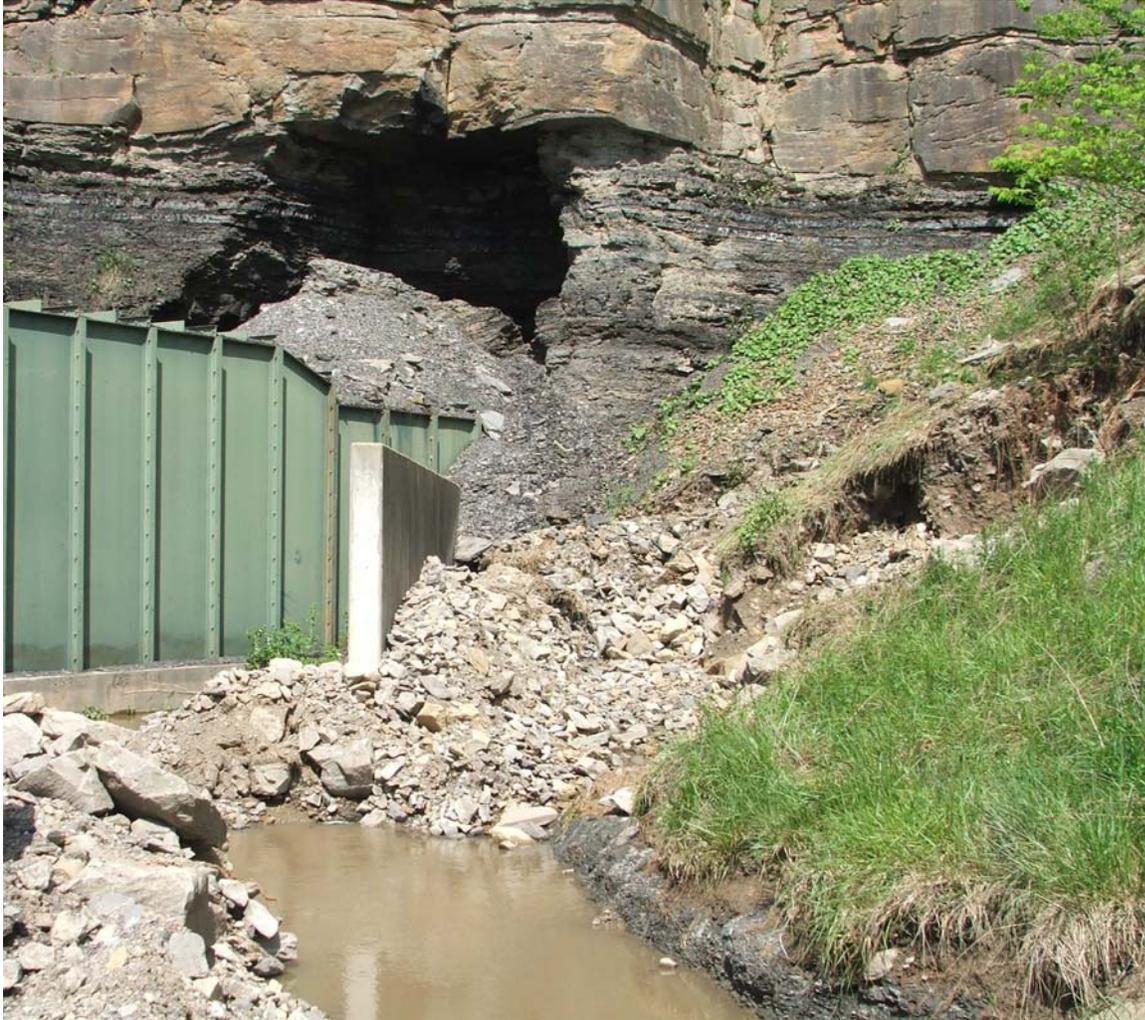
Clogged Culverts Due to Slide

The storm runoff water that entered the mine portals was diverted when culverts underneath the portals were blocked by debris, mud, and rock, caused by scouring (removal of sediment by swiftly moving water) and erosion from a mud slide. The slide prevented water flow through the culverts, which caused the water to back up and enter the mine. Another factor that contributed to the accident was the inability of the mine's system of diversion ditches to handle the storm water flow, as designed. The diversion ditches were not maintained or kept cleared of sediment, rocks, or vegetation, such as trees and underbrush. This allowed the runoff water to overtop the diversion ditches, flooding surface areas above the mine portals.

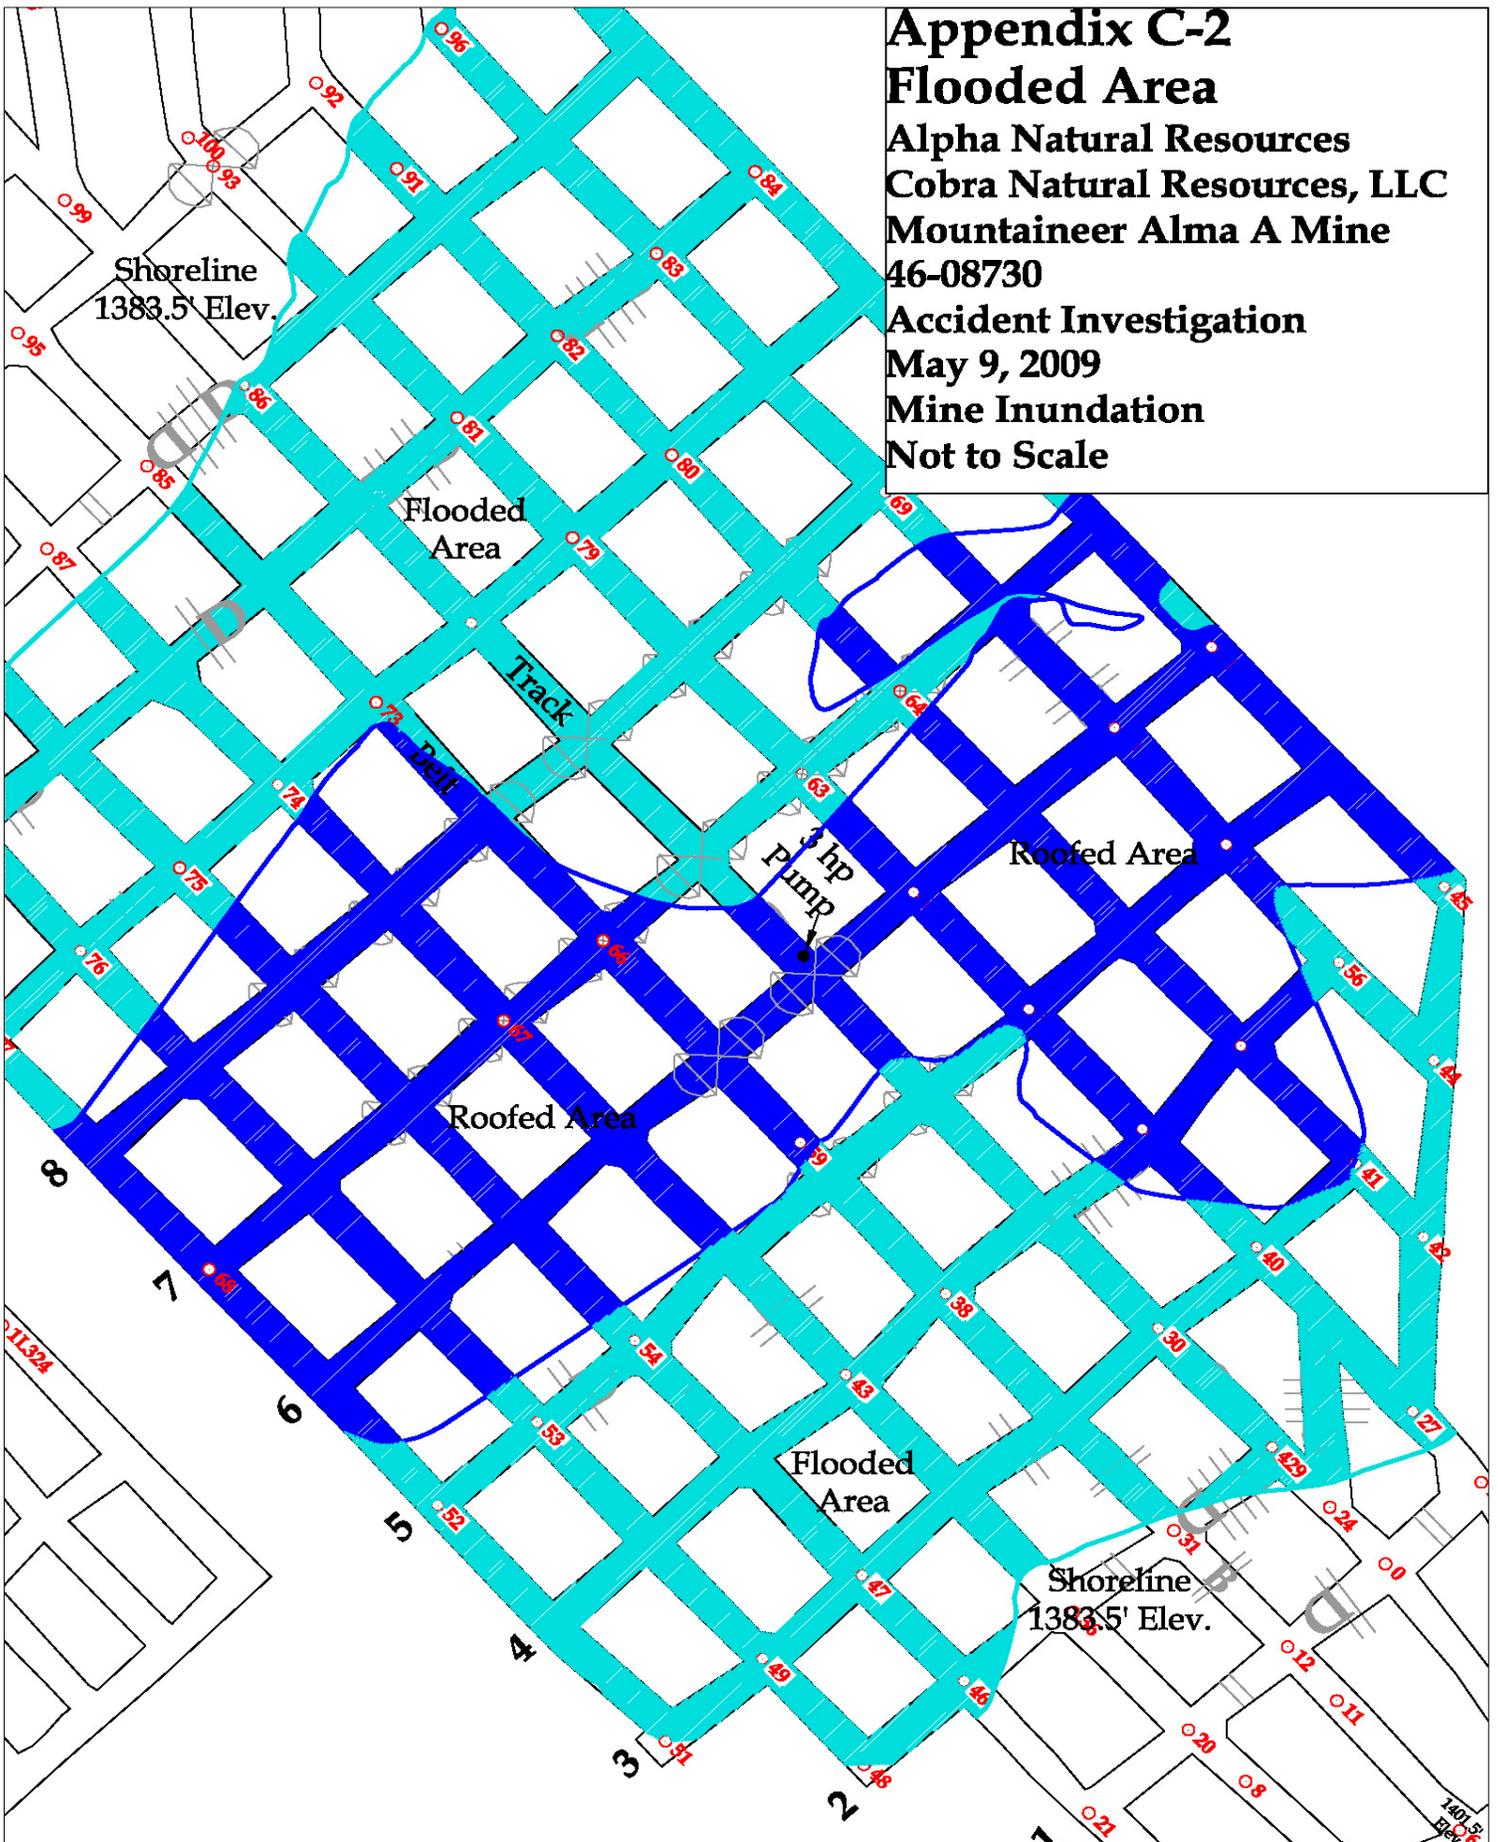
Appendix C-2
Flooded Area
Alpha Natural Resources
Cobra Natural Resources, LLC
Mountaineer Alma A Mine
46-08730
Accident Investigation
May 9, 2009
Mine Inundation
Not to Scale

2. Root Cause: The mine operator failed to monitor the portals of the underground mine where storm runoff surface water entered the portals, accumulated in a low area in the mine and blocked the primary and alternate escapeways.

Corrective action: The mine operator submitted a plan under 30 CFR, §75.380(e), which, if followed, is designed to assure that the mine portals are actively monitored during periods of rainfall and that miners will be evacuated from the underground mine when the plan action levels are reached.

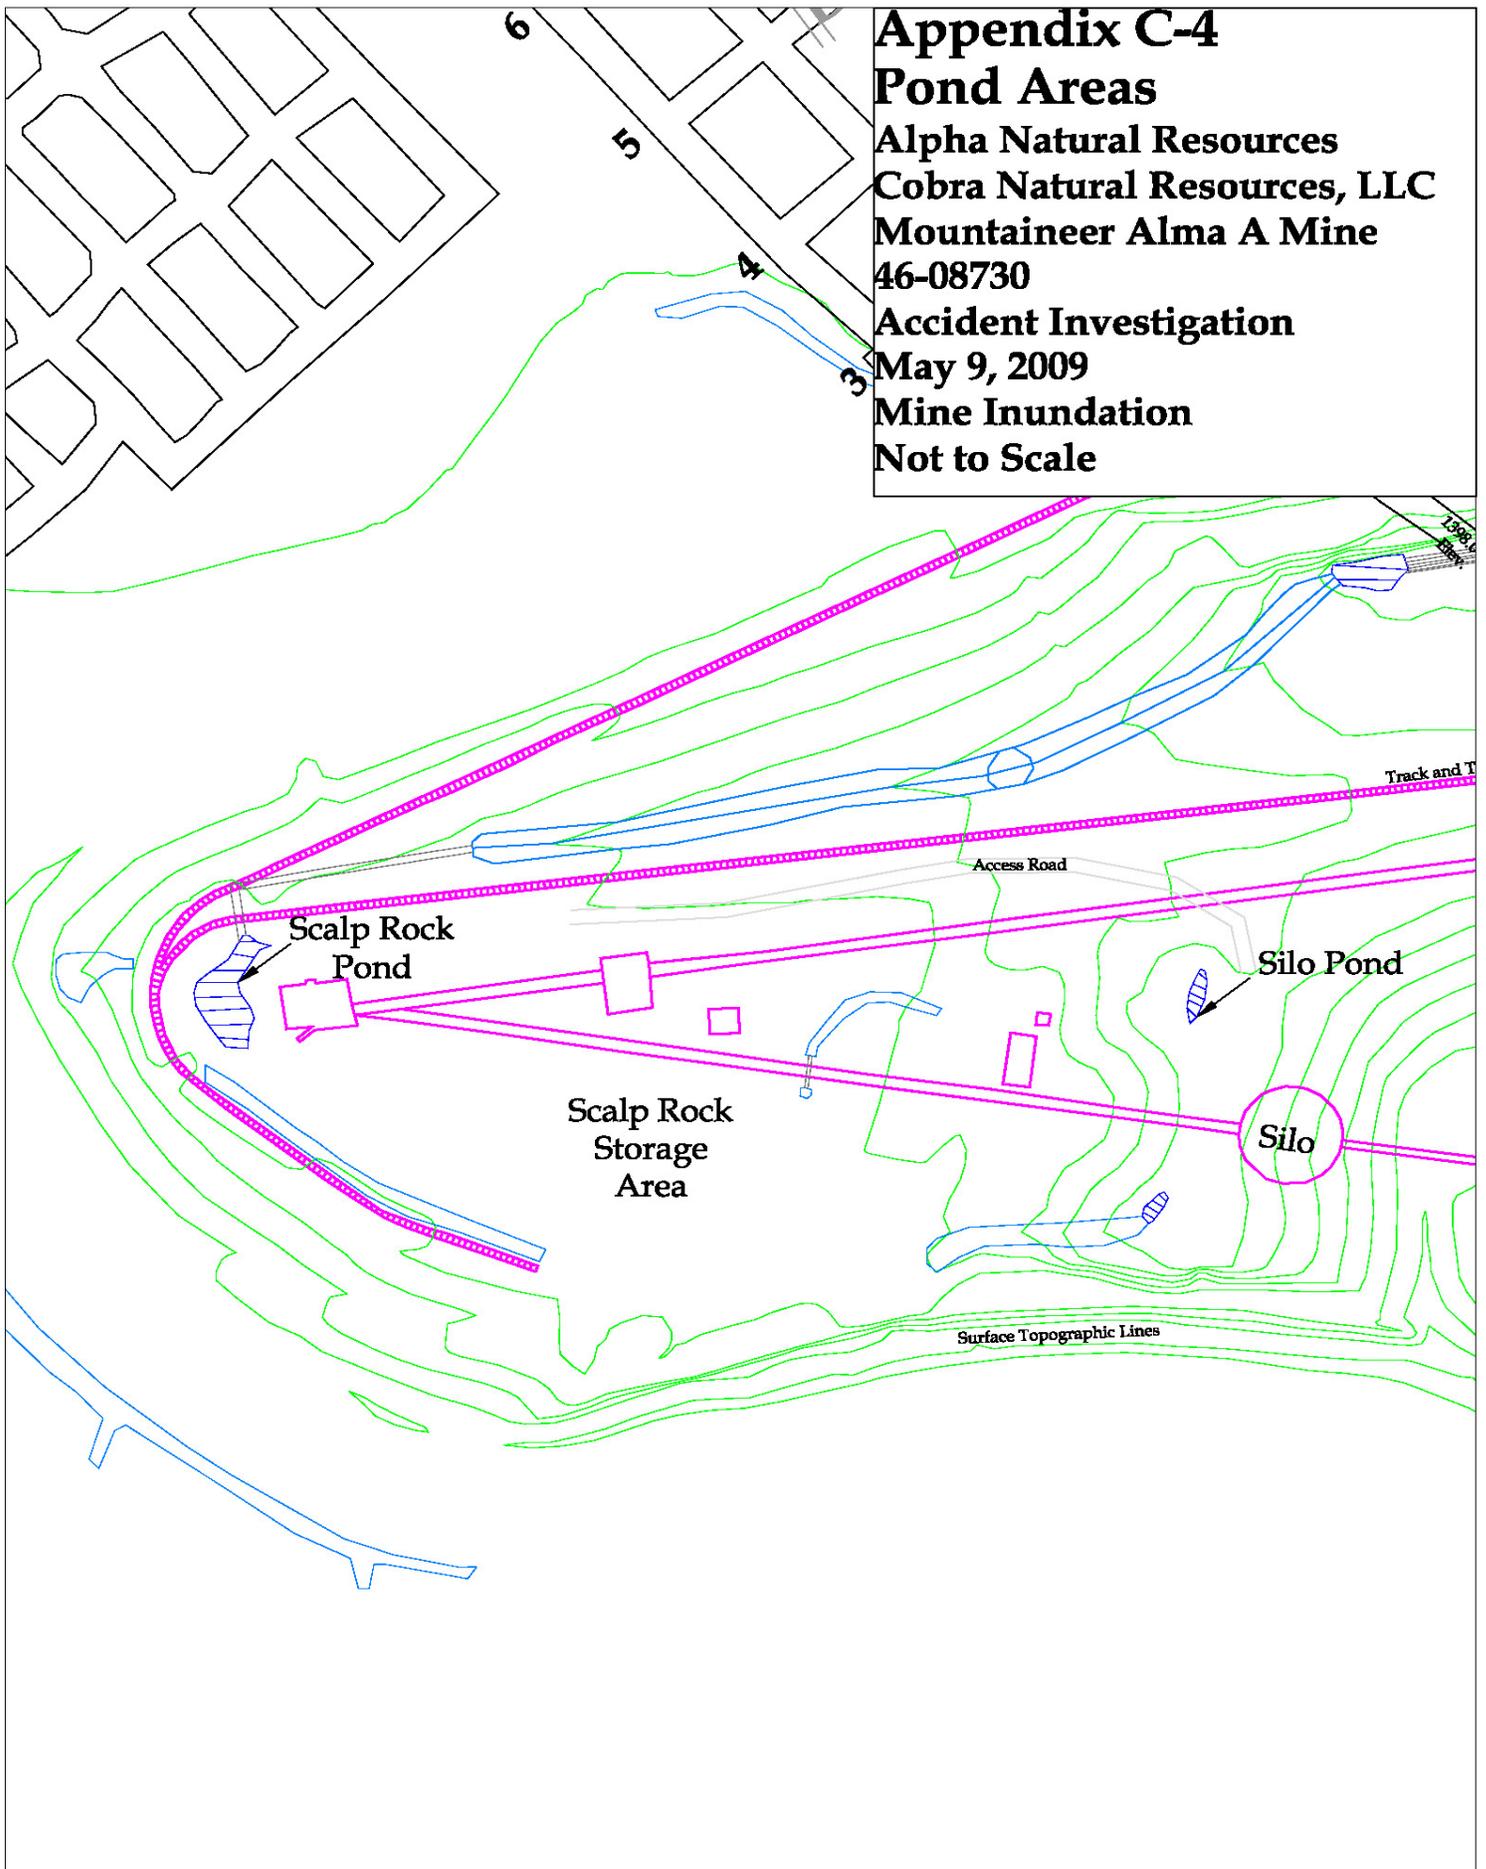
Appendix C-4 Pond Areas

The design for handling surface water, both on the Alma A level and the Lower Cedar Grove level uses various surface features. Rain that falls in the side hollow, and flows toward the Alma A level, routinely collects in one of two small ponds or depressions. One is the Scalp Rock Pond at the curve of the track housing near the Scalp Rock Storage Area, and the other is the Silo Pond along the west side of the silo (See Appendix C-4).

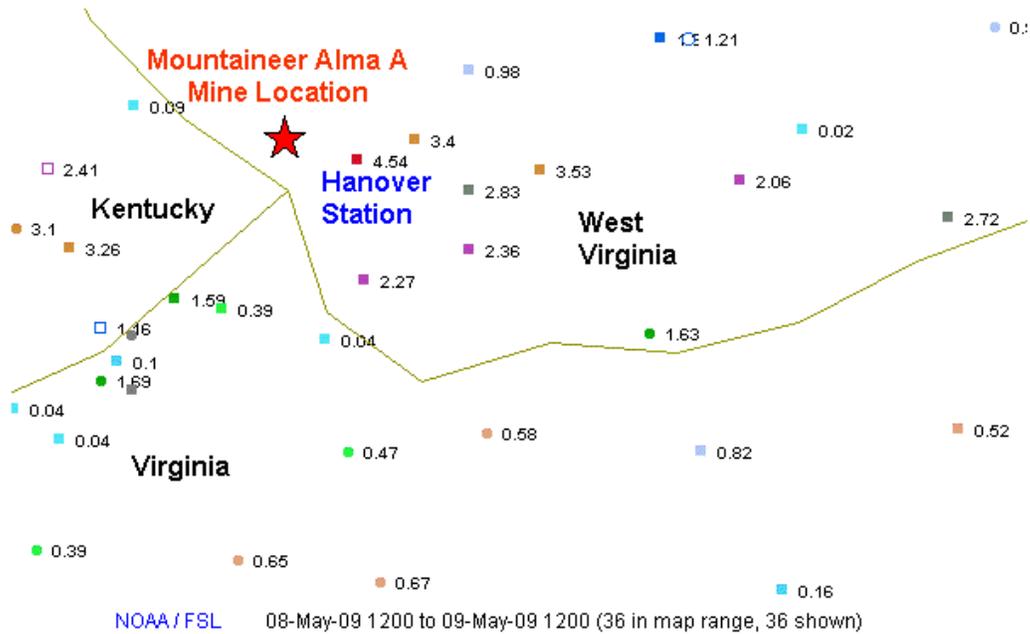
Appendix D - Hourly Rainfall Data - Noon May 8 to Noon May 9, 2009
 (The rainfall starts on the bar chart about 10 pm on May 8th and stops about noon on May 9th)

approximately 10:00 p.m. on May 8, 2009 and ending around noon on May 9, 2009 (approximately 14 hours), of 4.54 inches. The most intense period of this rainfall was between 5:00 a.m. and 8:00 a.m., when approximately 2.29 inches of rain fell in three hours, approximately 50.4% of the total rainfall, with the most intense hour having 0.84 inches (18.5% of the total). The Hanover rainfall duration is consistent with the observations at the mine. The rainfall started at the mine sometime between 10:00 p.m. and 11:00 p.m., continuing until late the next morning or early afternoon. The NWS reported that the heaviest rain occurred shortly after 5:00 a.m. Cobra Natural Resources, LLC maintains rainfall gauges at various mine locations, which are read about once every 24 hours. The rainfall gauge at the Ben Creek office measured a total rainfall of 3.38 inches on May 8-9, 2009.

The total rainfall at the mine was believed to have been between a 10 year and 25 year rainfall event, which is the largest rainfall expected to occur on average once every 10 or 25 years. It should be noted that despite the 2.29 inches of rain that fell in three hours in Hanover, a rainfall event typically used for designing critical water conveyance structures, such as a ditch carrying water away from a mine opening, would have a far more severe rainfall intensity distribution. For example, the National Resources Conservation Service's (NRCS) Type II design curve, which is the typical design curve used for this type of analysis, would distribute 59.5% of the rainfall in three hours, with 42.8% of the total rain falling within a single hour.

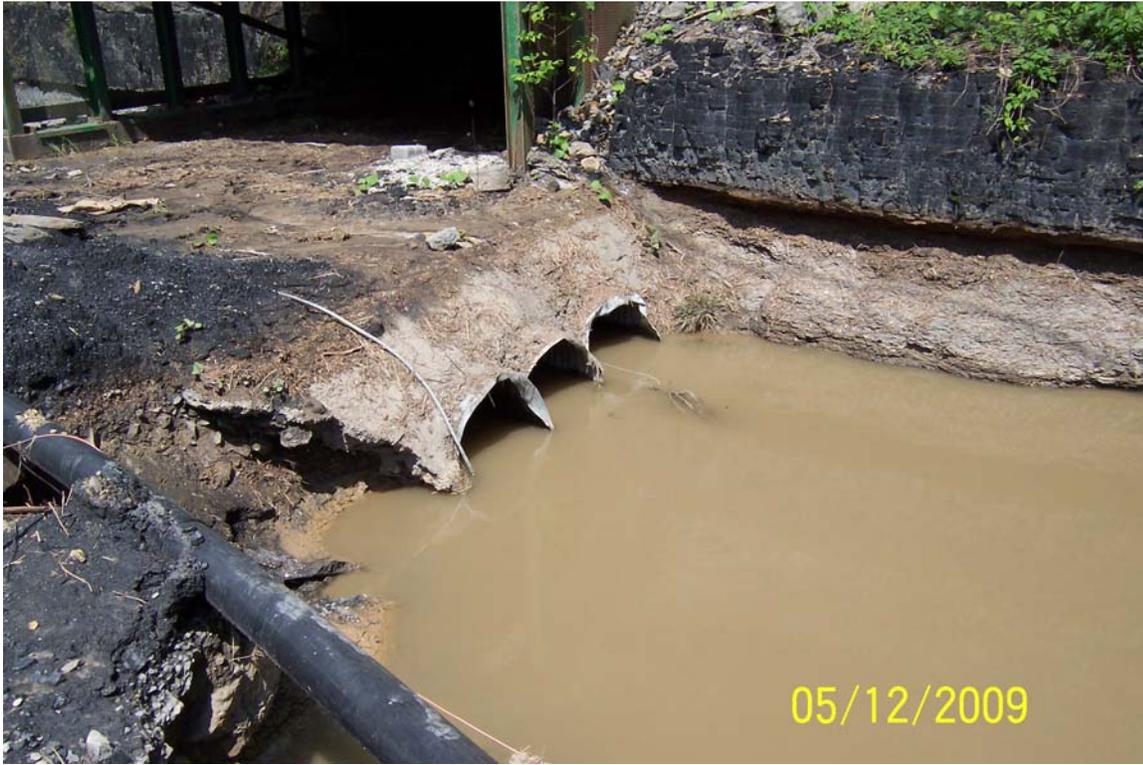
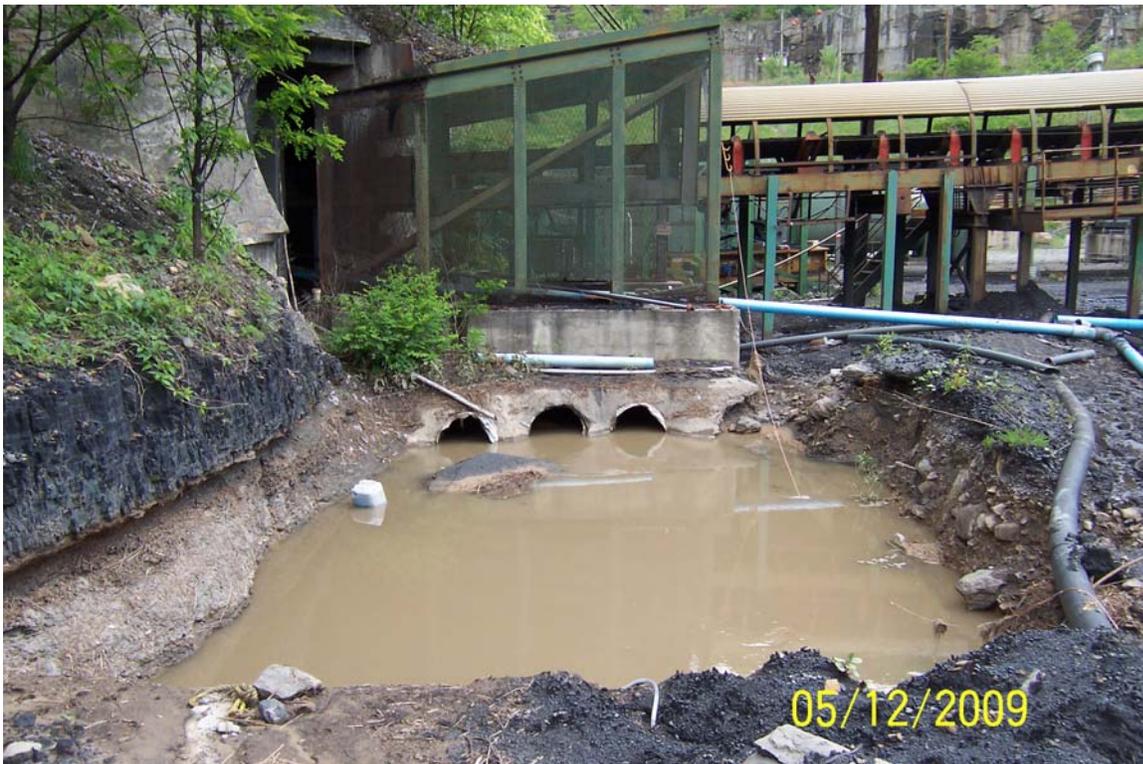
APPENDIX E - Culverts at the portals

The failure of the surface drainage system at the Mountaineer Mine Complex was the primary cause of the extent of flooding in the Mountaineer Alma A Mine on May 8-9, 2009. At the upper end of the mine supply yard, the ditches and culverts that carry the runoff from a large percentage of the watershed above that point had failed. This failure was in part due to a lack of maintenance. Trees were found growing in a portion of the ditch and the intake end of one of the culverts was completely buried, allowing almost no water to flow through. Consequently, this runoff, which should have flowed away from the Alma A coal seam portal area, instead flowed along the sediment channel between the track housing and the highwall, through the CMP culvert under the track housing, and down toward the Alma A level and the sedimentation pond through a rip rapped ditch that discharges near the outlet of the CMPs draining the small pond between the Alma A coal seam Portals No. 4 and 5. A hydrologic model, using estimated parameters, showed that the failure of this upper ditch resulted in an increase of over 600% in the flow through this culvert. This increased flow resulted in serious scouring in the steep, rip rapped ditch, which extended down from the Lower Cedar Grove level to the Alma A level. This scoured material collected at the bottom of the ditch, covering the outlets and clogging the three culverts draining the area in front of the Alma A coal seam portals. Consequently, much of the runoff which should have

flowed through these culverts, instead backed up into the area in front of the portals and then entered the portals.

The accident occurred because storm runoff water entered the mine portals after being diverted when culverts underneath the portals were blocked by debris, mud, and rock, caused by scouring and erosion from a mud slide. The slide prevented water flow through the culverts, which caused the water to back up and enter the mine. Another factor that contributed to the accident was the inability of the mine's system of diversion ditches to handle the storm water flow, as designed. The diversion ditches were not maintained or kept cleared of sediment, rocks, or vegetation, such as trees and underbrush. This allowed the runoff water to overtop the diversion ditches, flooding surface areas above the mine portals. The mine's escapeways were blocked when the surface water entered the mine, preventing seven miners from exiting the mine and entrapping them for approximately 24 hours.

Corrective action: The mine operator submitted a plan under 30 CFR, §75.380(e), which, if followed, is designed to assure that storm runoff surface water, will not enter the mine portals.
