Appendix J – Inundation by Water of the 1 North Longwall Headgate

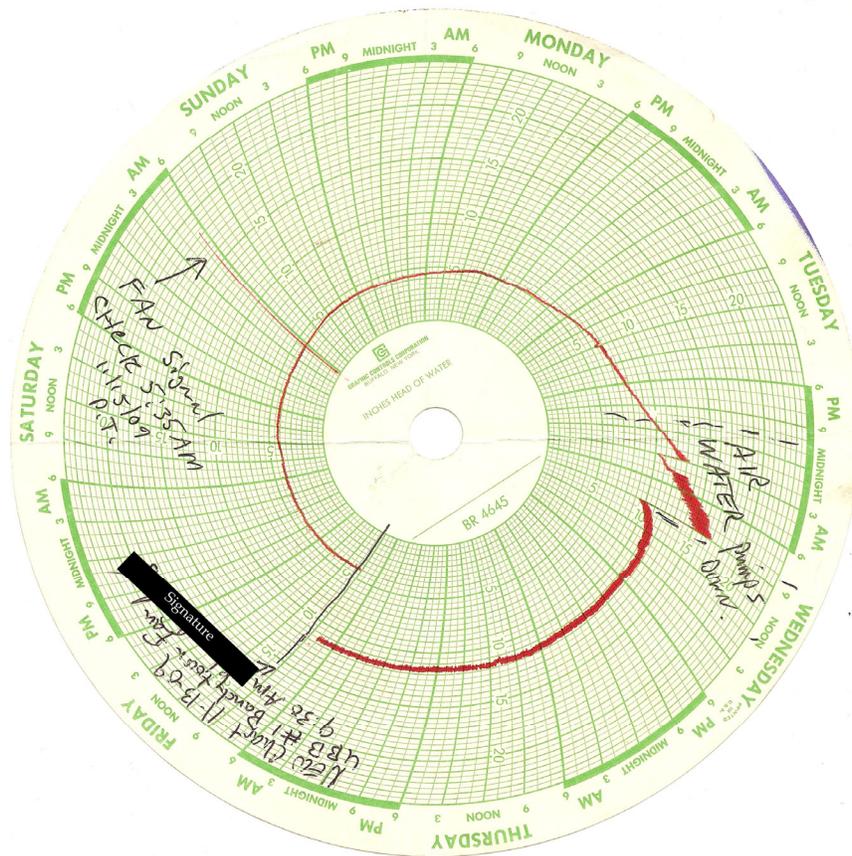
Figure 22 - Bandytown Fan Chart from November 2009

On November 13, 2009, the fan pressure recorded at the Bandytown Fan was approximately -4.0 inches of water.⁷³ On Monday, November 16, the fan pressure began to gradually increase. By Wednesday, November 18, a fan pressure of -17.0 inches of water was recorded. During this time period, a handwritten notation on the Bandytown Fan pressure chart indicated “pumps down.” The fan pressure chart is shown in Figure 22.
