**Internal Review of MSHA's  
Actions at the Upper Big Branch Mine-South  
Performance Coal Company  
Montcoal, Raleigh County, West Virginia**

U.S. Department of Labor  
Mine Safety and Health Administration  
Program Evaluation and Information Resources

March 6, 2012

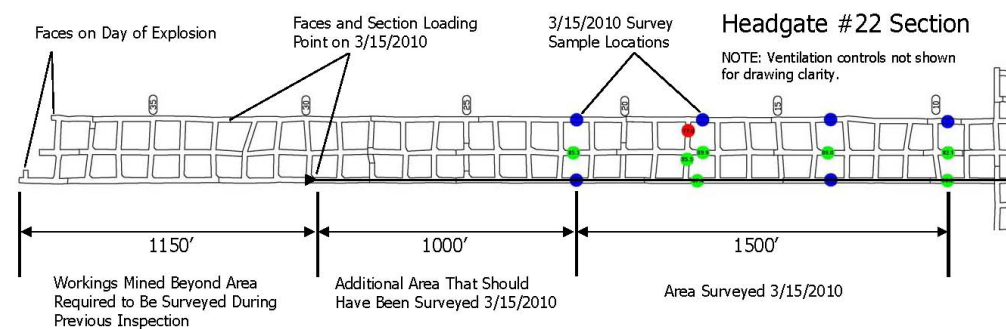
**Figure 12 - Headgate #22 Section showing faces at time of explosion relevant to face and belt locations during March 15, 2010, rock dust survey.**

MSHA procedures directed inspectors to make visual observations of rock dust application adequacy when inspecting sections between surveys. However, accurate visual estimation of mine dust IC was not reliable. In January 2010, District 4 managers provided additional guidance for determining compliance with rock dusting requirements on working sections when they instructed inspectors to collect spot samples of mine dust inby section loading points during each regular inspection. During interviews, District 4 managers stated that these instructions were intended to stress the requirement to rock dust within 40 feet of working faces, as well as to improve compliance with clean-up programs. An inspector collected one spot sample in accordance with this guidance at UBB, which was compliant, on March 17, 2010, on 4 Section (Barrier Section).

Active sections not surveyed to within 50 feet of the loading point. MSHA procedures direct inspectors to conduct a rock dust survey to within 50 feet outby the section dumping point on each advancing active working section. However, these procedures did not direct inspectors to document the location of the section loading point when conducting rock dust surveys. Thus, supervisors could not verify that inspectors sampled to within 50 feet of the loading point. Failure to follow this directive resulted in two un-surveyed zones within the explosion area.

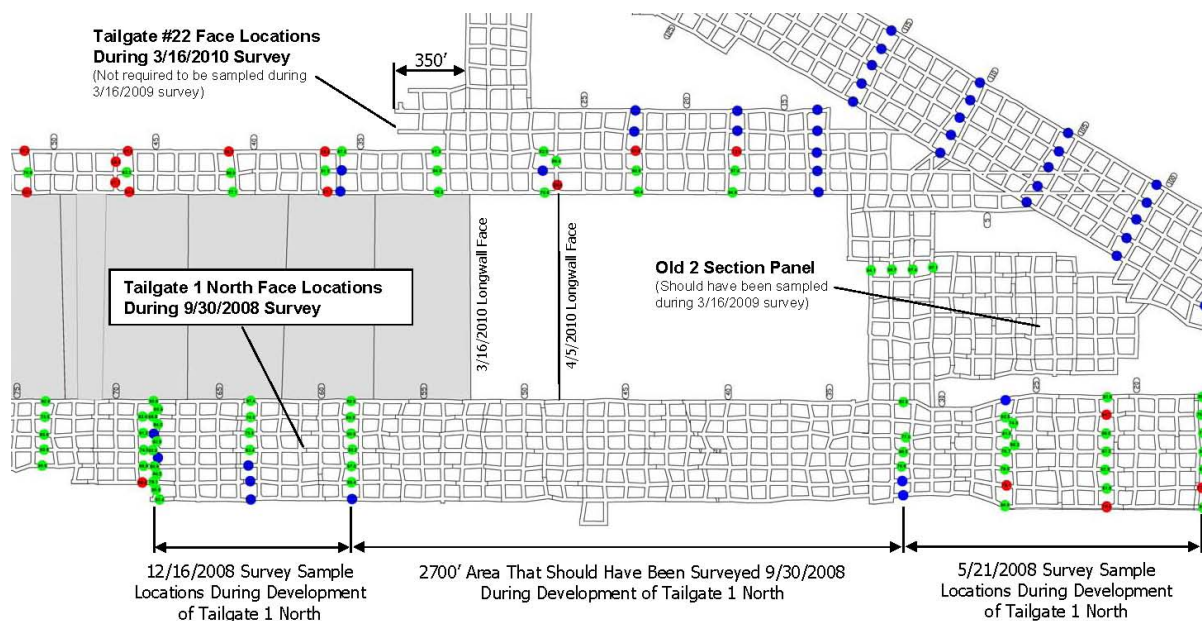
**Figure 13 - Survey samples collected near the 1 North Longwall Panel.**

In another case, an inspector uploaded data for a September 30, 2008, rock dust survey during development of Tailgate 1 North. However, he did not provide a zero point that precisely identified the sampling area so it could be located on the mine map. The inspector listed two rows of samples rather than the five rows of samples needed to survey the area mined since the last inspection (see Figure 13). He also listed all of the survey sample locations as being too wet to sample. With no way to map these wet sample locations, subsequent inspectors could not accurately determine where to begin the next survey or to collect samples if the area dried out.

On December 16, 2008, another inspector started the next rock dust survey in Tailgate 1 North at Crosscut 58, which would have corresponded to the section loading point at the time of the previous survey. However, deficiencies in documentation for the September 30 survey and lack of sampling at previously wet locations resulted in a 2,700-foot long area where MSHA did not collect rock dust samples. At the time of the explosion, this unsampled area extended from 1,000 feet inby to 1,700 feet outby the longwall face.

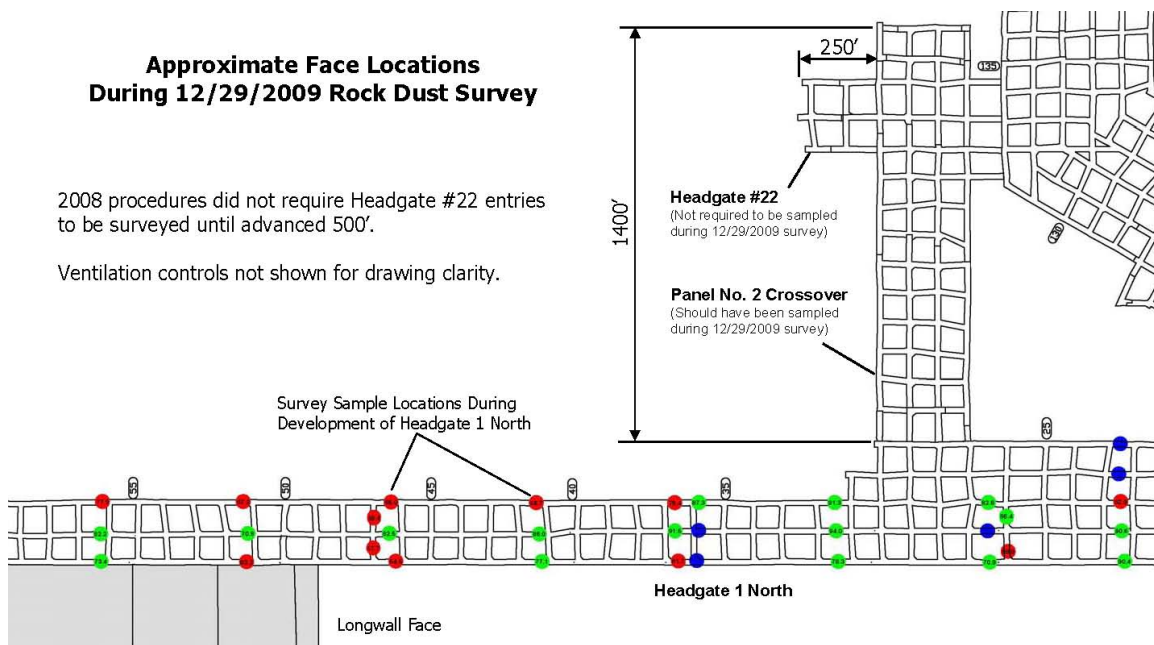
**Figure 14 - Face locations at time of December 29, 2009, rock dust survey for MMU 029-0.**

After MSHA implemented the revised inspection procedures in 2008, some inspectors continued to sample only the set of entries being mined at the time of the survey. On December 29, 2009, an inspector documented conducting a survey for 1 Section in which he did not collect any samples, reporting a single location as "No Sample." The inspector commented on the Rock Dust Sample Submission Form, "The mine operator has mined less than 500 feet since last survey area." However, since the prior rock dust survey for 1 Section, it had mined the last 500 feet of Headgate 1 North (Bandytown Shaft bottom area), the entire 1,400-foot long Panel No. 2 Crossover, and the first 250 feet of Headgate #22 (refer to the Figure 14). The April 5 explosion propagated through the two latter areas.

During interviews, the inspector stated that he did not conduct a rock dust survey in Headgate #22 because the distance from the mouth of the section to the tailpiece was less than 500 feet. While MSHA procedures did not direct him to sample Headgate #22 entries at that time, he did not consider surveying the two areas from which the MMU was removed. He also stated that he primarily learned how to conduct surveys by traveling with other inspectors. The only National Mine Health and Safety Academy training he remembered was the instruction to take samples every 500 feet and how to collect band samples. This further demonstrated that at least some inspectors continued to follow superseded procedures, passed on by more experienced inspectors and supervisors, regardless of training to the contrary. As a result, MSHA did not collect survey samples before the explosion in the Bandytown Shaft bottom area and the Panel No. 2 Crossover.

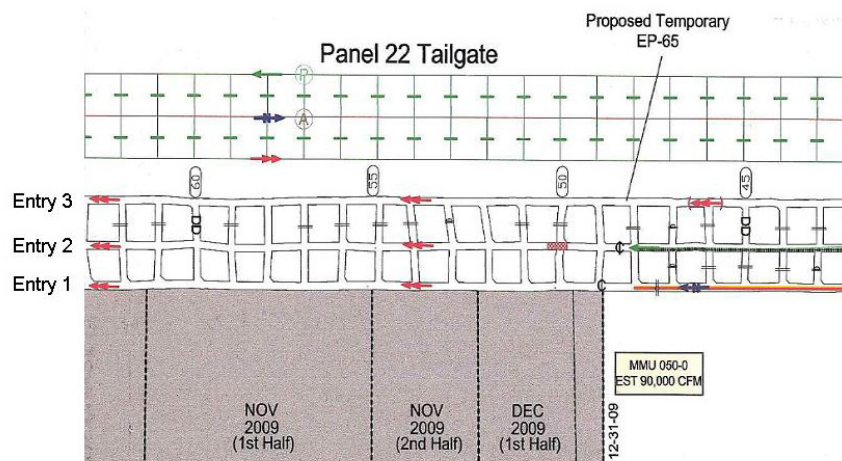
**Figure 18 - Portion of ventilation plan supplement approved January 22, 2010, showing EP-65**

In the ventilation plan supplement approved January 22, 2010, a temporary evaluation point (EP-65) was added (See Figure 18) to account for the return air split from Headgate #22 section which entered the worked out area. The Operator specified that the EP would move outby with the 1 North Longwall face until it reached the regulator installed in this crosscut. Once the longwall face reached crosscut 31, the EP would become permanently established at the regulator installed in this crosscut. This evaluation point was critical in determining the effectiveness of ventilation on the headgate side of the worked out area. However, there was no record of an air reading being taken at this EP by either MSHA inspectors or UBB examiners.

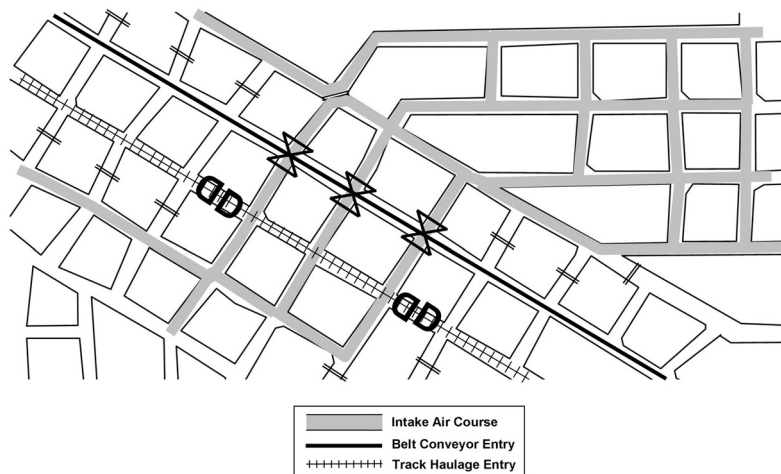
**Figure 19 - Depiction of actual installation of equipment doors in the North Glory Mains**

Figure 19 shows one such installation in the main track haulage road of the North Glory Mains. At the time of the explosion, miners accessed the 1 North Longwall and two development sections (Headgate #22 and Tailgate #22) using this roadway. Coal was transported in the adjacent belt conveyor entry. The two entries containing the track and belt conveyor were ventilated by a common air split along much of their length. However, where a separate intake air course crossed the belt conveyor air course, the Operator installed two sets of equipment doors. Miners drove track equipment through one set of doors, into the separate intake air split, then through a second set of doors, back into the air course containing the belt conveyor system. The belt conveyor air course was reduced from two entries to one where it crossed a set of overcasts that permitted the two air splits to cross without mixing. These air courses could not mix at this location since they isolated primary and alternate escapeways and the intake split (shown in gray) that ventilated the working sections.
