ACCIDENTAL RELEASES OF SLURRY AND WATER FROM COAL IMPOUNDMENTS THROUGH ABANDONED UNDERGROUND COAL MINES

*Stanley J. Michalek, P.E., George H. Gardner, P.E., Kelvin K. Wu, Ph.D., P.E.
Mine Safety and Health Administration, Pittsburgh Safety and Health Technology Center*

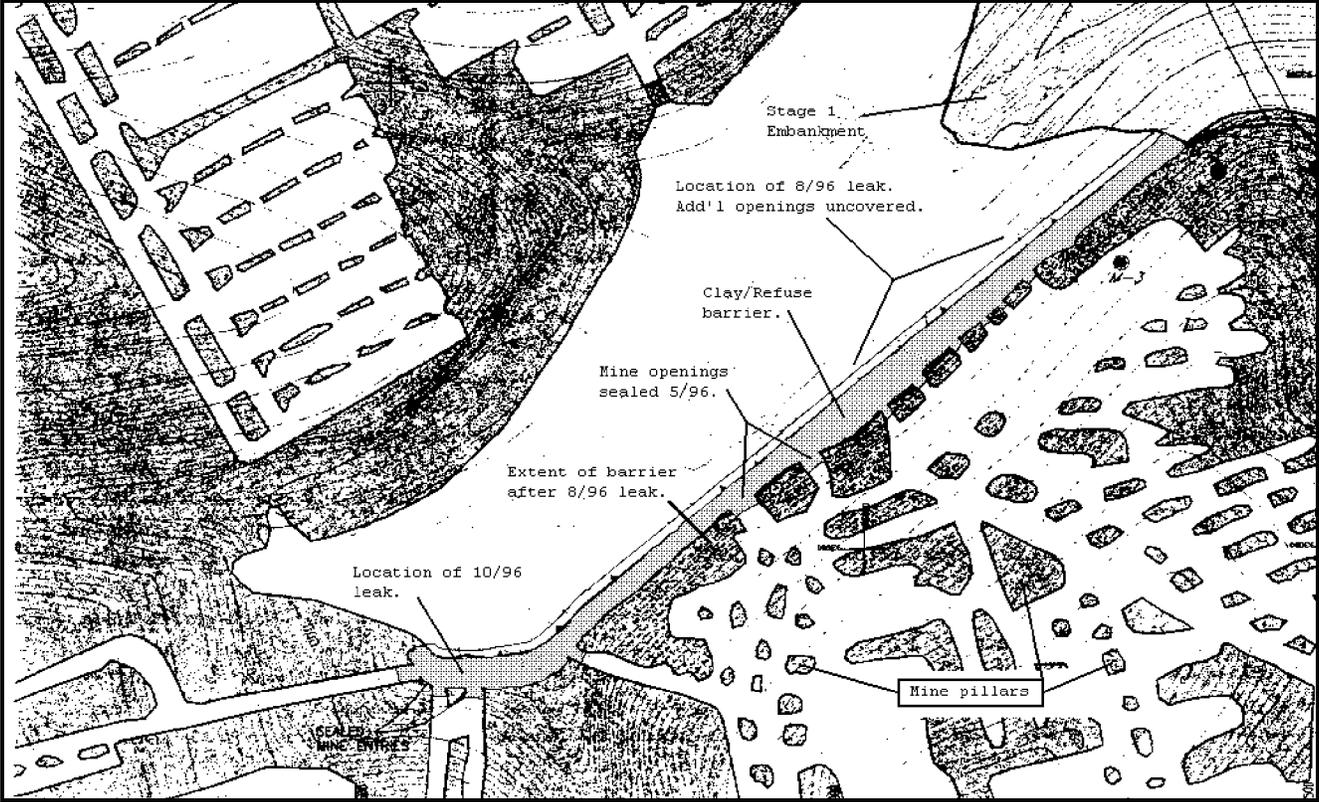
elevation of the coal seam, it was found that the seals constructed in known mine openings were intact. Further exploration revealed that the leak had occurred in an area that was originally thought to have a thick, solid barrier of coal. Available mine maps indicated that at least 25 feet of solid coal were present between the outcrop and underground mine workings in this area. The barrier was found to be less than two feet thick. It is believed hydrostatic pressure from the slurry had opened cracks in the coal seam and a piping type failure had begun. The thin coal barrier was progressively eroded, allowing water/slurry to flow uncontrolled into the mine. Figure 3 shows a portion of the mine map and the locations of mine openings.

Plan view of Miller Cove Impoundment showing extent of mining in upstream abutments and locations of mine openings.

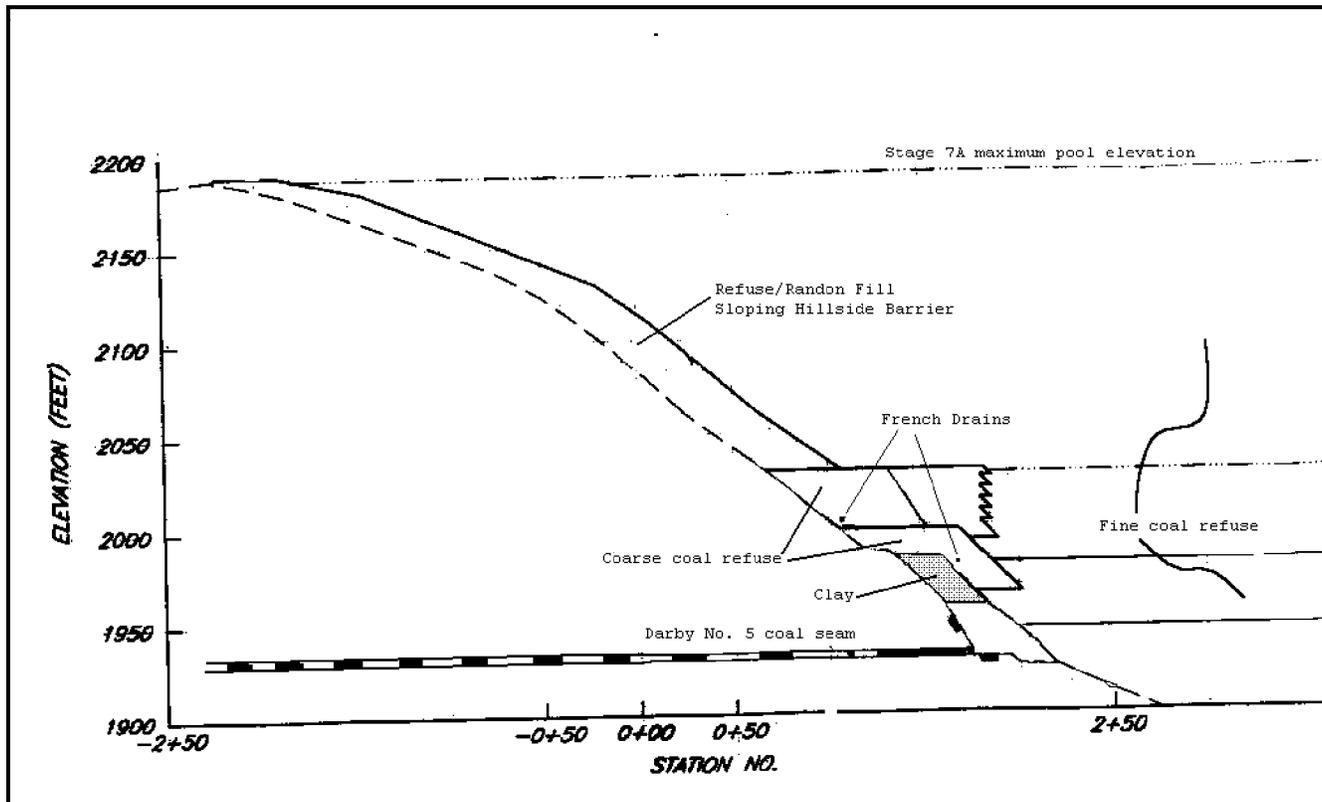
Figure 4
Cross-section showing earthen liner to be constructed around impoundment.

To repair the situation, several hundred feet of the outcrop along the west abutment were cleared and thoroughly inspected. Weak areas and newly discovered openings were excavated and closed with designed seals. Then, a 20-foot-wide layer of low permeability earthfill was placed against the original hillside to impede the flow of water to the seals and to separate the fine refuse from the hillside. This liner was to be placed in compacted lifts and carried up the hillside until a vertical thickness of 100 feet was reached between the top of the liner and the coal seam. Figure 4 shows a cross-section view of the liner details.

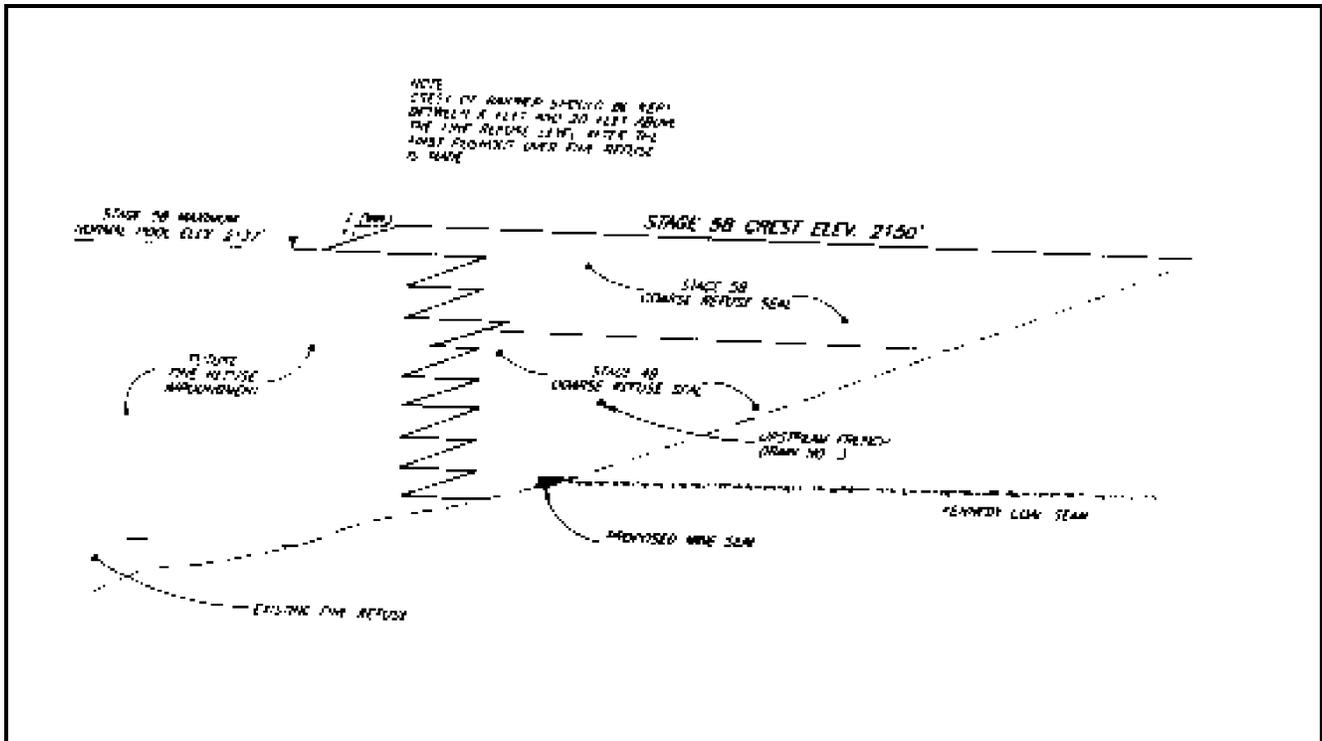
Figure 6
Proposed long-term mine seal.

The long-term remediation plan requires the mine seal barrier to eventually be constructed entirely around the reservoir. It is to be constructed such that free water is maintained as far as practicable from the mine openings. An extensive network of French drains will be installed to minimize the head and subsequently the flow into the mine openings. These drains have been designed to handle the anticipated seepage determined using finite-element methods. Piezometers were also installed at various locations around the barrier to confirm that excess hydrostatic pressures do not develop. Further, provisions were included in the specifications to inspect the hillsides for any evidence of subsidence. Figure 6 shows a cross-section of the proposed mine seal.
