PROGRAM INFORMATION BULLETIN NO. P08-17

SUBJECT: Potential Boom Failure on Komatsu America Corp. Model
PC400LC-7L Excavator

CAMPAIGN NUMBER: 7C064 1

SUBJECT: PC400LC-7L REPAIR OF ARM CYLINDER BRACKET ON BOOM. ***NOTE:
EXTENDED COMPLETION DATE 6/27/2008 KF***

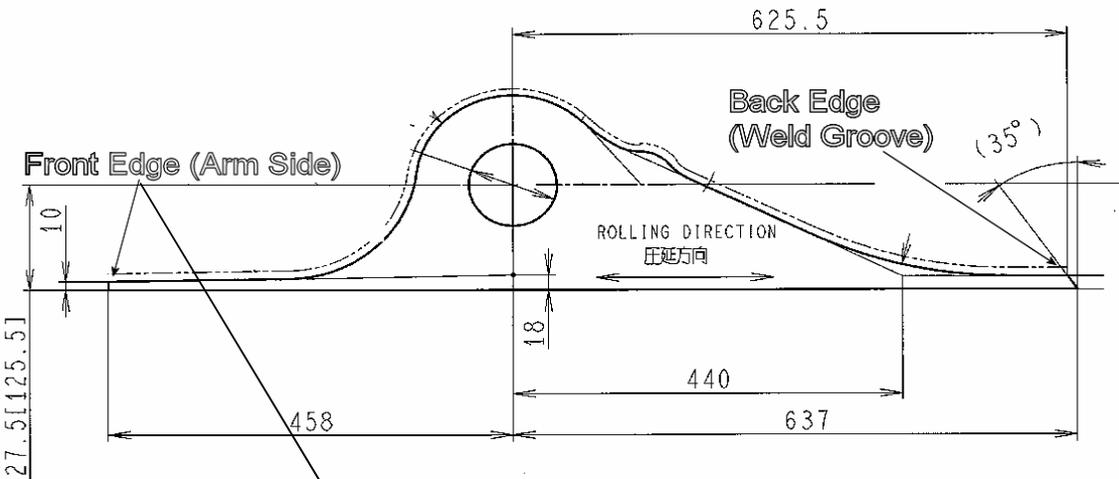
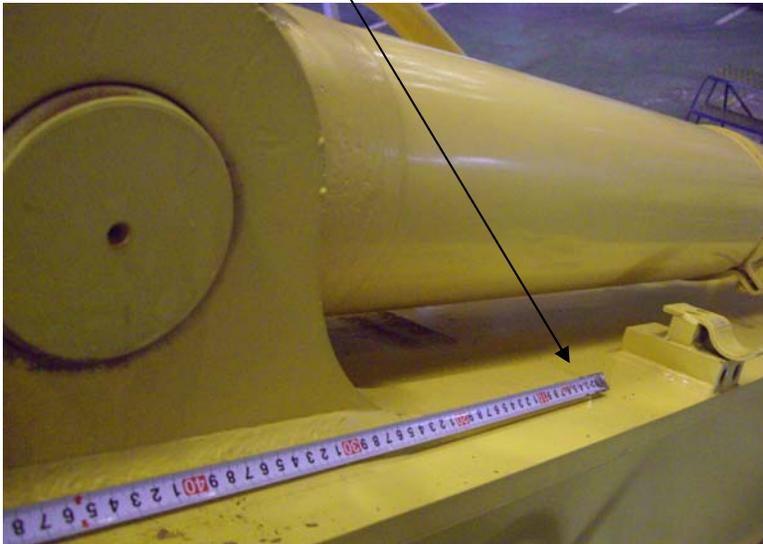
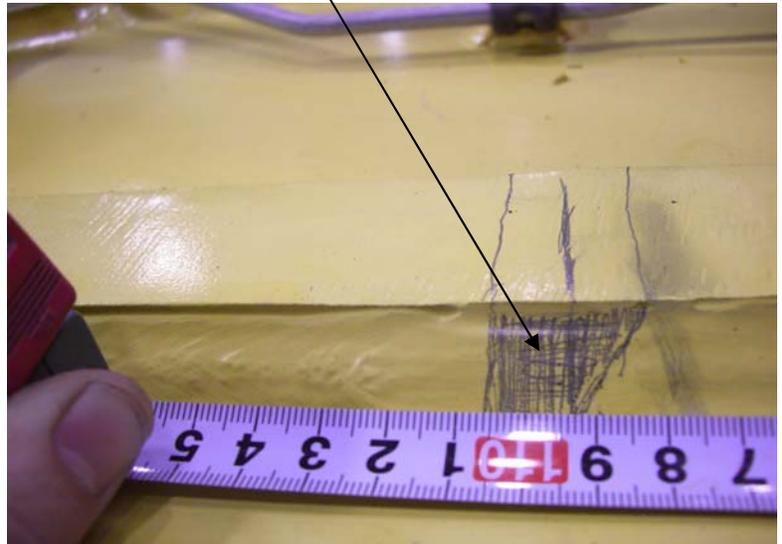
If there is no visible crack, weld root is 1095 mm from front edge of bracket.

4. Layout and mark area to be ground out.

Note: Protect work lamp, hoses, cab etc. from grinding/gouging sparks with fire proof blankets.

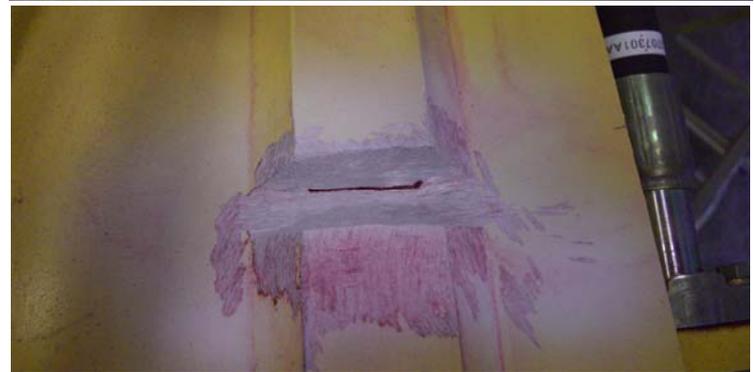
6. Liquid penetrant (PT) inspect weld groove to ensure top plate is not cracked. *Note: Dye will bleed out between cyl. bracket and top plate and between reinforcing strip and top plate as shown; Check is to ensure there is no crack in fillet welds at side of bracket or in the boom top plate.*
If cracking has occurred in top plate; See page 4/5 for additional instructions.

Proceed with step 7 if top plate is not cracked.

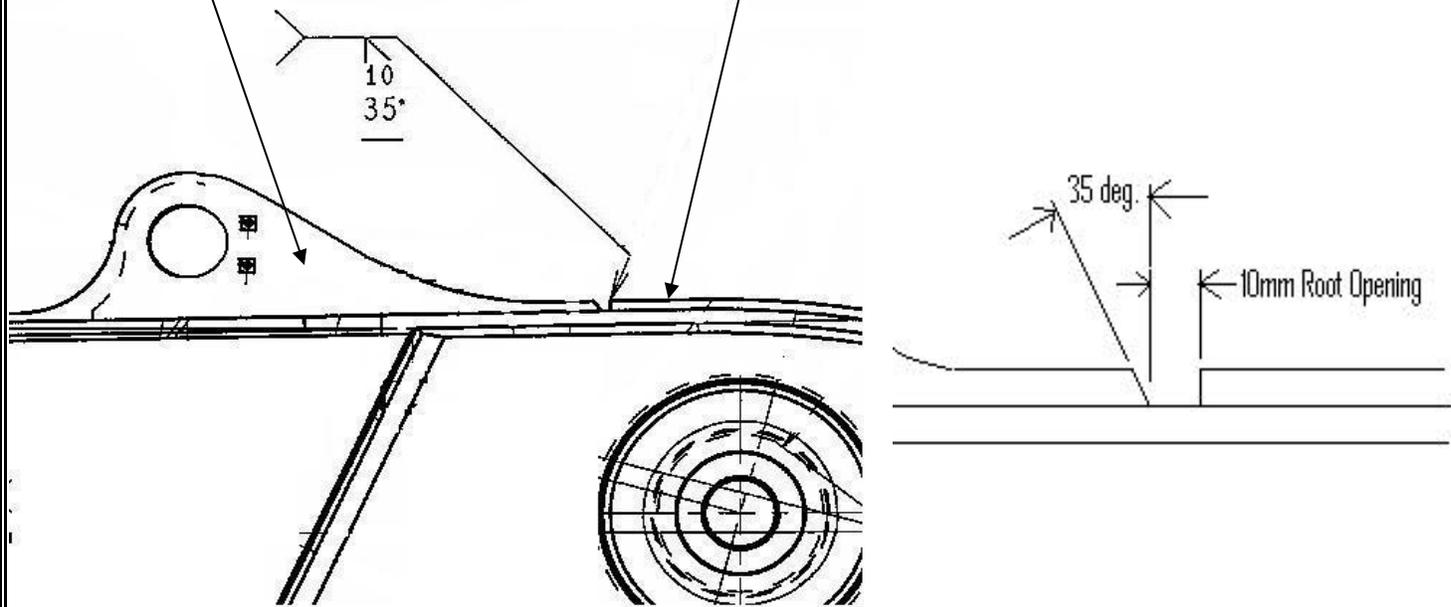
WELD JOINT

There have been field failures on PC400LC-7L due to the arm cylinder bracket to bracket strip weld set-up. The drawing calls for a 10mm gap to be maintained at this weld joint to achieve penetration. However some units may have been manufactured with a gap below 10mm. With high stress and improper weld penetration at these points, cracks may develop in this area and in some cases propagate across the top plate.

**PROCEDURE AND SEQUENCE**

1. Air arc or grind out entire crack 16mm deep including 5mm on each side into sound base metal. Include 35 deg. Bevel.
2. Liquid penetrant (PT) or Magna Flux (MT) inspect weld root area to ensure crack has not progressed into boom top plate.
3. Weld per procedure on page 6.
4. Grind weld cap pass flush with bracket and blend ends of weld with existing fillet weld.
5. Recommended (but not mandatory) UT inspection of finished weld to ensure there is no lack of fusion.
6. Paint.

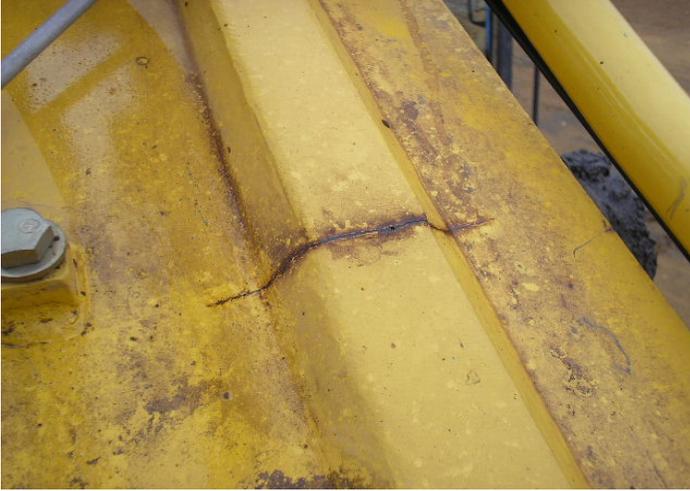
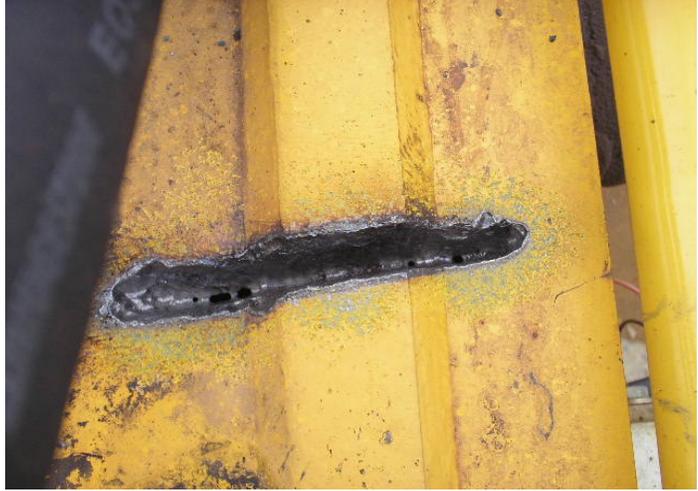
If visual or PT/MT inspection reveals cracking in top plate, use grinder or air arc to completely remove.

If crack has propagated through the thickness of the top plate; open up enough of a groove to allow for inserting a backing plate made of A36 material. This is recommended to ensure complete joint strength.

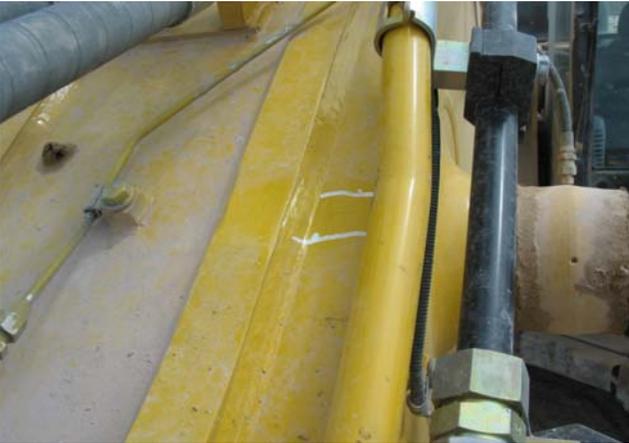
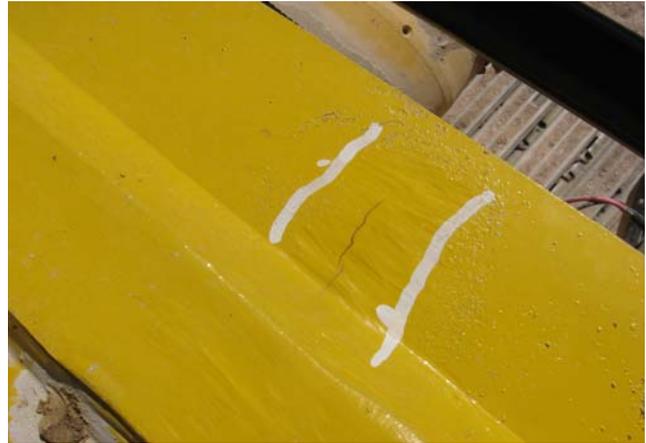
Do not bridge groove without backing: cracking may reappear as shown in pictures below of a previously repaired machine.

Use liquid penetrant insp. to ensure entire crack has been completely removed prior to weld repair.

If cracking is excessive and has propagated from top plate into sideplates, please contact service representative prior to performing any work.
