Coal Mine Fatal Accident 2003-11

Operator:	Freeman United Coal Mining Co.
Mine:	Crown III Mine
Accident Date:	April 15, 2003
Classification:	Machinery
Location:	District 8, Vincennes, Indiana
Mine Type:	Underground
Employment:	243
Production	8,500 tons/day

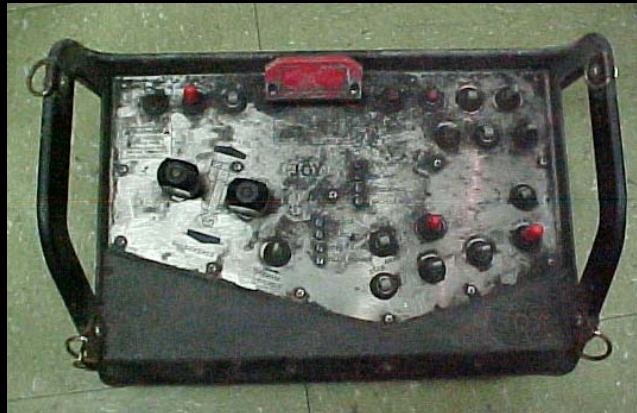
Continuous Mining Machine

- An examination of the continuous mining machine and remote control box revealed no visual or operational defects.
- The following components of the remote control system and related components were removed from the continuous mining machine for further testing:
 - Limited Remote Control Demultiplexer,
 - Limited Permissible Radio Transmitter, Model TX3,
 - Limited Receiver, Type RX1, and
 - Magenetek Firing Package.
- Tests revealed no operational or physical defects in these components that could have contributed to the accident.

- A second TX3 remote control unit was being used to control the continuous mining machine on the left side of the fishtail unit at the time of the accident.
- Tests were conducted and no cross activation was indicated during any of the tests.
- Motorola HT1000 radios being used on the working section for communication were tested and transmitting frequencies of these radios had no effect on the remote control components that could have caused the accident.

- The continuous mining machine and remote control unit had been moved from their original positions to free the victim.
- Switch position on the remote unit at the time of the accident could not be determined since all switches return to the neutral position when released.
- Mine personnel, who first arrived at the accident scene, stated that the pump motor was off, and the machine headlights were ON.
- This indicates that the remote control Shutdown Bar, CB Trip, or Pump Start/Off switch had been activated.
- The continuous mining machine was configured for the following tram speeds:
 - 15 ft/min - "SLOW"
 - 30 ft/min - "FAST"
 - 85 ft/min - "HIGH/TURBO"

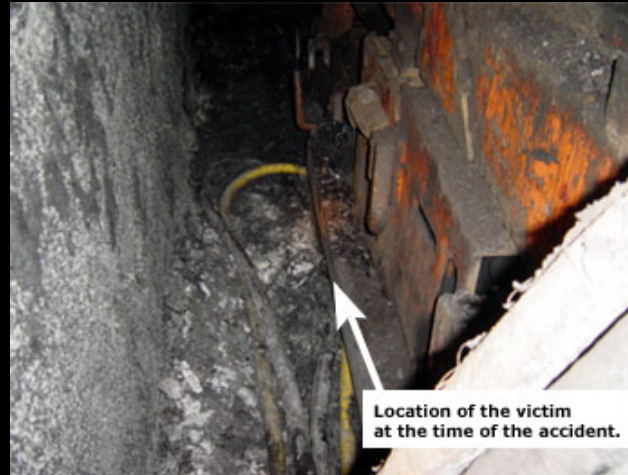
- Tests were performed to determine the machine's slew rate, the time for the left rear corner of the machine to contact the rib, for various tramming conditions with 26 inches separating the machine and the rib. These results are tabulated below:

Tram Condition	Time (seconds)
Split cat condition (left forward, right reverse) in fast speed	3.1
Split cat condition (left forward, right reverse) in slow speed	6.3
Right tram reversed in fast speed	9.8
Left tram forward in fast speed	10.0
Right tram reversed in slow speed	13.0
Left tram forward in slow speed	15.5
