Coal Mine Fatal Accident 2003-16

Operator:	Mountain Spring Coal Company
Mine:	#1 Mine
Accident Date:	June 13, 2003
Classification:	Electrical
Location:	District 2, Beaver Co., Pennsylvania
Mine Type:	Underground
Employment:	32
Production	1,400 tons/day prior to being placed in BA Status on 6/11/03

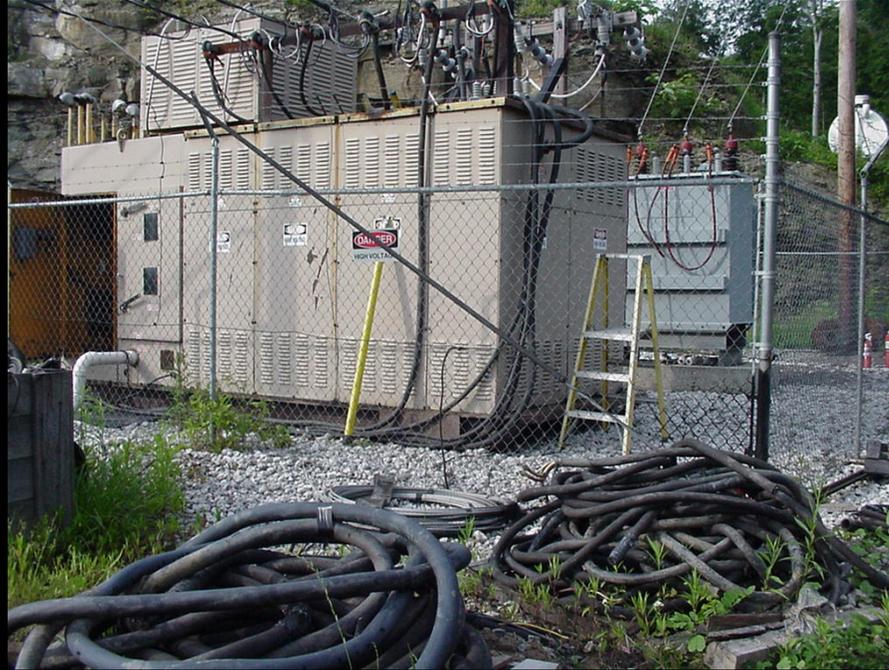
- They were joined by the mine electrical foreman as they entered the fenced area of the substation, which included the main transformer and enclosed transformer/switchgear unit.
- They then opened the 480 volt circuit breakers in order to test the circuits.

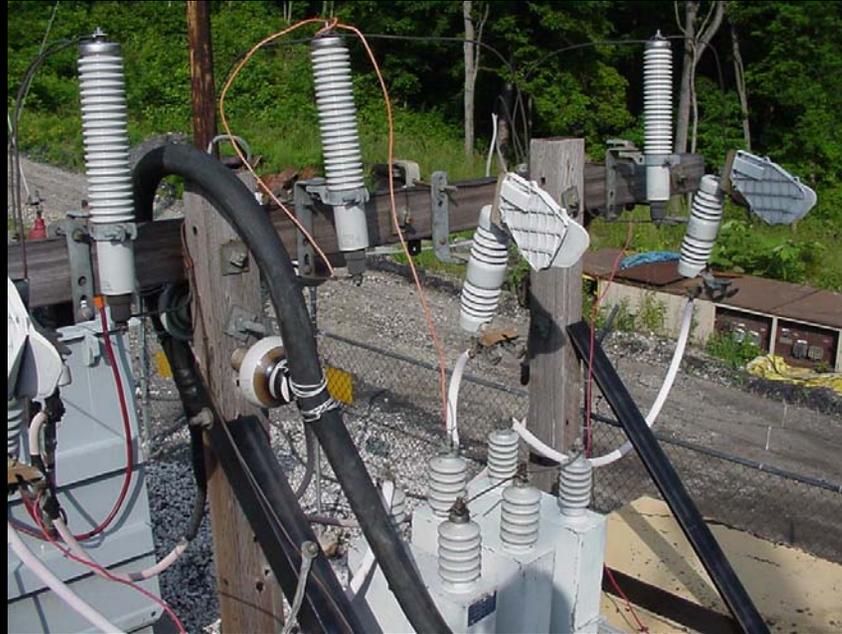
- The victim noticed that the fuse in the center phase disconnect for the capacitor bank appeared to be blown.
- The three fused disconnects were installed above the capacitor bank which was located on the roof of the enclosed unit.
- The victim then donned high voltage gloves and used a hotstick to pull fused disconnects.

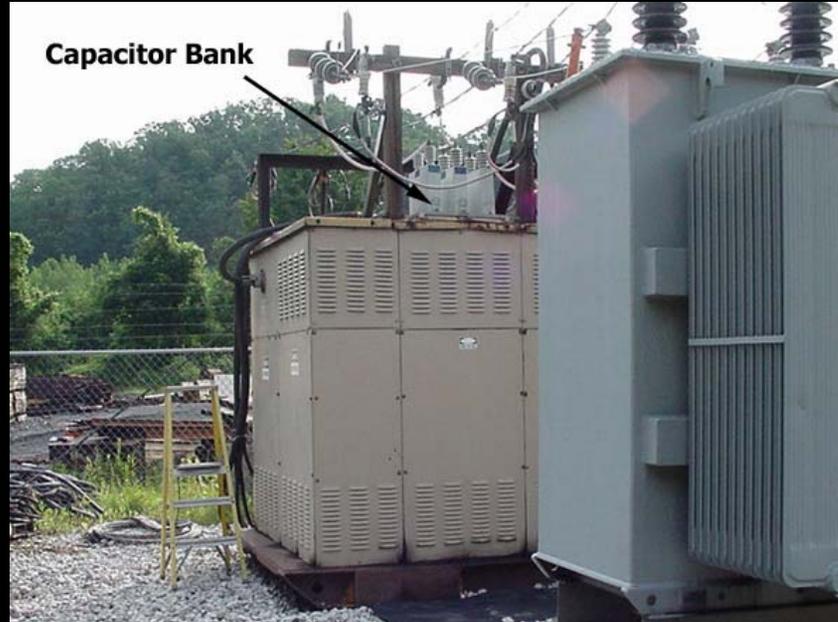
- They decided that the suspected blown fuse could be performed without opening the main disconnects, which were located 40 feet above ground.
- The victim used a 3-foot stepladder to climb on top of the roof of the enclosed unit and again donned the high voltage gloves.
- He was reminded by the other foremen to be careful because the high voltage capacitor bank circuit was still energized and instructed him to extend the hotstick, one section which would position him further back from the energized circuit.

- *Causal Factor:* The location of the main disconnects, 40 feet above ground, made the main disconnects very difficult to operate from the ground.
- *Corrective Action:* The GOAB was installed and is readily accessible.

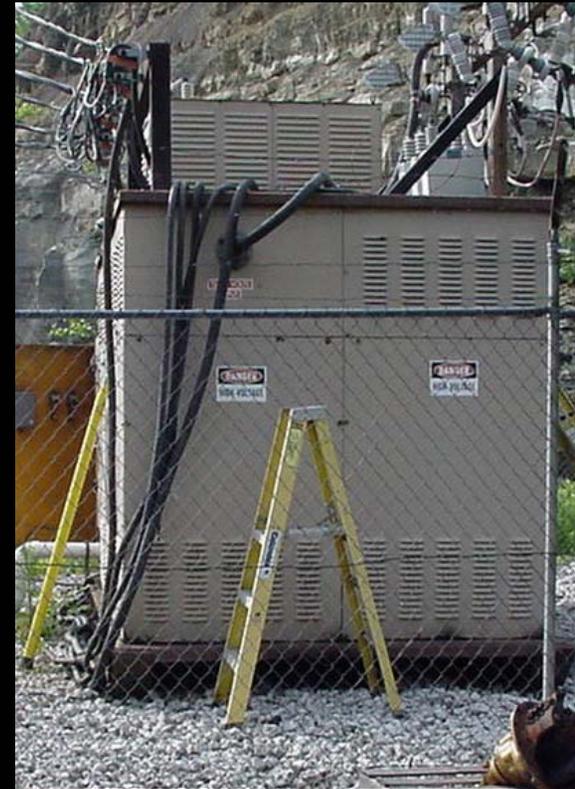
- The victim opened the three disconnects feeding power to the capacitor bank. He tried to remove the suspected blown fuse from the center phase disconnect but could not because the capacitor bank was located below it and prevented the fuse from being rotated far enough to be lifted out.
- He pushed the capacitor bank forward 6 to 8 inches, removed the fuse from the center phase disconnect and handed it down to the mine maintenance foreman, who determined that the fuse was not blown.
- The mine maintenance foreman trimmed the excessive fuse link material from the fuse and then handed it back to the victim to reinstall.

- *Causal Factor:* The location of the capacitor bank and capacitor disconnects required the victim to be exposed to unguarded live parts .
- *Corrective Action:* When and if the capacitor bank is reinstalled it will be completed in accordance with the National Electrical Code. The use of hotsticks shall be discussed in the retraining of qualified electrical personnel.

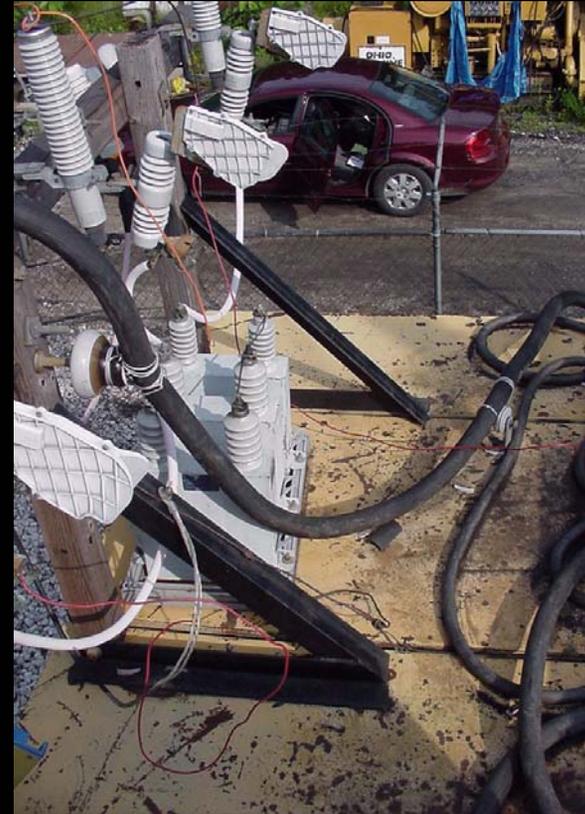
- The victim knelt in front of the capacitor bank as he closed the last of the three disconnects with his gloved hand.
- The electrical maintenance foreman looked away for a moment and heard a “pop.” Looking back, he saw the victim fall onto the capacitor bank and observed a flash around the victim’s head.
- The mine maintenance foreman saw the victim’s right hand jerk backwards and then suddenly come forward toward the capacitor bank. The victim was pronounced dead at the scene.

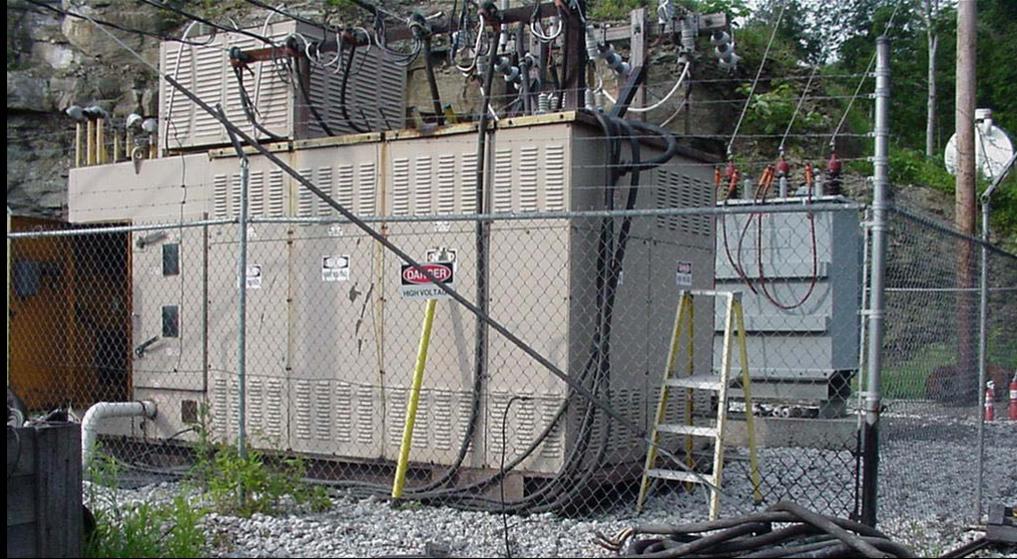
- After the accident, the hotstick was found leaning against the substation fence.
- The victim's injuries were consistent with the physical evidence obtained from the terminals on the capacitor bank.
- Following the accident, the high voltage gloves were tested by an independent laboratory according to ASTM F 496 testing procedures and passed.

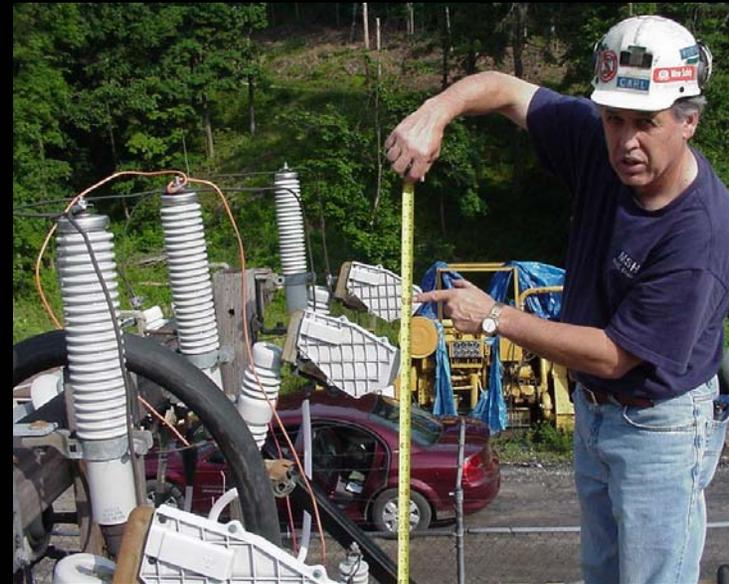
- 104(d) (1) Order for a violation of 30 CFR 77.516.
 - The high voltage capacitors installed on the roof of the enclosed unit in the surface substation did not comply with the provisions of the 1968 National Electric Code.
 - Article 710-34 (f) of the NEC states “Unguarded live parts above working space shall be maintained at elevations not less than required by the following table: Table 710-34 (f) Voltage between phases 11001 – 22000, Minimum Vertical Clearance of Unguarded Parts 9 foot 3 inches”.
 - The high voltage capacitor disconnect switches were mounted 44 inches above the roof of the enclosed unit.
 - The capacitor bank and terminals were located below the disconnects.
