Coal Mine Fatal Accident 2003-23

| Operator: | Twin Star Mining, Inc. |
| Mine: | No. 2 Surface Mine |
| Classification: | Exploding Vessel |

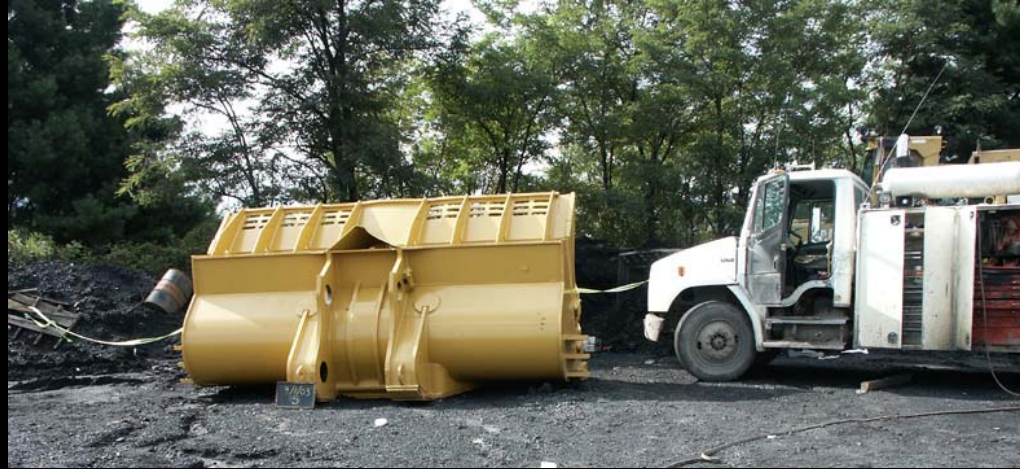
- The drum was placed inside an unattached Caterpillar, Model 992-G, front-end loader bucket, which concealed its view and shielded the blast from nearby buildings.
- The fatally injured victim received massive fatal head injuries when he was struck by debris from the explosion.
- The most likely ignition source was static electricity, which was generated by acetylene flowing from the torch tip. An electrostatic discharge likely occurred when the torch tip touched the grounded steel drum.

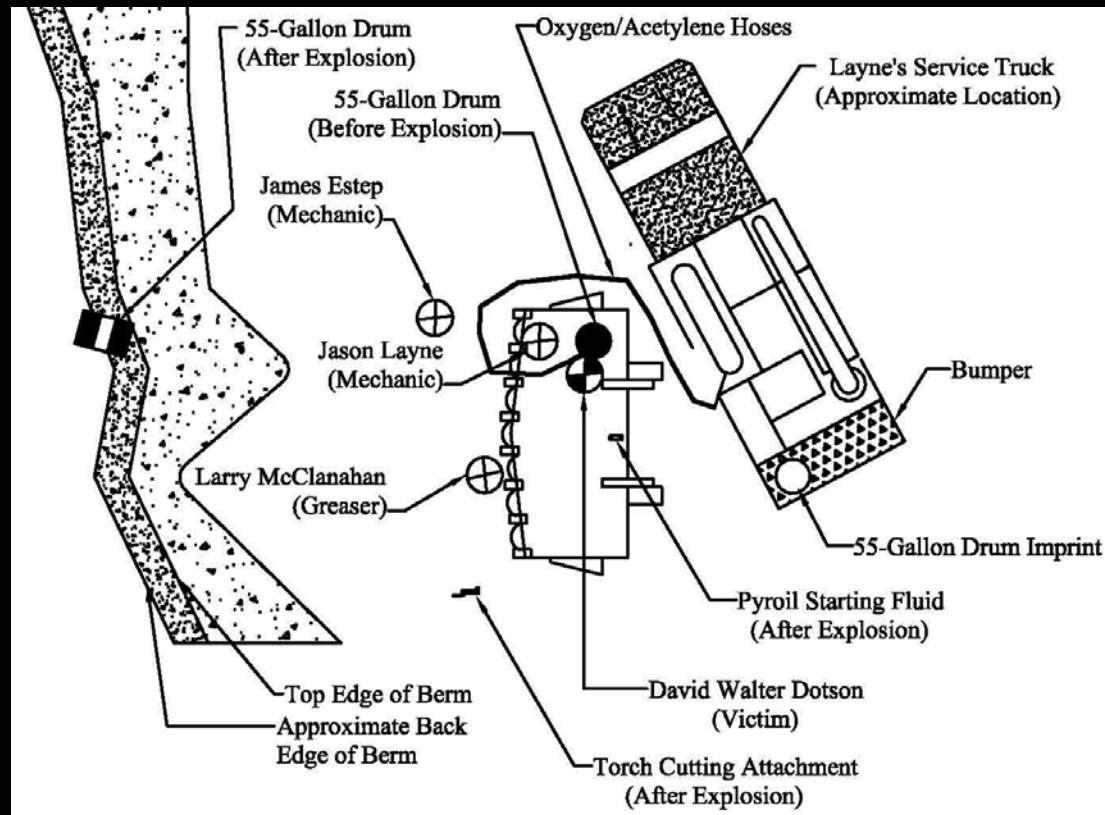
- Dotson was struck by debris and was thrown approximately 6 feet, sustaining massive head trauma.
- Layne, was forced to the ground by the explosion and burned by flames from the torch body, which struck him in the neck.
- Estep's eyes were hit by debris, temporarily impeding his vision, and McClanahan was thrown to the ground.

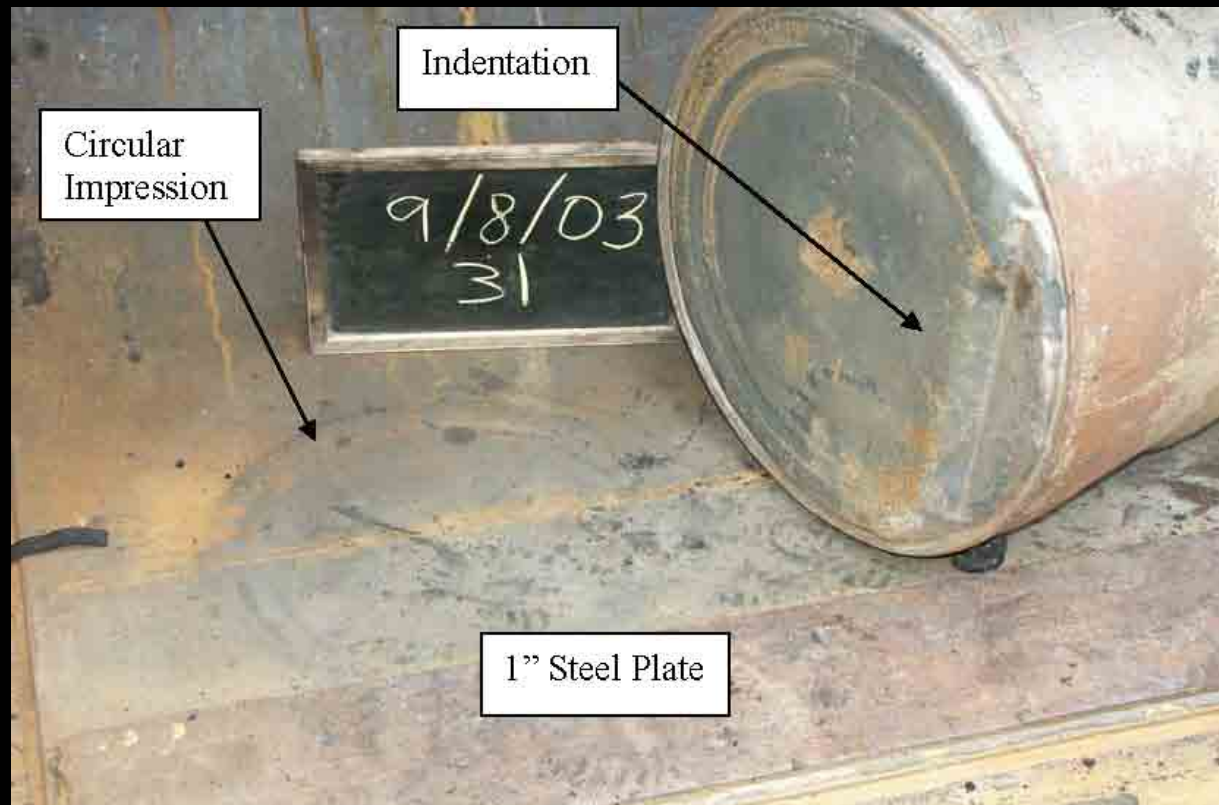
The direction of explosive forces extended outward in all directions from the 55-gallon drum, which indicated that the explosion originated inside the drum. Its lid separated from the drum and impacted the top, inner surface of the loader bucket. The bottom of the drum was indented, but did not separate from the drum. The indentation in the bottom of the drum conformed to a one-inch thick, flat steel reinforcing plate in the bottom of the bucket..

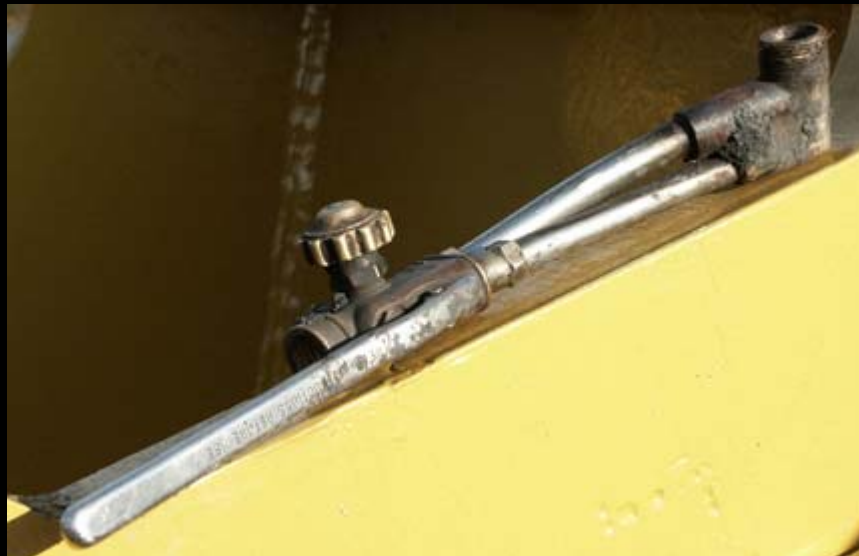
- The threads on the tip were stripped but no impact marks were present, indicating that the threads were protected from impact by the tip, and that the tip was attached at the time of the accident. The impact was likely caused by either the torch being struck by the drum lid or the torch being forced into the front surface of the bucket.
- Damage to the threads connecting the cutting attachment to the base indicated that a prying action stripped the attachment from the base, possibly caused by the same lateral force that twisted the attachment.
- The rate of pressure rise for acetylene can be as much as 25 times faster than methane, which can cause damage consistent with that observed at the accident site.
