**REPORT OF INVESTIGATION**

**Fatal Exploding Vessel Accident  
September 5, 2003**

**No. 2 Surface Mine  
Twin Star Mining, Inc.  
Hurley, Buchanan County, Virginia  
ID No. 44-03658**

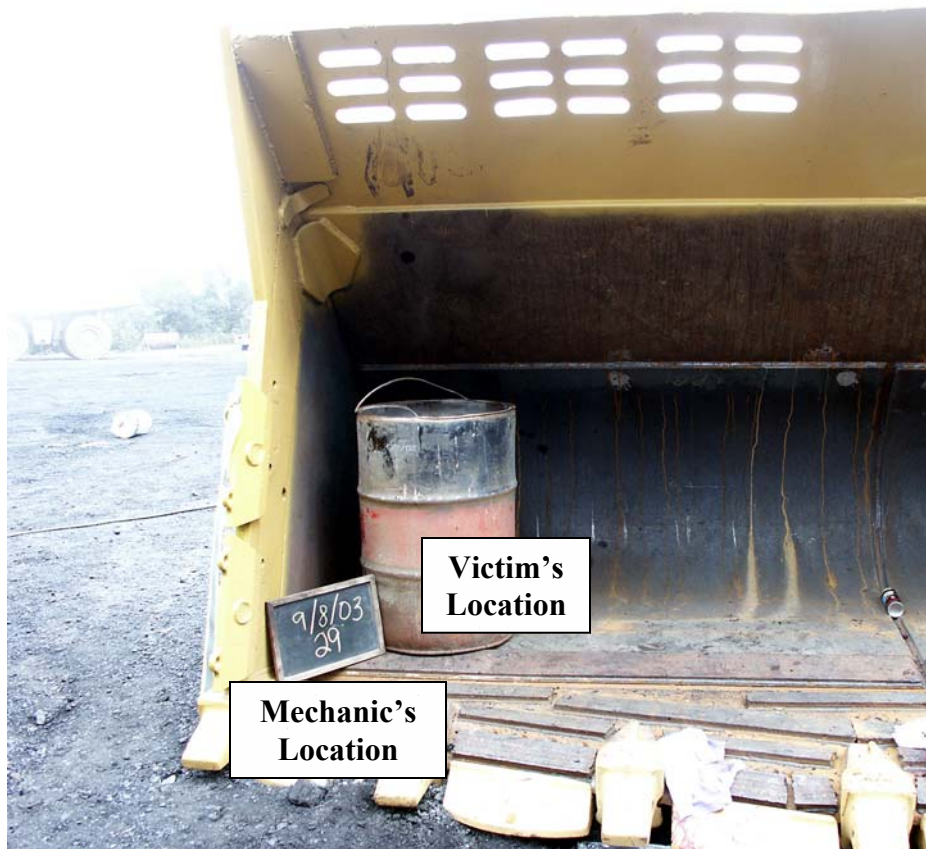
**Figure 1** – Photograph of the accident site, showing the barrel after it was repositioned inside the front-end loader bucket, at its location prior to the explosion.

The direction of explosive forces extended outward in all directions from the 55-gallon drum, which indicated that the explosion originated inside the drum. Its lid separated from the drum and impacted the top, inner surface of the loader bucket. This was evidenced by a scuff mark on the painted inner surface of the bucket that corresponded to the location of the drum in the bucket. The lid was not found during the investigation and may have traveled down over a steep hillside behind the embankment after ricocheting off the angled inner surface of the bucket. The bottom of the drum was indented, but did not separate from the drum. The indentation in the bottom of the drum conformed to a one-inch thick, flat steel reinforcing plate in the bottom of the bucket (as shown in Figure 2). A circular impression of the drum was also visible on the lower, inner surface of the bucket. During the investigation, these factors were used to position the drum at its location at the time of the accident (as shown in Figure 1) in the northeast corner of the loader bucket.

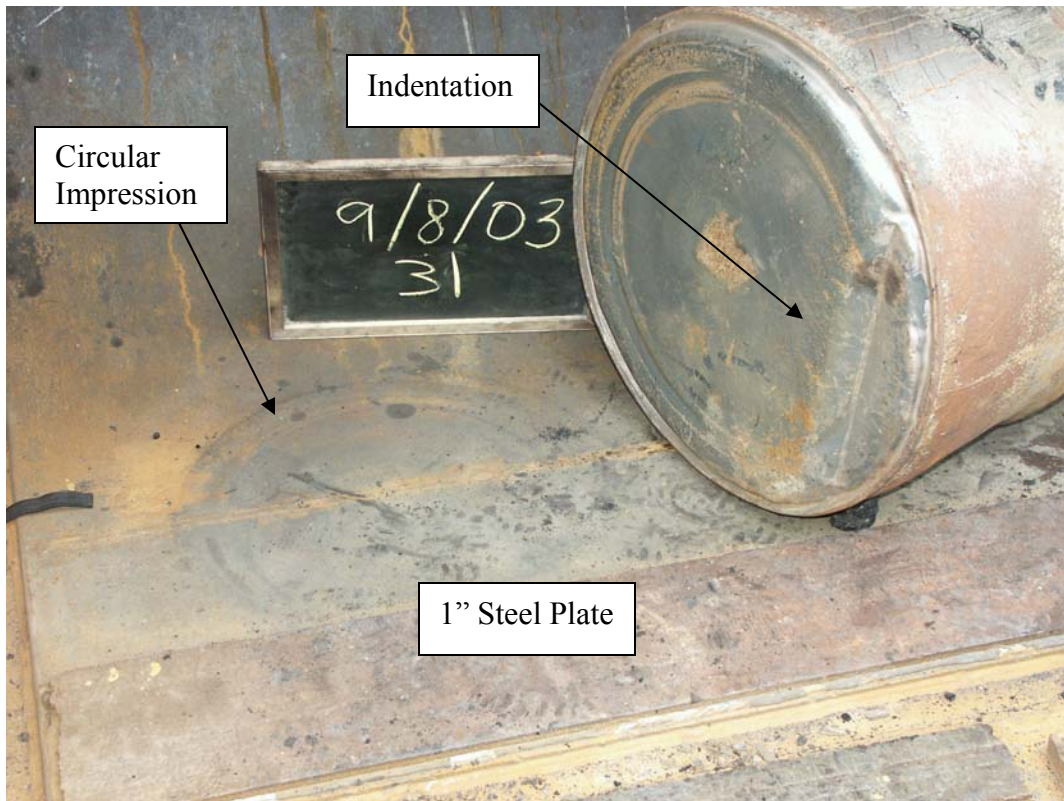
**Figure 2** – Photograph showing the bottom of drum, the steel plate on the bucket, and the circular impression of the drum on the lower inner surface of the bucket.
