REPORT OF INVESTIGATION

Fatal Powered Haulage Accident  
September 9, 2003

Belle Ayr Mine  
RAG Coal West, Inc.  
Gillette, Campbell County, Wyoming  
ID No. 48-00732

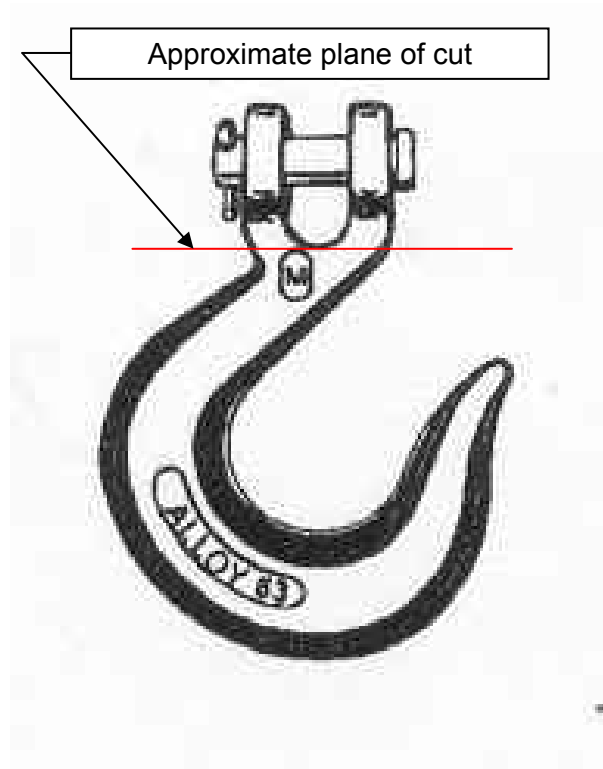
Figure 1: Illustration of hook taken from page 75 of Columbus McKinnon Corporation product catalog number IPC-10B, "CM Chain and Forged Products":

- 6) RECEIVER HOOK: Identification markings on the hook indicated that the hook was originally a Midland (Columbus McKinnon Corporation) alloy clevis type slip hook, grade 63, manufactured for use with a ½-inch chain. The clevis pin eyes had been cut off. Technical specifications indicate the original weight of the hook prior to the eyes being cut off was approximately 2.55 pounds and the original Working Load Limit was 9,400 pounds. An illustration of the original hook is shown in Figure 1, below. Cutting off the pin clevis eyes left a base on the hook approximately ¾ inches thick and 1¼ inches in length. The base of the hook appeared to have then been butt welded to the receiver hitch's tubular frame. The outside circumference of the weld beads made a rectangular shape of approximately one inch by two inches. The approximate orientation of the hook when it was attached to the receiver frame is shown in Appendix C. Columbus McKinnon Corporation legal personnel contacted by investigators stated that this hook was not intended to be welded since it would affect the mechanical properties of the hook and that Columbus McKinnon Corporation does manufacture or distribute weld-on type hooks.

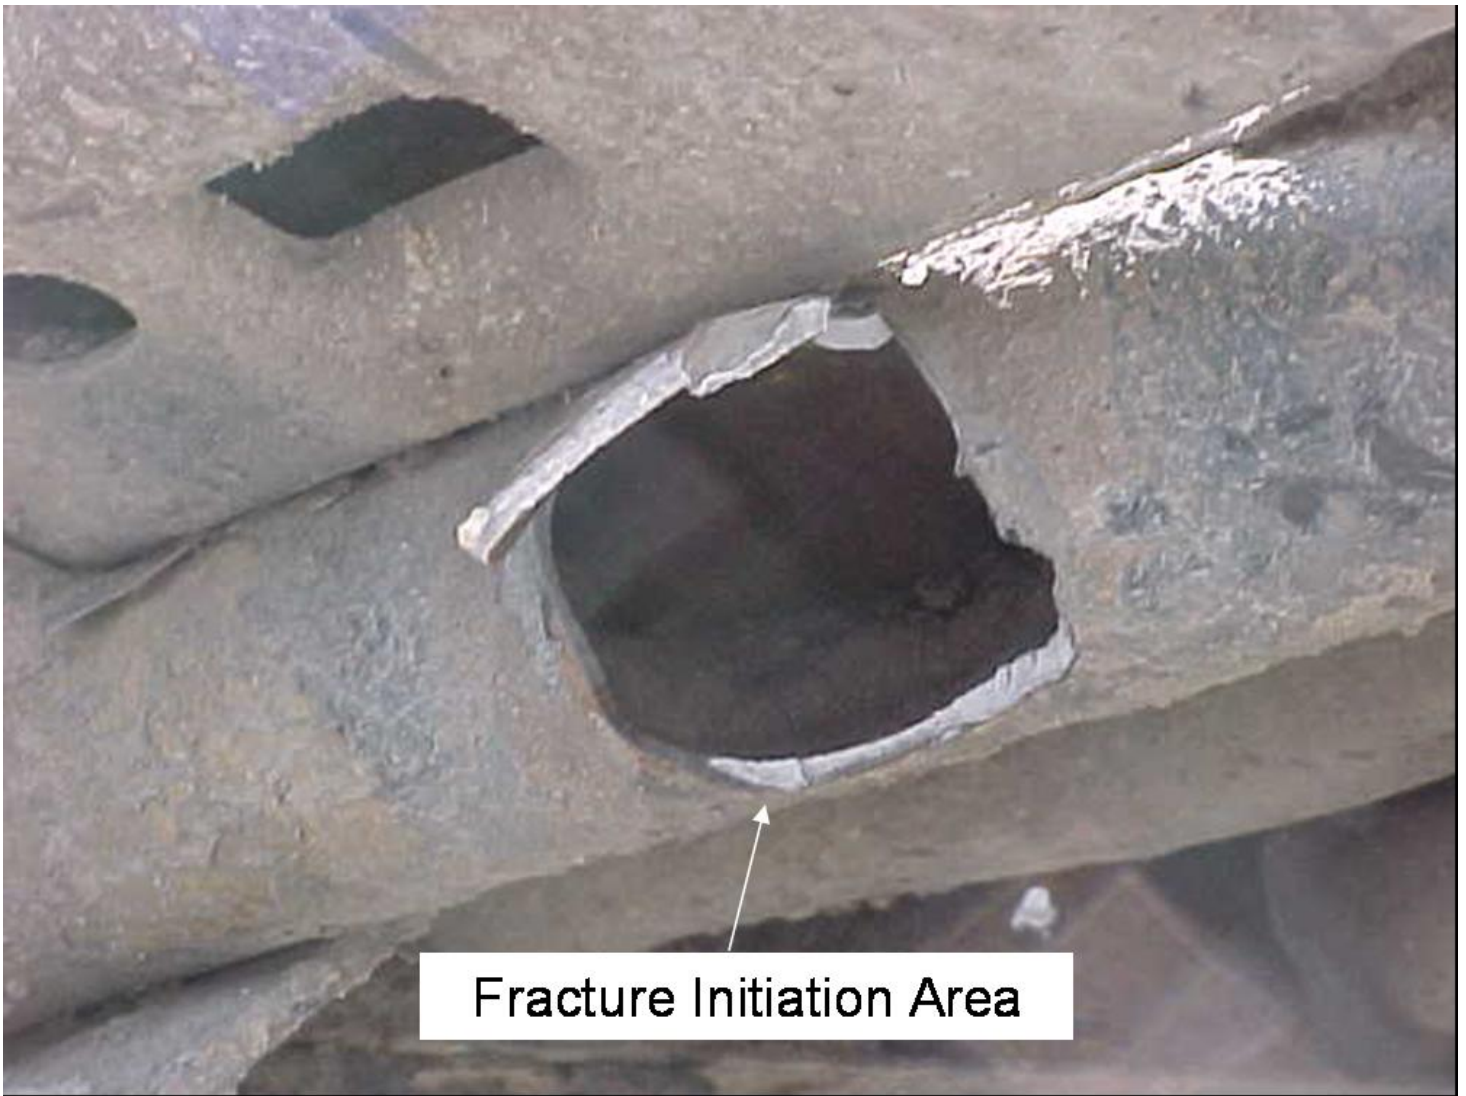
APPENDIX E

- 7) **FAILURE OF RECEIVER FRAME:** The tubing of the receiver frame failed, allowing the hook to dislodge from the receiver frame. Visual observations indicated the welds remained intact but the tube wall failed around the welds on the sides adjacent to the hook base. This left a section of the tubing, approximately the size of the 1-inch X 2-inch weld filler pattern, attached to the hook base as shown in Appendix D. The failure of the tubing material appeared to have started in the lower left corner area of the hook base as shown in Appendix E.

Corrective Action: The rope's pulling force was not applied to the hitch, the point of the receiver designed to carry the rated load. RAG removed all rear tow hooks from all light service vehicles and implemented a policy that hooks shall not be installed in this manner on such trucks in the future.

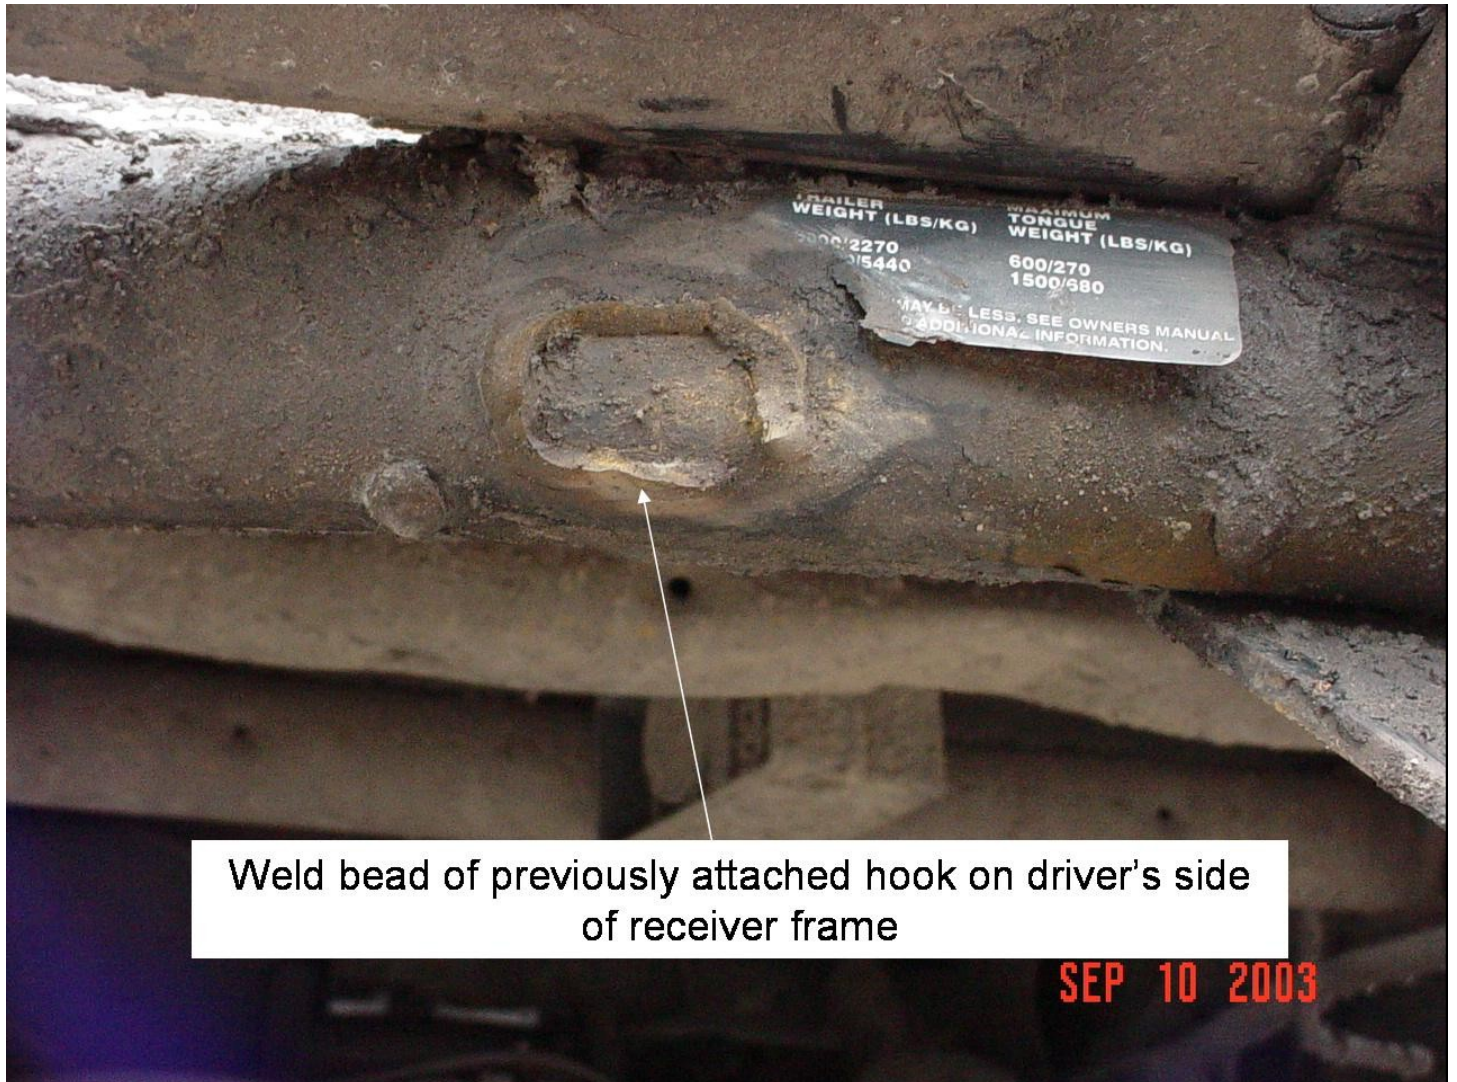
APPENDIX F

- 12) WELDS: The quality and/or the type of welds attaching the two hooks to the receiver frame were inconsistent with each other. This is suggested by the weld failure on the driver's (left) side hook on the receiver frame, whereas the weld did not fail on the hook involved in the accident. The weld for the left side hook is shown in Appendix F.

- 14) On August 20, 2003, a towing incident occurred in which the hook on the left side of the hitch receiver on the towing truck (No. 968.21) involved in the September 9, 2003, accident was broken off. Information indicated that this truck became stuck in wet, soupy material, deep enough that it seeped into the cab of the truck. A motor grader was called to pull it out. The motor grader backed up to the rear of the truck and a nylon strap was placed between the two vehicles. The strap was put on the hook on the left side of the hitch receiver. When the motor grader pulled the strap, the hook broke off and fell into the muck around the truck. The hook was not retrieved. The strap was then attached around the hitch and the motor grader used its ripper to lift the rear of the truck and extricate it from the muck. The motor grader was then able to pull the truck out of the mud. When lifting the truck, the hitch and bumper were bent in an upward position. The truck was then taken to the garage, washed, and examined. It was determined that no immediate repairs were needed and the truck was put back into

Corrective Action: Following the September 9, 2003, accident RAG removed all rear tow hooks from all light service vehicles and implemented a policy that hooks shall not be installed on such trucks in the future.

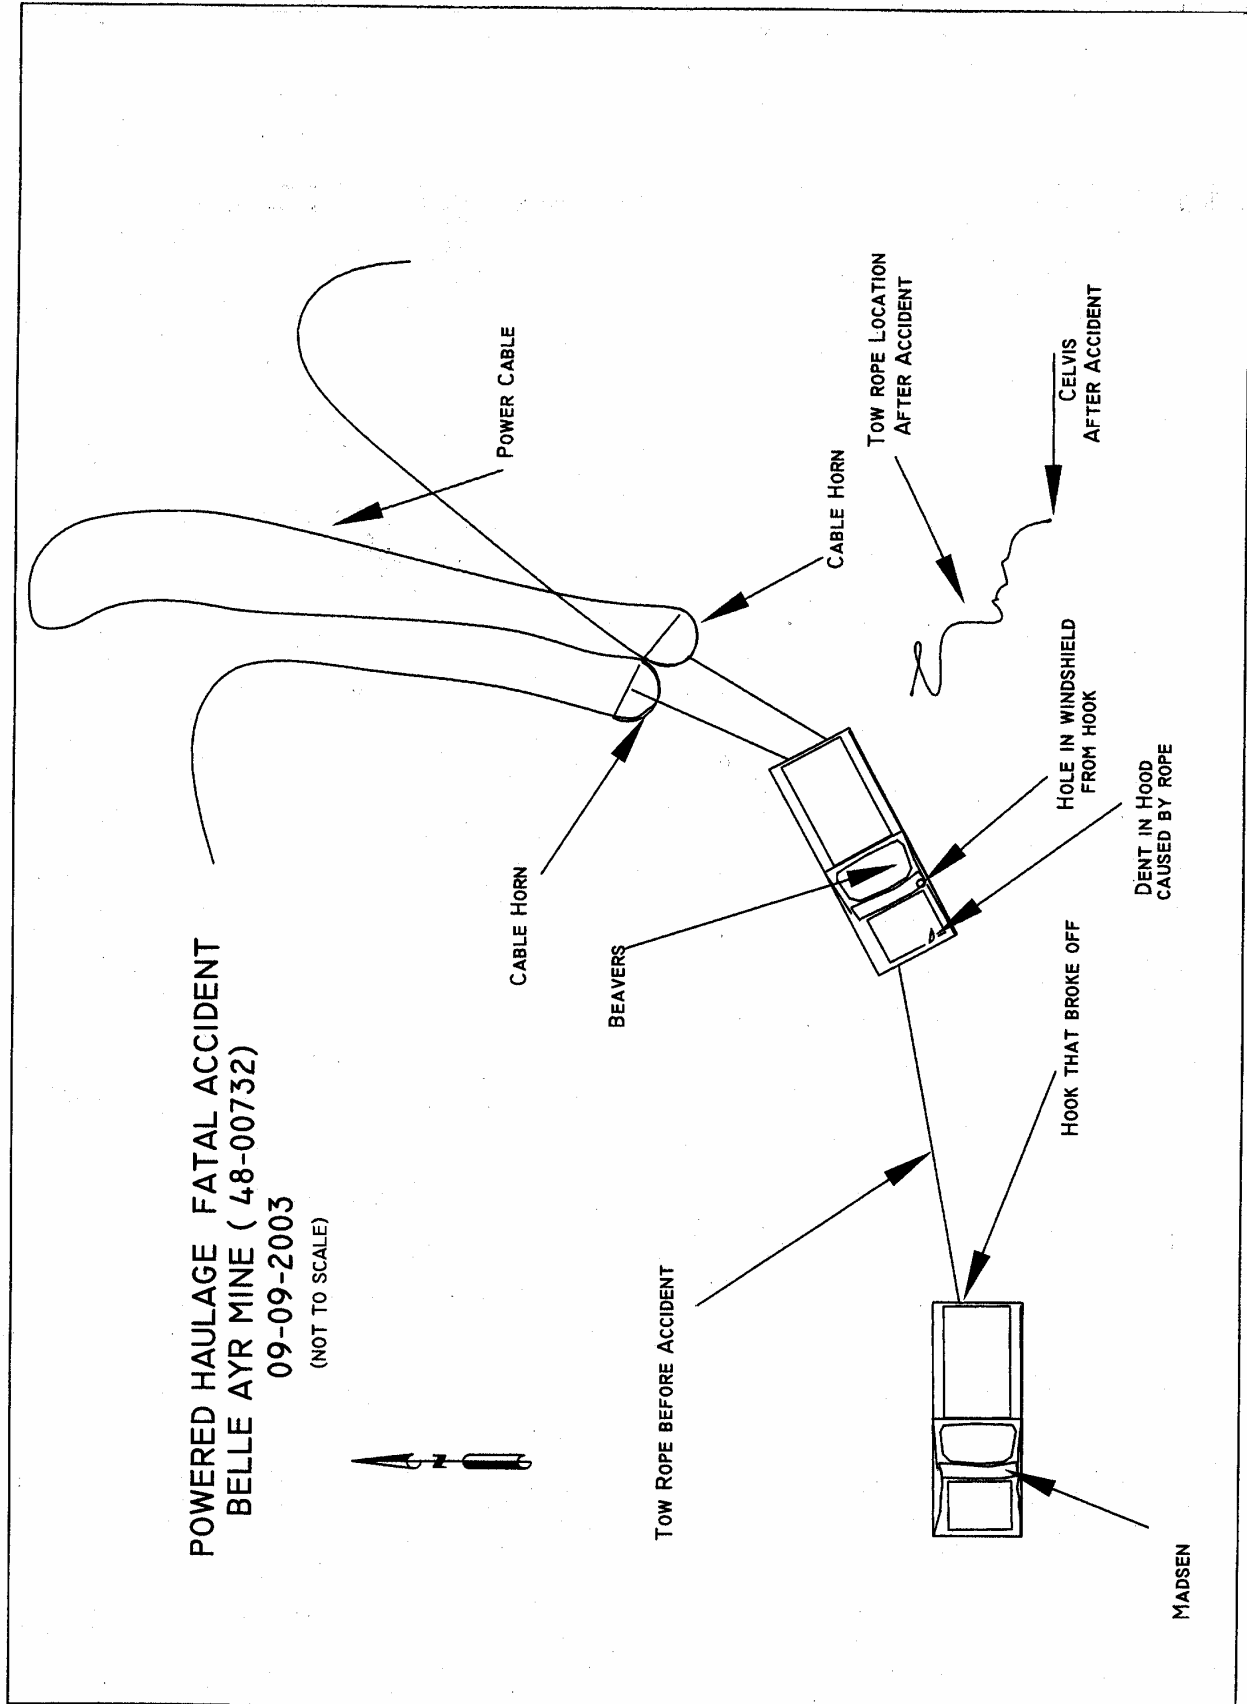
- 8) Statements indicated that Beavers placed the tow rope on the right front hook of his truck. He placed the eye with the clevis on the hook. Examination of the hook found no obvious markings from the steel clevis, indicating only the rope eye had been placed over the hook. After the accident, the tow rope was found on the ground on the left side of the truck to the rear. See Appendix G for the location of the rope.
