## Coal Mine Fatal Accident 2004-14

Operator:	Dags Branch Coal Co., Inc.
Mine:	No. 6 Mine
Accident Date:	June 17, 2004
Classification:	Fall of Roof
Location:	District 6, Pike County, KY
Mine Type:	Underground
Employment:	14
Production	350 Tons/Day

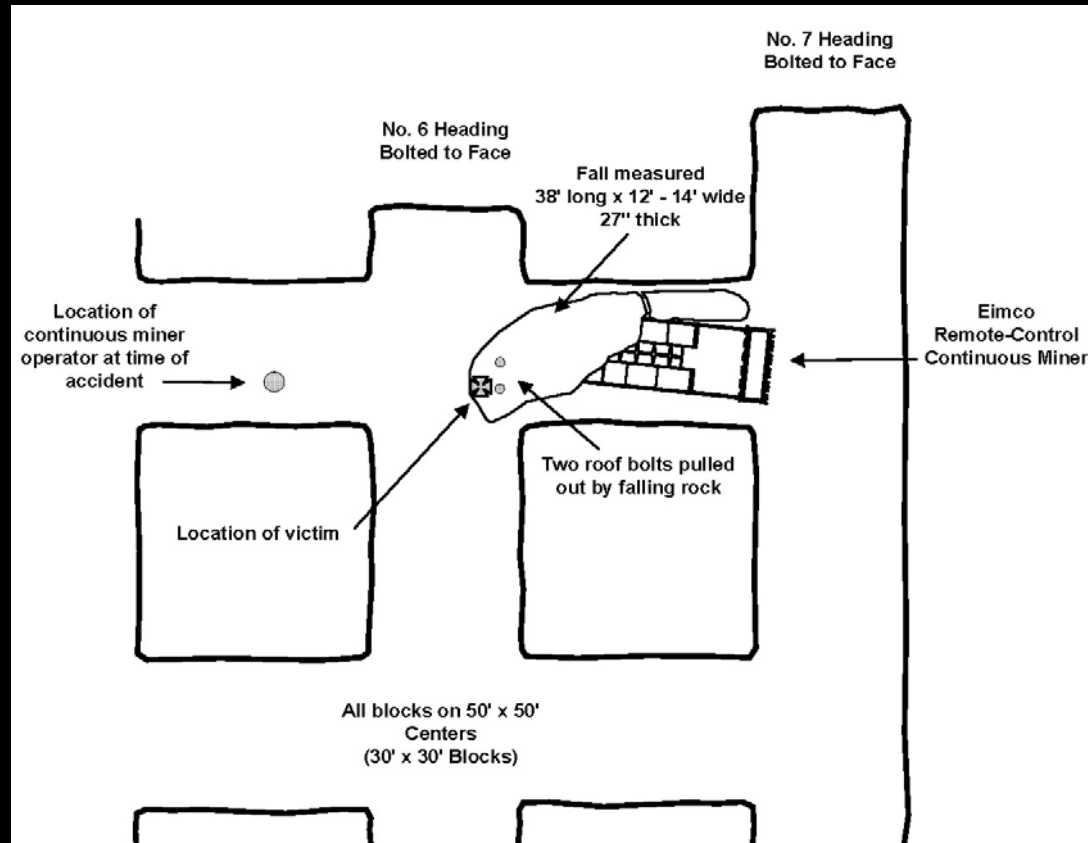
The victim, a utility man, was assisting the continuous miner operator with the miner cable after mining the crosscut between the No. 6 and No. 7 Entries. As the victim bent over to pick up the miner cable, a "slickensided" rock, measuring 38 feet long by 12 to 14 feet wide by 27 inches thick, fell from the unsupported area of the crosscut. The fall also pulled out two previously installed roof bolts, striking the victim.

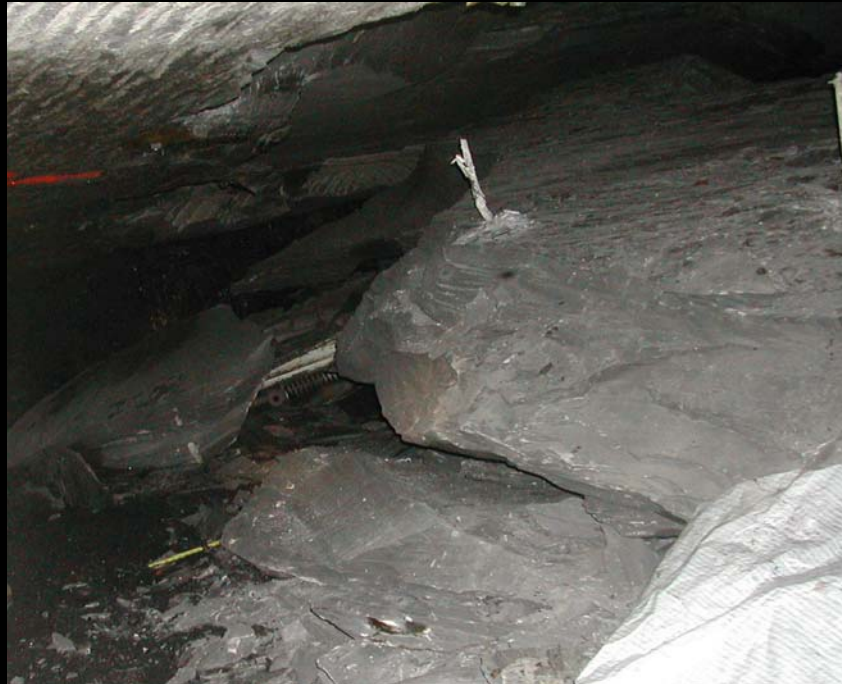
The accident occurred when the victim was positioned in by the second row of permanent roof supports immediately after an extended cut had been mined. A warning device, which would have increased the likelihood that the victim would have recognized his proximity to the last row of bolts, had not been installed on the last row of permanent roof supports. An undetectable, slickensided section of roof rock fell in the unsupported area and extended to the second row of bolts in the No. 6 Entry, striking the victim and causing fatal injuries.
