REPORT OF INVESTIGATION

Fatal Fall of Roof Accident
June 17, 2004

No. 6
Dags Branch Coal Co., Inc.
Feds Creek, Pike County, Kentucky
ID No. 15-17979

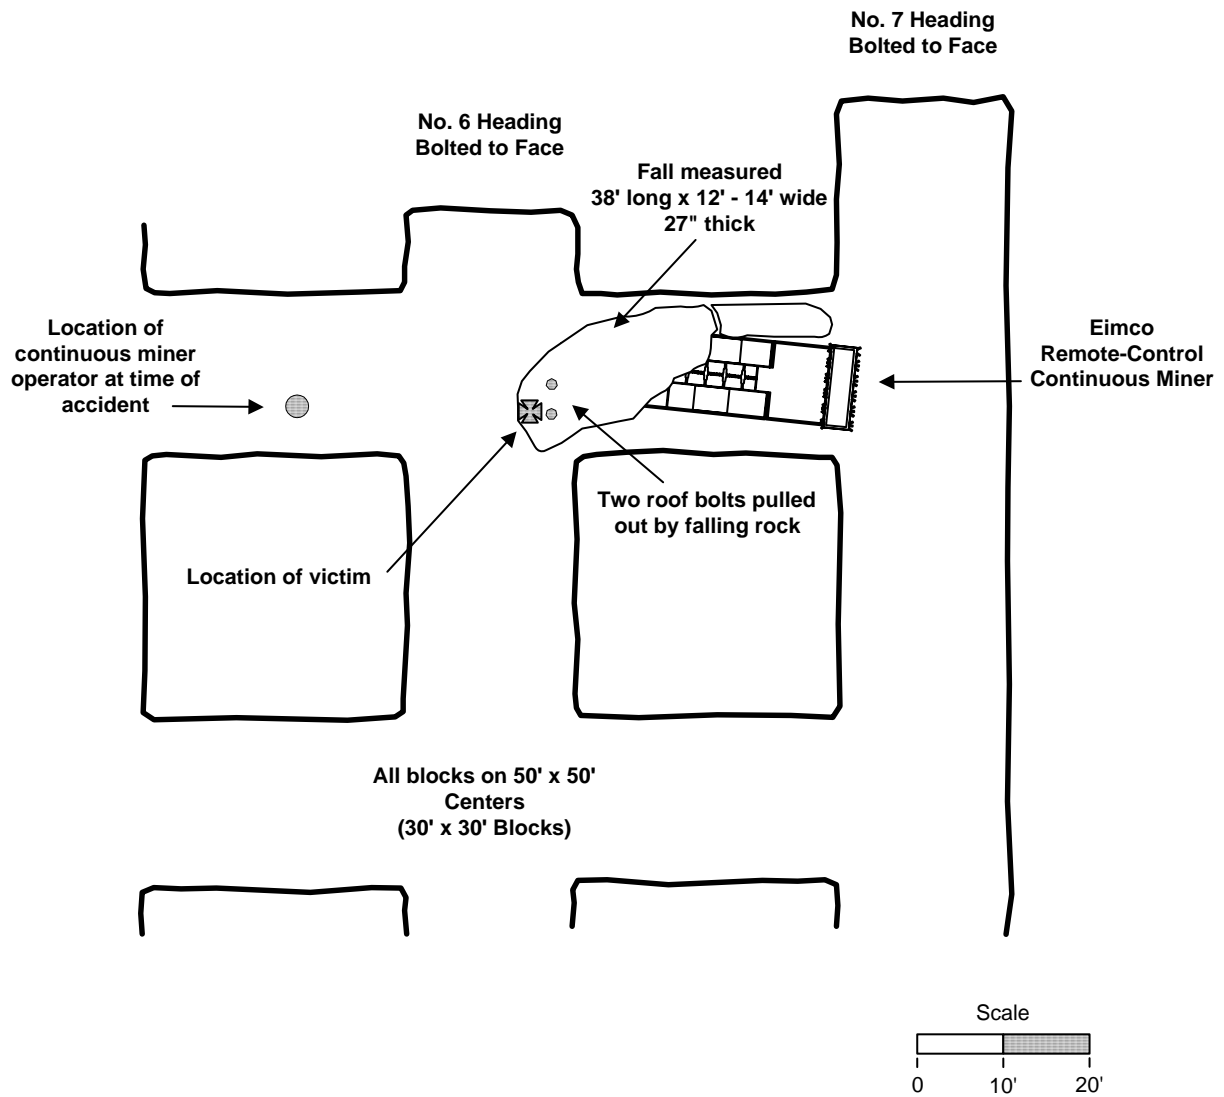
Sketch of Accident Scene

The accident occurred as Chaney was assisting the continuous miner operator with the miner cable after mining in the crosscut between the No. 6 and No. 7 Entries was completed. As Chaney bent over to pick up the miner cable, a “slickensided” rock, measuring 38 feet long by 12 to 14 feet wide by 27 inches thick, fell from the unsupported area of the crosscut. The fall, which pulled out two previously installed roof bolts in the area where Chaney was located, caught Chaney beneath it, resulting in his death.

The fatality occurred because the victim was in an unsafe area following the completion of an extended cut. The victim was located between the first and second row of installed roof bolts.

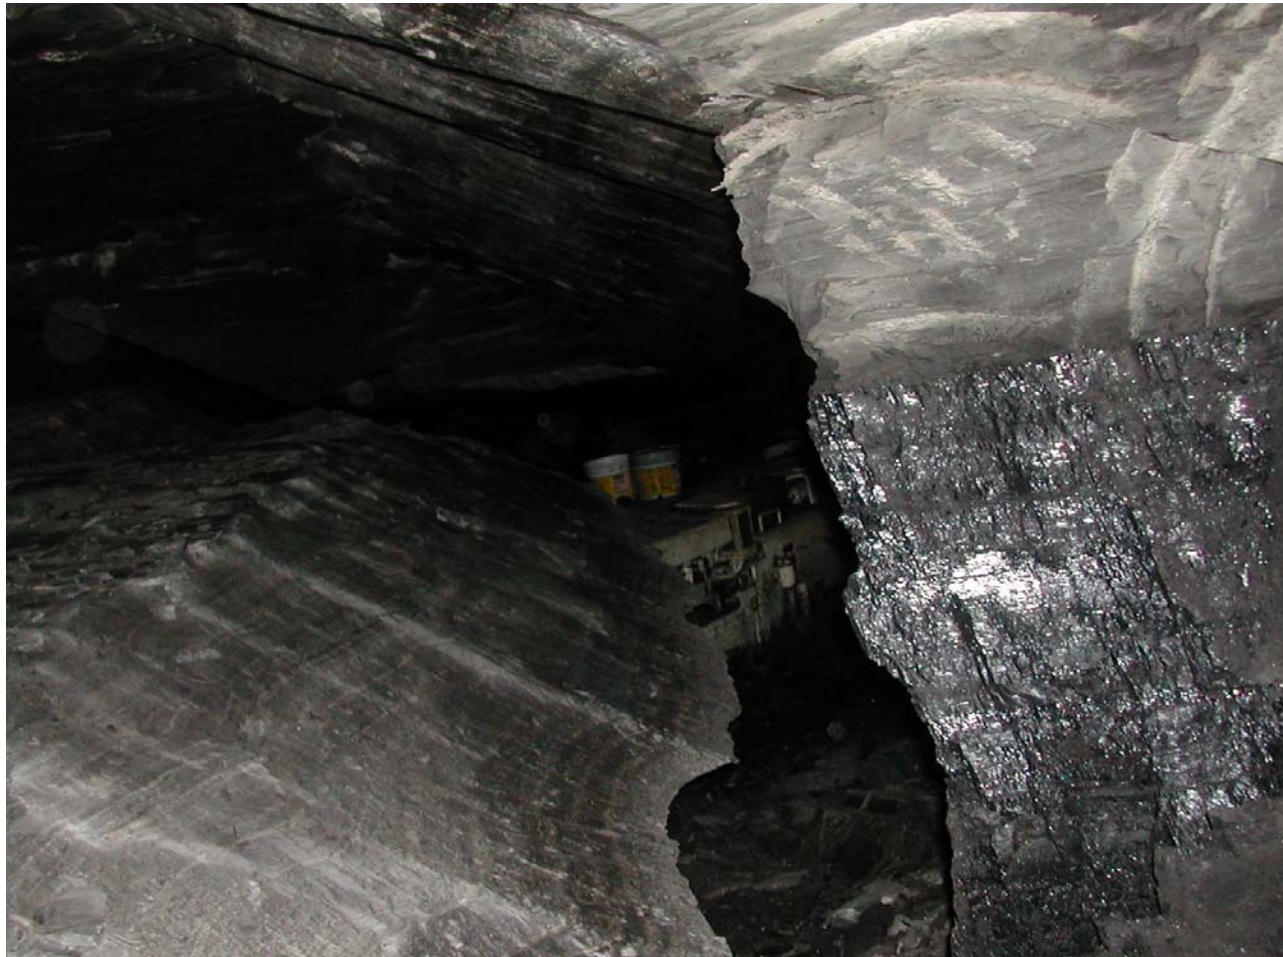
APPENDIX C

The immediate roof and the fallen material were composed of laminated sandy-shale. The fallen material predominately remained intact as two pieces, and measured 38 feet long by 12-14 feet wide and 27 inches thick. The fall began in the unsupported crosscut and extended to the second row of bolts in the No. 6 Entry. Two roof bolts in the last row of permanent roof support failed during the fall. The fall was bounded by two slickensided surfaces, which could not be detected from the supported area. The rock

appeared to have released suddenly, falling from the inby point to the outby point as evidenced by the bending of the two roof bolts pulled out by the fall. A photograph of the rock fall is shown in Appendix C.

Photograph of Accident Scene
(Crosscut as viewed from No. 6 Entry)
Showing Continuous Miner and Rock that Fell

Corrective Actions: The roof control plan was reviewed and explained to each and every employee prior to mining being resumed. Special emphasis was placed on the importance of never positioning any part of the body inby the second row of undisturbed permanent roof supports (roof bolts).

Corrective Actions: The operator will have either the roof bolter operator or continuous miner operator install bright red reflectors on the last row of permanent supports prior to the continuous mining machine beginning a new cut.
