REPORT OF INVESTIGATION

**Underground Metal Mine
(Gold)**

Fatal Powered Haulage Accident

**Barrick Goldstrike Mines, Inc.
Meikle Mine
Carlin, Elko County, Nevada
Mine ID No. 26-02246**

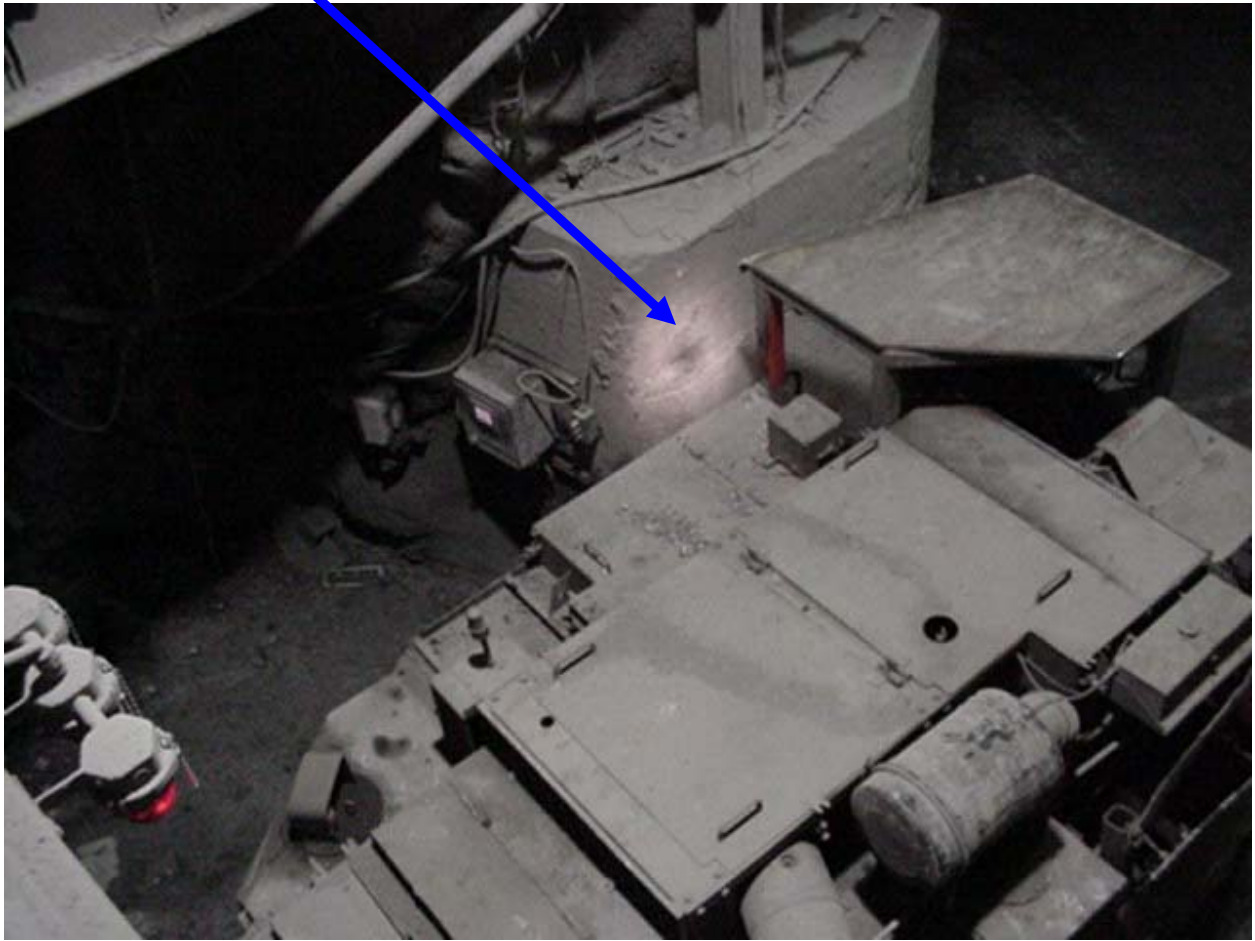
The victim was pinned between the concrete pillar and the haul truck

truck started to drift forward as he exited or entered the cab. He was pinned between the side of the truck and a concrete pillar.

Accident Reenactment After the deficiencies on the truck were repaired, it was placed at the accident scene to reconstruct the accident. The engine was running, the transmission was in neutral, and the brakes were not applied. As the truck was filled, it moved forward. The combination of the two and a half percent grade and the force of the aggregate entering the dump box caused the forward movement.
