Appendix Y - Selected Photographs

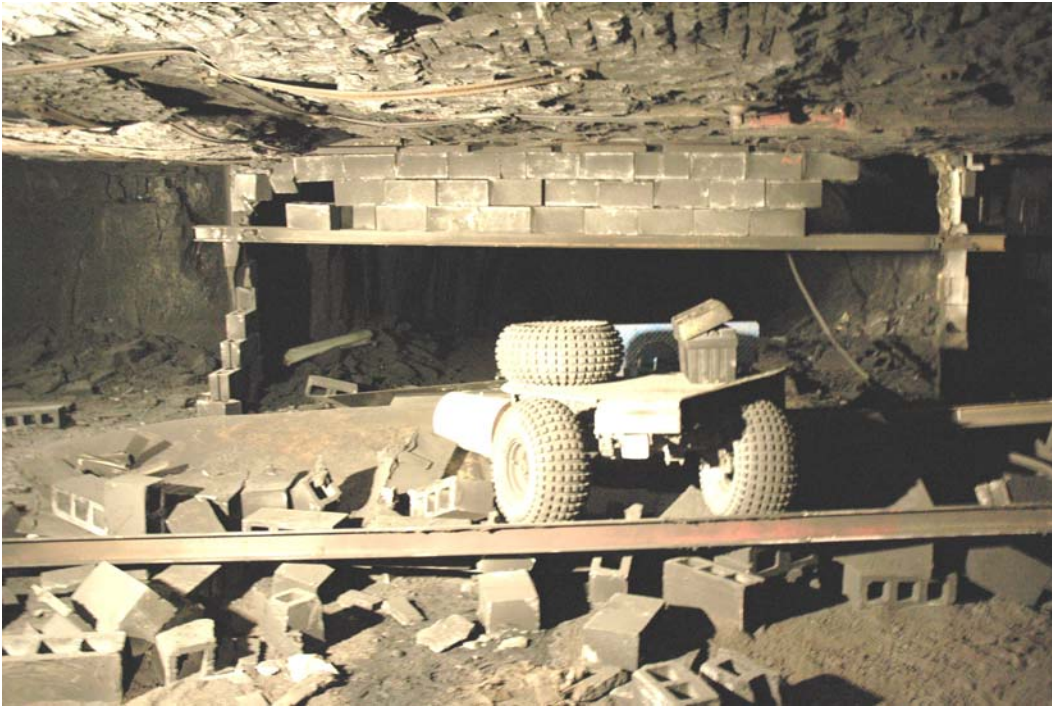
Photograph 1 - No.1 personnel carrier on damaged overcast

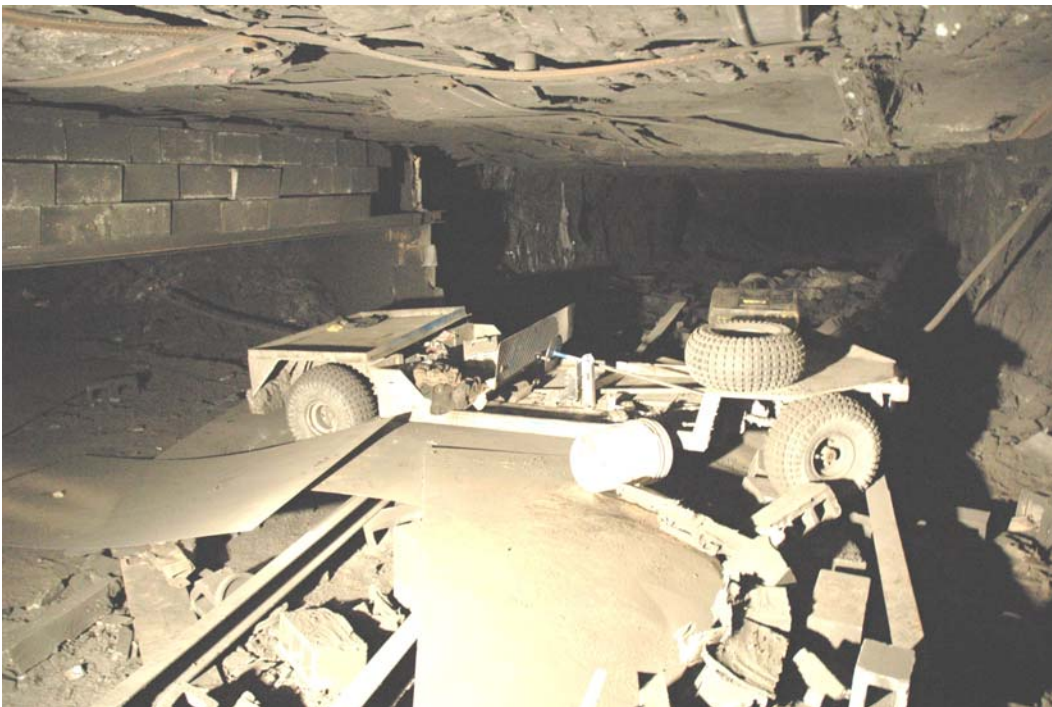
Photograph 2 - No.1 personnel carrier on damaged overcast

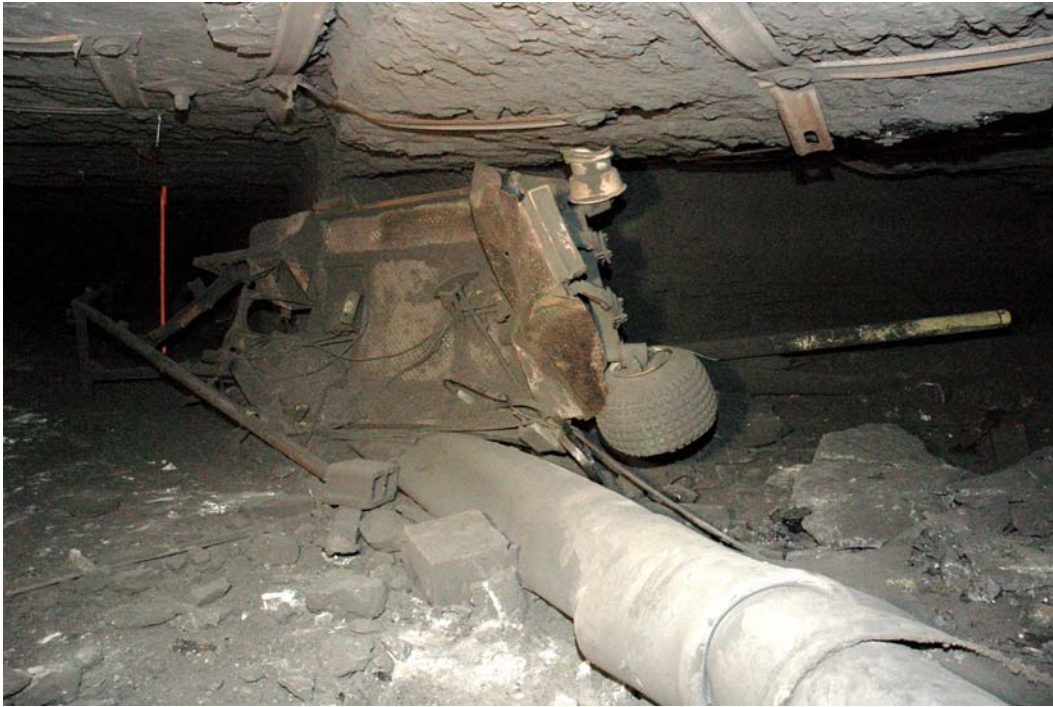
Photograph 3 - No. 3 personnel carrier in the No. 4 Entry

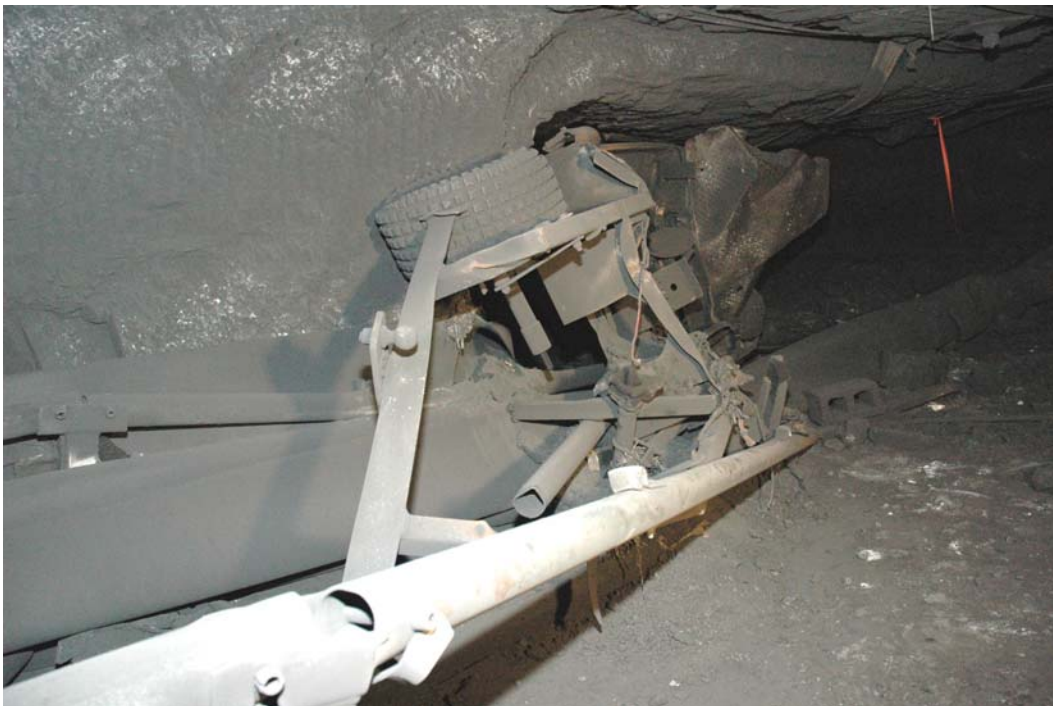
Photograph 4 - No. 3 personnel carrier in the No. 4 Entry

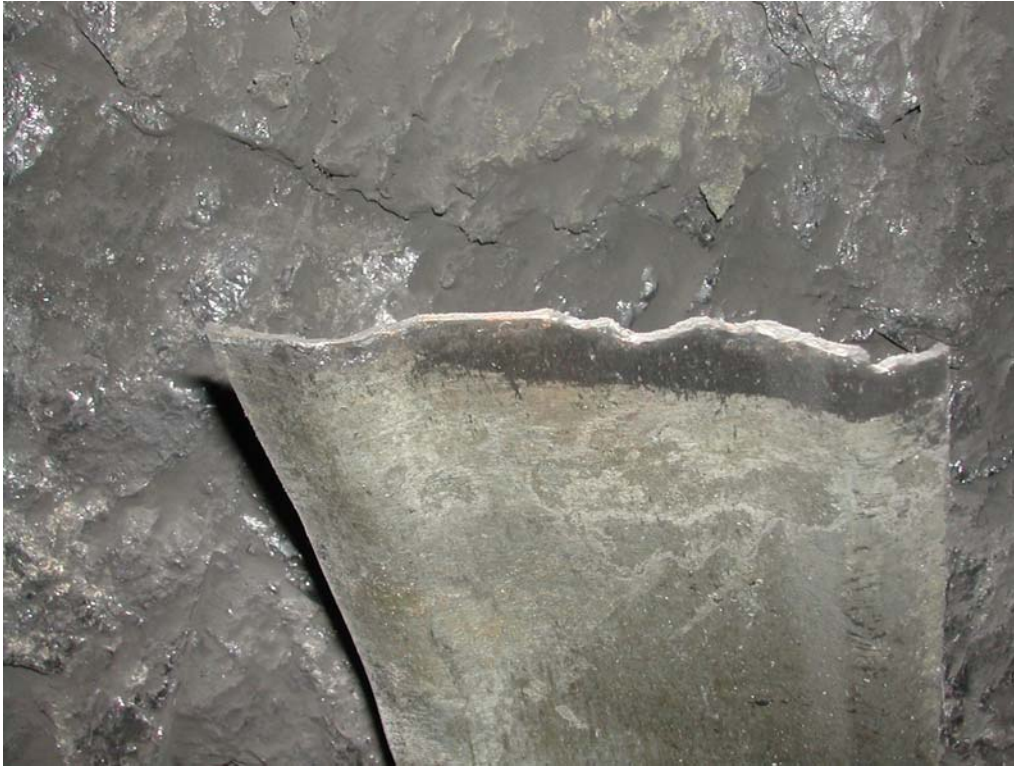
Photograph 5 - Inby segment of roof strap at A Left No. 3 Seal

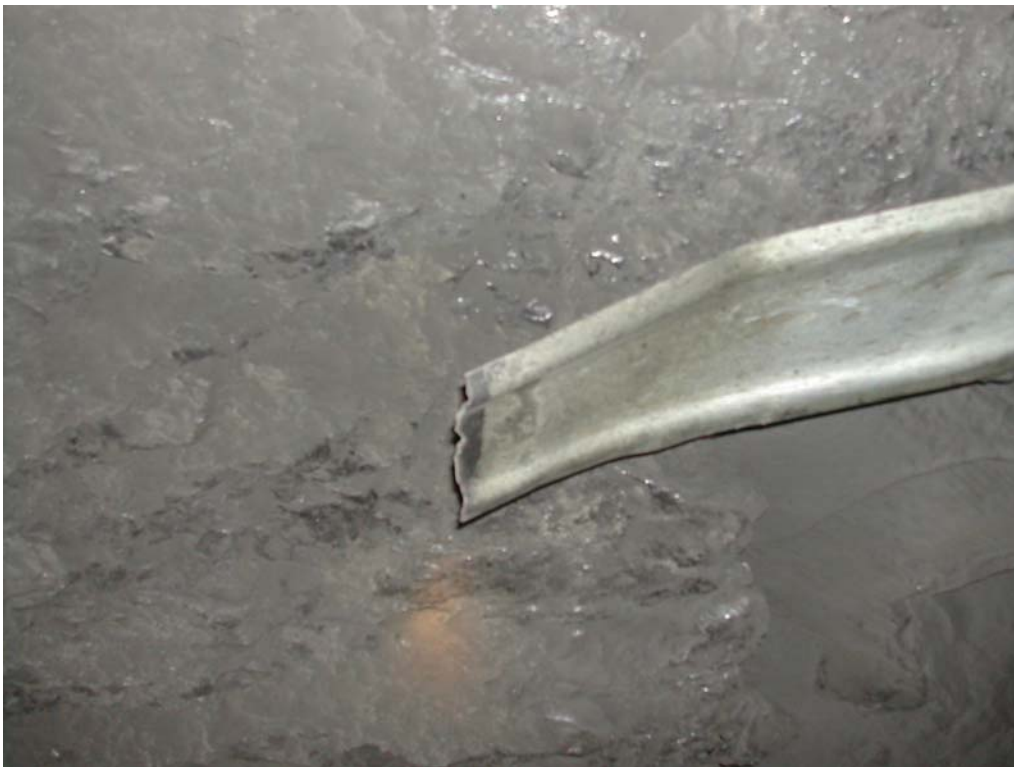
Photograph 6 - Inby segment of roof strap at A Left No. 3 Seal

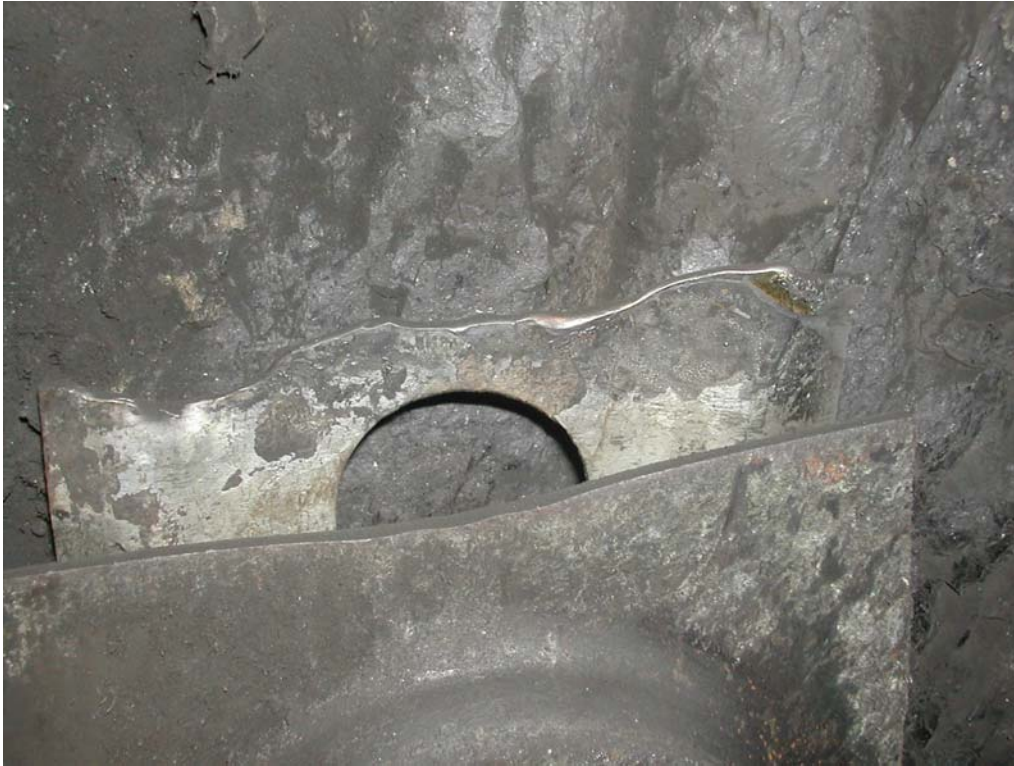
Photograph 7 - Outby segment of roof strap at A Left No. 3 Seal

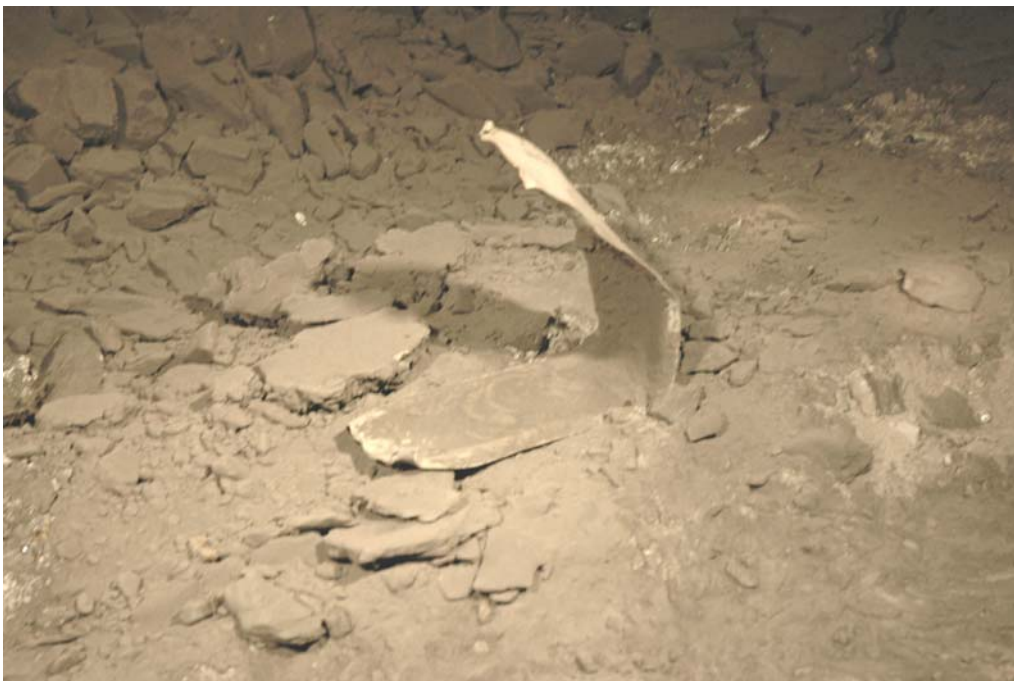
Photograph 8 - Middle segment of roof strap found in No. 5 Entry

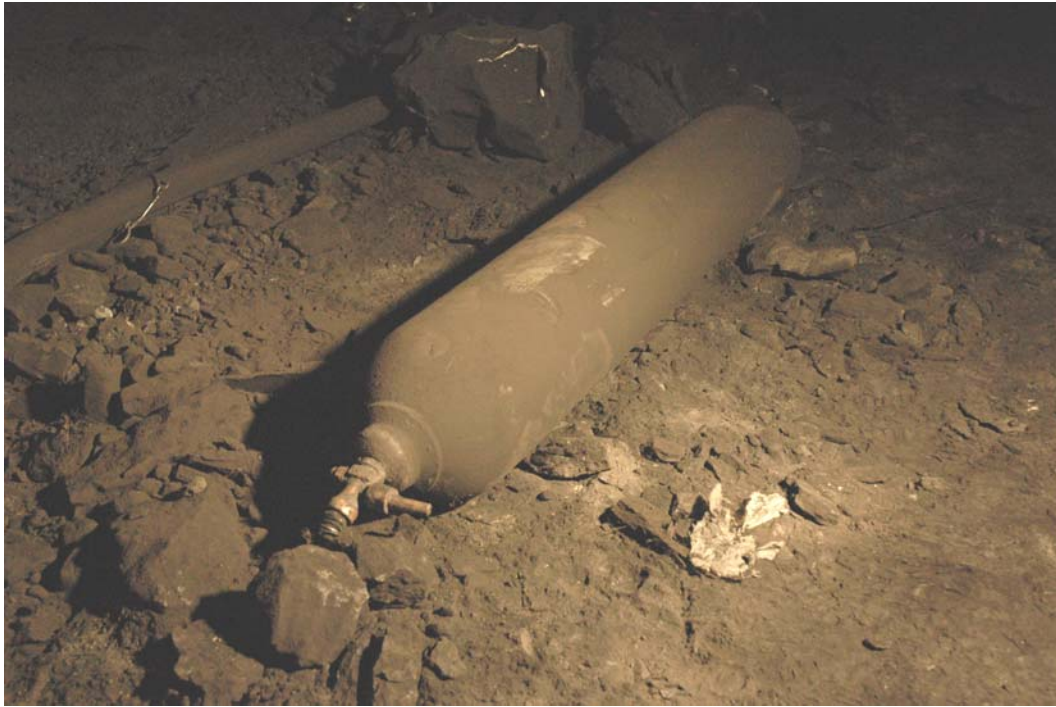
Photograph 9 - Oxygen cylinder found in the No. 5 Entry

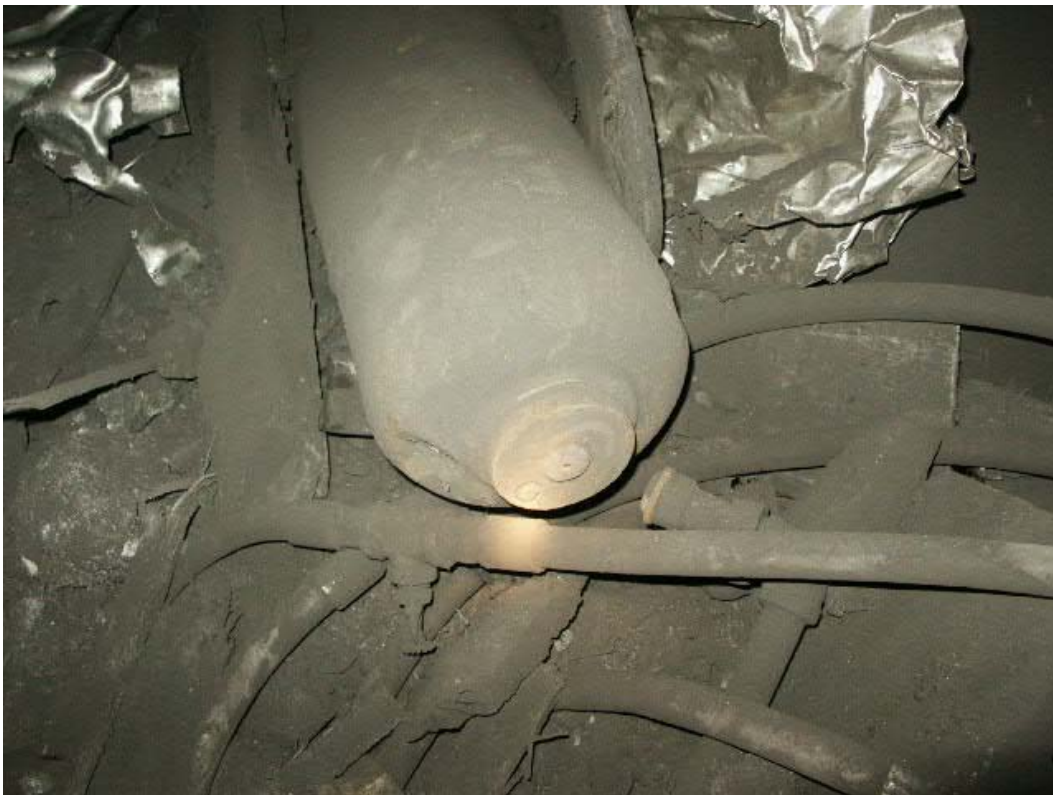
Photograph 10 - Acetylene cylinder found in the No. 5 Entry

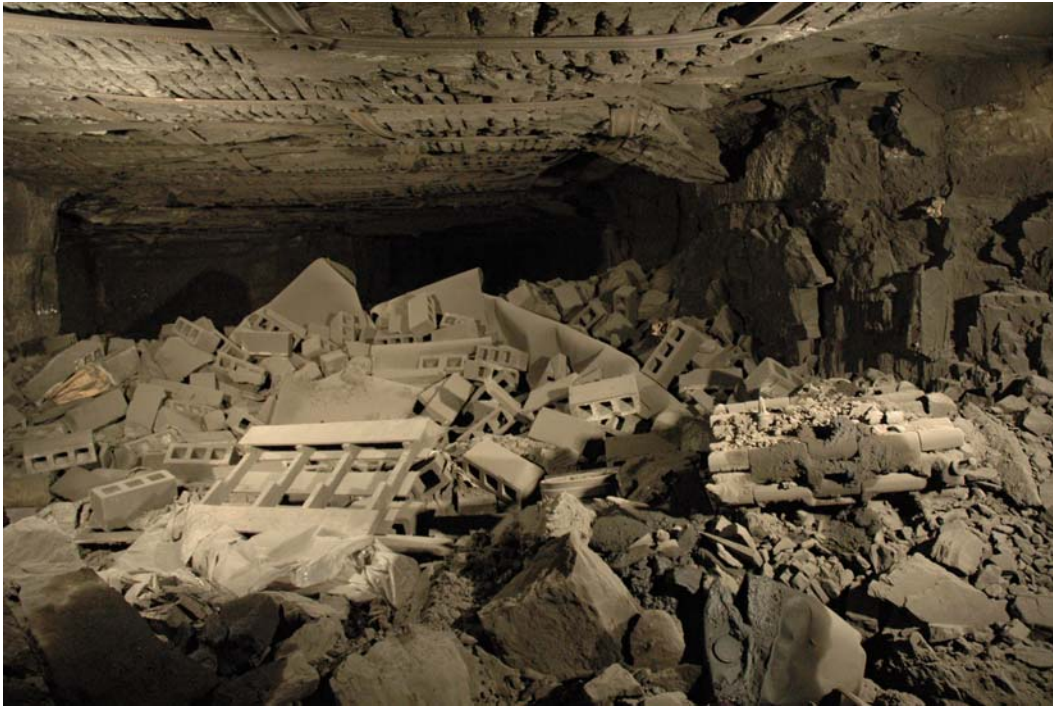
Photograph 11 - Debris from stopping near B Left Section

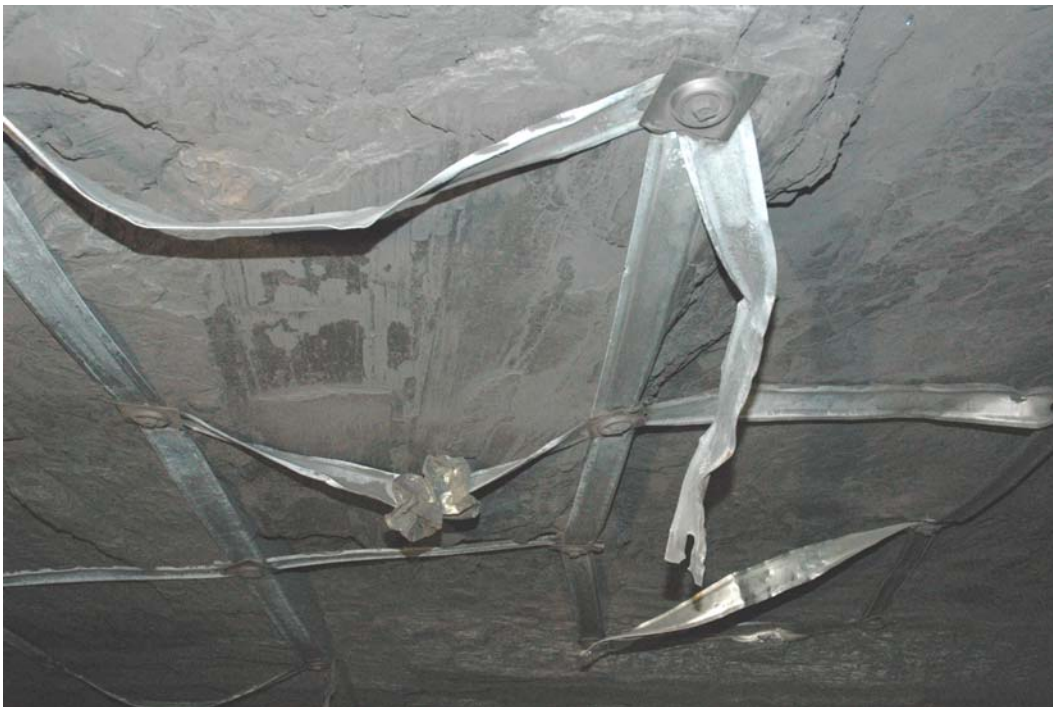
Photograph 12 - Damaged roof straps near A Left No. 3 Seal
