**COAL MINE SAFETY AND HEALTH
REPORT OF INVESTIGATION**

**Fall of Face, Rib, Pillar, or Highwall
October 20, 2006**

**Whitetail Kittanning Mine
Kingwood Mining Company LLC
Fellowsville, Preston County, West Virginia
(I.D. No. 46-08751)**

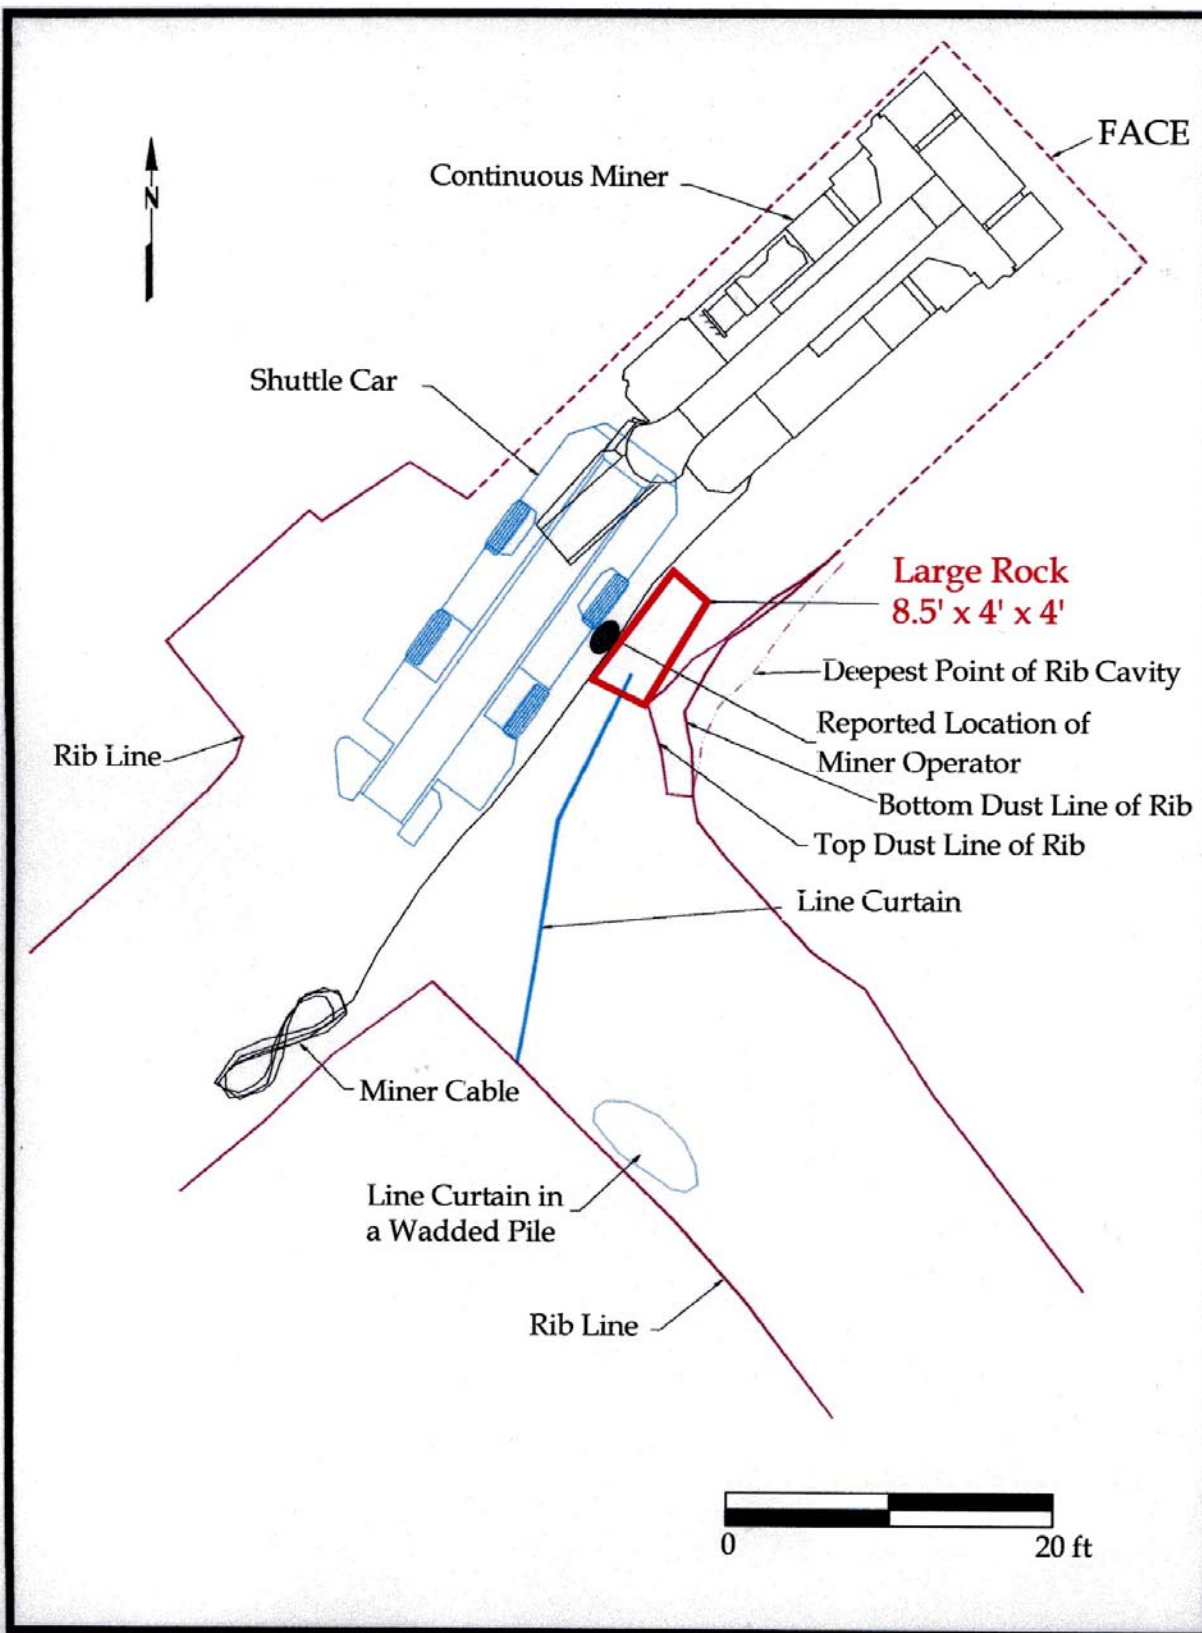
APPENDIX B
Sketch of Accident Site

The rib failure mechanism is defined and controlled by geologic features. A pronounced slickenside plane oriented at N22°E, dipping 42°NW, existed at the pillar corner. The slickenside plane is near parallel to the orientation of the crosscut. The base of the plane dips towards the crosscut and “day-lights” in the crosscut just above the floor. This northwest dipping slickenside plane forms the base of the rib fall.

A less pronounced slickenside plane also exists in the rib-side oriented at N40°E, dipping 32°SE. These two slickenside planes form the wedge-shaped profile of the rib fall with the junction of the two slickenside planes forming the apex of the wedge within the pillar. Typical coal cleats also existed, a face cleat oriented N6-12°E and a butt cleat oriented N72-77°W. The northwest dipping slickenside allowed a sliding rib failure with the southeast dipping slickenside and the coal cleat contributing by allowing the rib material to detach from the pillar. The fallen material was irregular in shape with pronounced intersecting, slickenside edges and measured approximately 8 ½ feet long, 4 feet thick, and 4 feet high.

The victim was struck by a large, undetected loose portion of rock/coal rib while standing behind the line curtain between the frame of the shuttle car and the right-side rib. The rib detached and slid from the vertical wall without warning pinning the victim against the shuttle car causing crushing injuries. The material was irregular in shape with pronounced intersecting slickenside edges measuring approximately 8 ½ feet long, 4 feet thick, and 4 feet high. The rib fell due to the material having an angled slip plane (wedge shape dipping on a 42° slope) with slickenside (glass like) edges. Additional specialized training has been provided for underground examiners and miners to ensure that hazards of this type are identified and addressed.

Corrective Action: Requisite examinations of the section were conducted which did not detect the slickensided planes. The planes were most likely not recognized due to the condition being isolated. Management has instituted policies providing hazard recognition training of angle slip planes to all underground examiners and employees and if these conditions are found they are to be removed or controlled.
