UNITED STATES
DEPARTMENT OF LABOR
MINE SAFETY AND HEALTH ADMINISTRATION
COAL MINE SAFETY AND HEALTH

REPORT OF INVESTIGATION
Fatal Underground Coal Mine Explosion
January 2, 2006
Sago Mine, Wolf Run Mining Company
Tallmansville, Upshur County, West Virginia
ID No. 46-08791
By

Originating Office
Mine Safety and Health Administration
Office of the Administrator
Coal Mine Safety and Health
1100 Wilson Boulevard
Arlington, Virginia, 22209
Kevin G. Stricklin, Acting Administrator
May 9, 2007

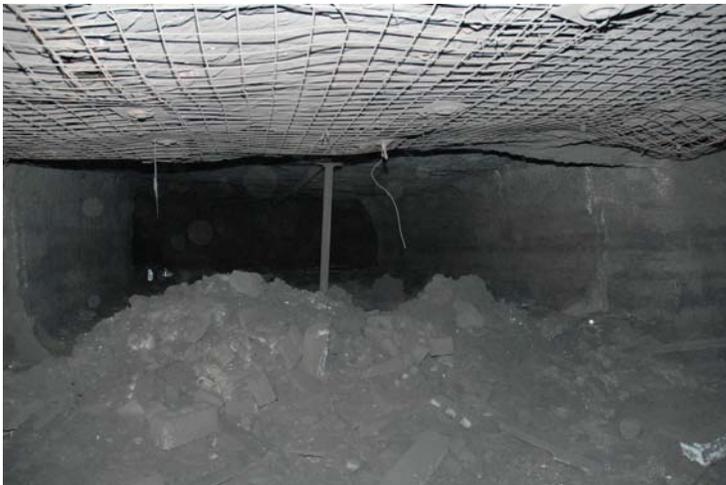
Figure 6 - Damaged Stopping at 59 Crosscut, No. 4 Belt

After the mine rescue/recovery teams examined and established ventilation throughout the mine, the underground portion of the investigation commenced on January 26, 2006. Figure 6 is a photograph of a damaged ventilation control between the Nos. 6 and 7 entries at 59 Crosscut, No. 4 Belt found during recovery of the mine.

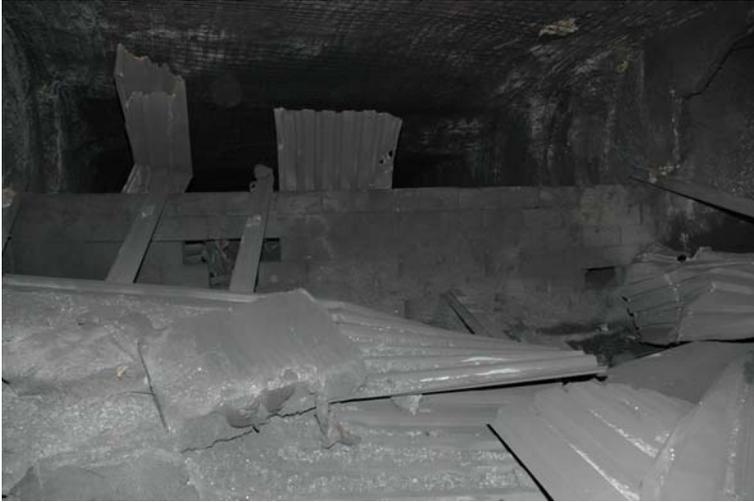
Figure 7 - Damaged Overcast at 58 Crosscut, No. 4 Belt

Figure 7 is a photograph of a damaged overcast in the No. 2 entry 58 Crosscut, No. 4 Belt found during recovery of the mine.

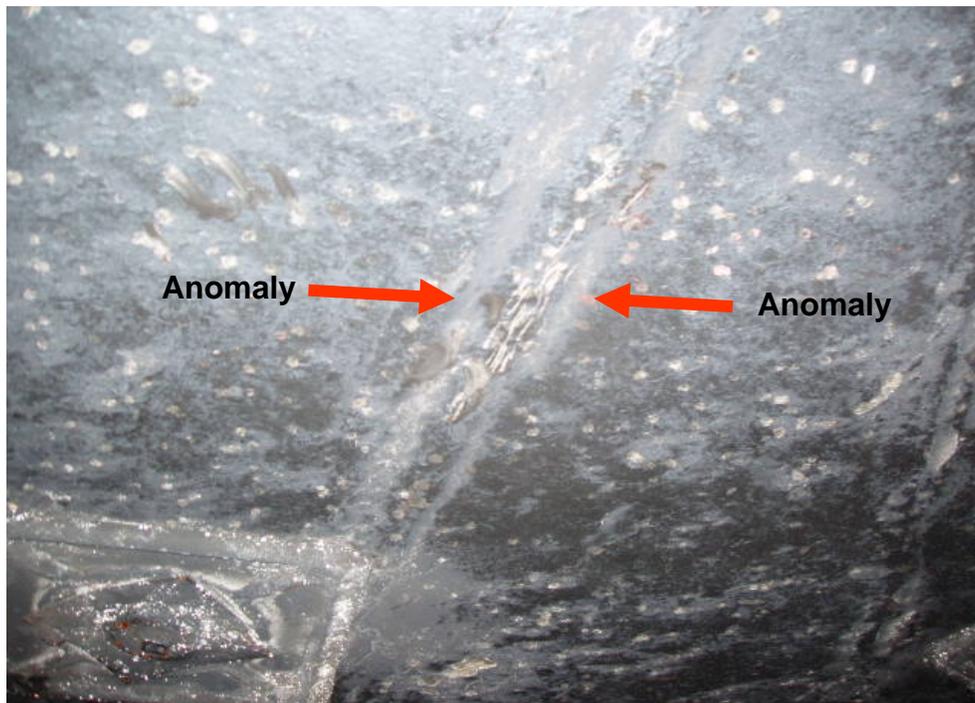
Figure 16 - Anomaly

Two linear geologic features were observed during the investigation. These two prominent features were located in the roof near survey station 4010, within the formerly sealed area of 2nd Left Mains. The features generated interest because they were located in the area where the explosion originated. Because the features seemed uncommon, they were referred to as "anomalies." Due to their location in the area where the explosion originated, some parties speculated that the linear "anomalies" might represent the effects of lightning. A picture of the anomaly is shown in Figure 16.

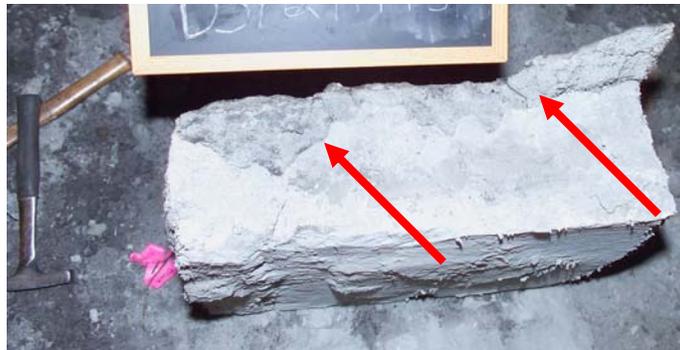
Figure 19 - Mortar in Vertical Joint

- Mine management knew prior to seal construction that the location of the No. 1 seal exceeded 20 feet in width.
- Up to three inches of dry BlocBond was spread on the floor prior to seal construction.
- Each course was laid dry and mixed mortar was spread across the top of each course and an attempt was made to force mortar into the vertical joints by hand. This is shown in Figure 19. The darker material is the BlocBond, which only slightly filled the vertical joint.
- Three wood planks were not always used on top of seals and wedges were not always installed properly.

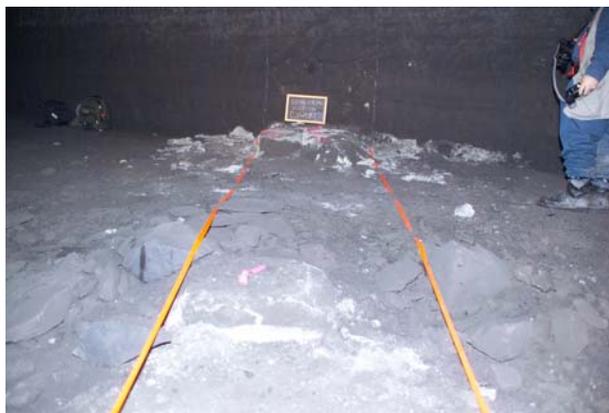
Figure 20 - Post-Explosion Location of Seal No. 1

The ten 2 North Main seal locations were evaluated during the investigation. The post-explosion location of Seal No. 1 is shown in Figure 20. Several whole and partial Omega blocks remained at the location of Seal No. 1 after the explosion. An exposed horizontal layer of BlocBond was easily removed from the remaining Omega blocks, indicating the lack of good bonding. No BlocBond was observed in some vertical joints. This seal had been constructed on a diagonal and was not perpendicular to either rib.

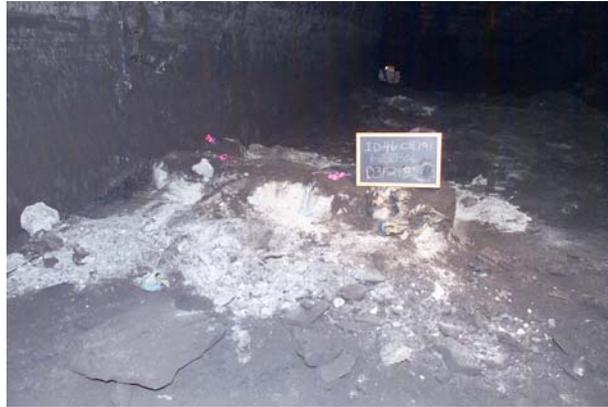
Figure 21 - Post-Explosion Location of Seal No. 2

The post-explosion location of Seal No. 2 is shown in Figure 21. Several Omega blocks remained at the location of Seal No. 2 after the explosion. Unburned paper material was observed imbedded within the mortar along one rib and also in a remaining joint between Omega blocks. No significant thickness of BlocBond was found between remaining Omega blocks. The vertical joint between two Omega blocks included BlocBond for only approximately 25% of the joint.

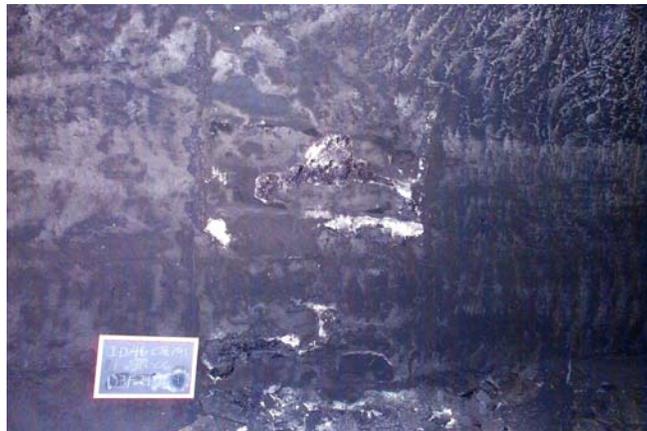
Figure 22 - Post-Explosion Location of Seal No. 3

The post-explosion location of Seal No. 3 is shown Figure 22. BlocBond on the rib was difficult to remove, indicating proper mixing prior to application. BlocBond on the floor had very little strength, indicating improper or no mixing with water prior to application.

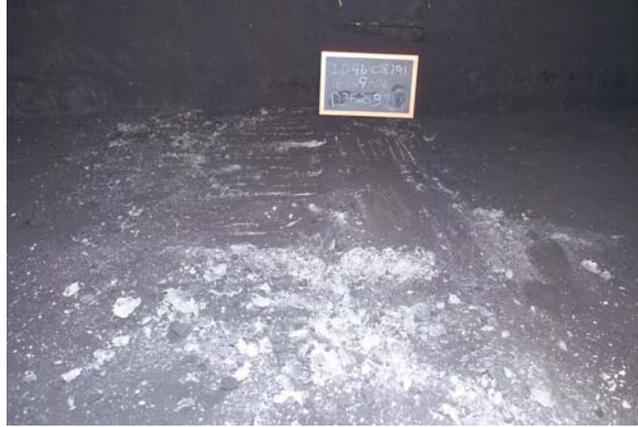
Figure 23 - Post-Explosion Location of Seal No. 4

The post-explosion location of Seal No. 4 is shown in Figure 23. BlocBond was observed on the floor as a smooth surface, indicating a lack of adherence to the Omega block.

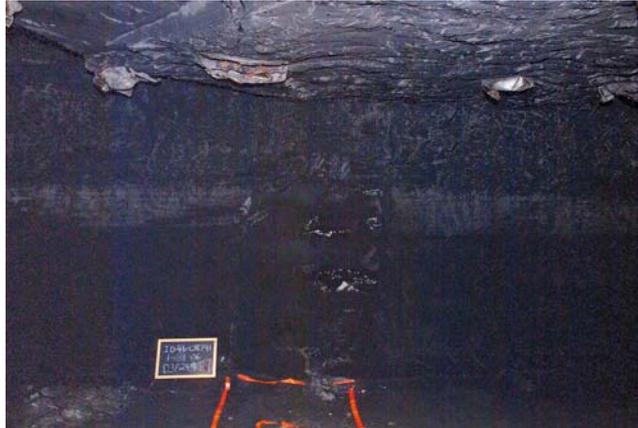
Figure 24 - Post-Explosion Location of Seal No. 5

The post-explosion location of Seal No. 5 is shown in Figure 24. BlocBond and Omega blocks were set on loose floor material at this location.

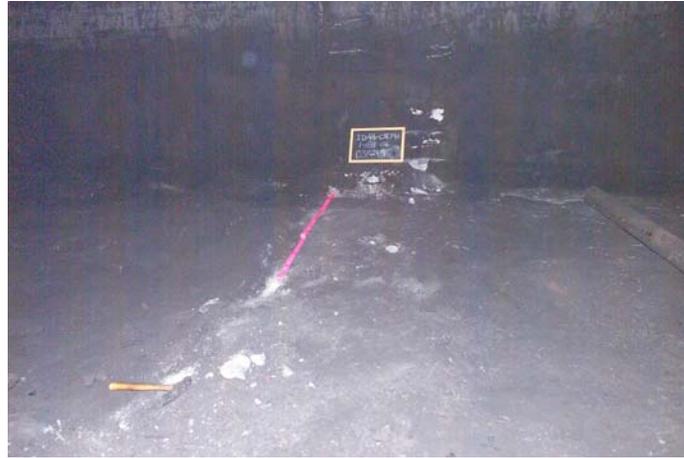
Figure 25 - Post-Explosion Location of Seal No. 6

The post-explosion location of Seal No. 6 is shown in Figure 25. It appeared that pieces of Omega block were used, along with dry BlocBond, to level the floor prior to construction of the seal.

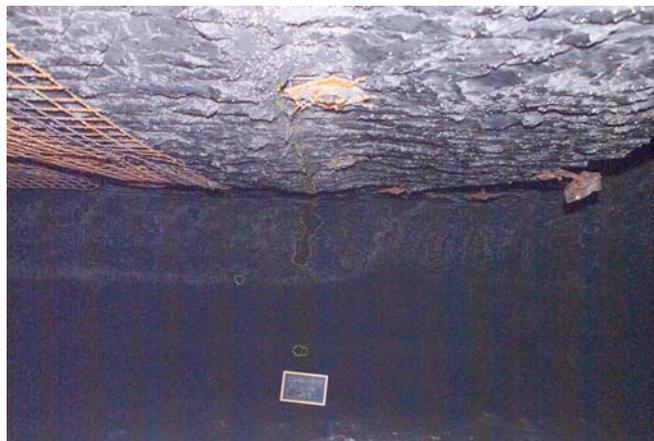
Figure 26 - Post Explosion Location of Seal No. 7

The post-explosion location of Seal No. 7 is shown in Figure 26. Very little BlocBond was observed on the ribs. The BlocBond was difficult to remove, indicating good strength characteristics.

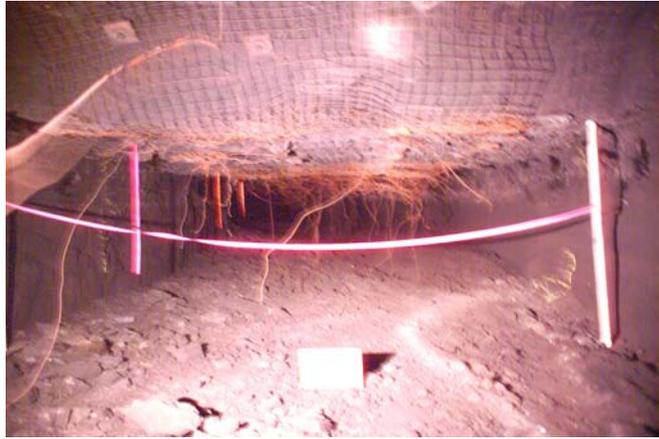
Figure 27 - Post-Explosion Location of Seal No. 8

The post-explosion location of Seal No. 8 is shown in Figure 27. Very little BlocBond was observed on the ribs. The BlocBond was difficult to remove, indicating good strength characteristics. Roof conditions deteriorated during the investigation at this location.

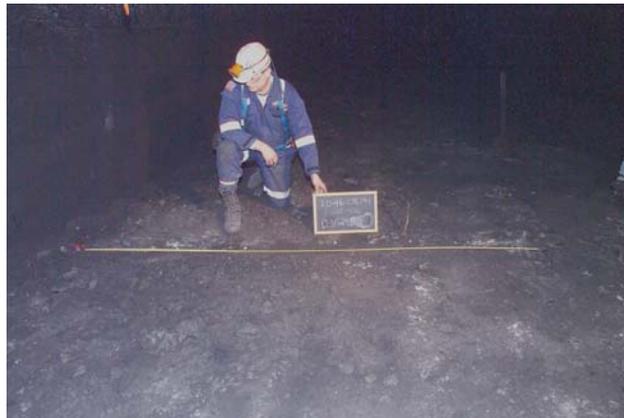
Figure 28 - Post-Explosion Location of Seal No. 9

The post-explosion location of Seal No. 9 is shown in Figure 28. Several Omega blocks remained at the location of Seal No. 9 after the explosion. Unburned plastic and paper material was observed imbedded within the mortar along one rib. A coating of dry, unmixed BlocBond was observed on the floor.

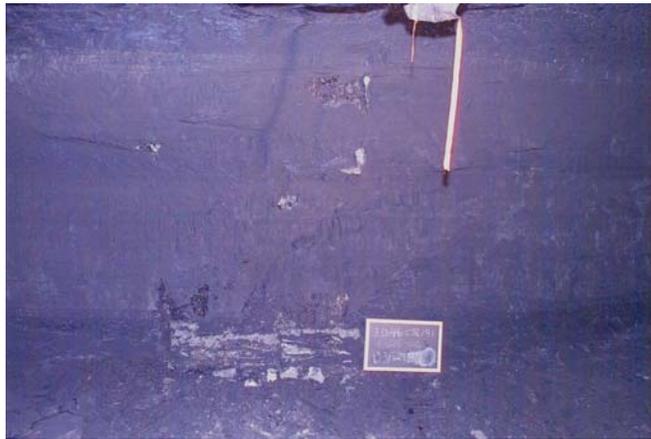
Figure 29 - Post-Explosion Location of Seal No. 10

The post-explosion location of Seal No. 10 is shown in Figure 29. No Omega blocks remained on the floor. There were some indications of mortar on the ribs.

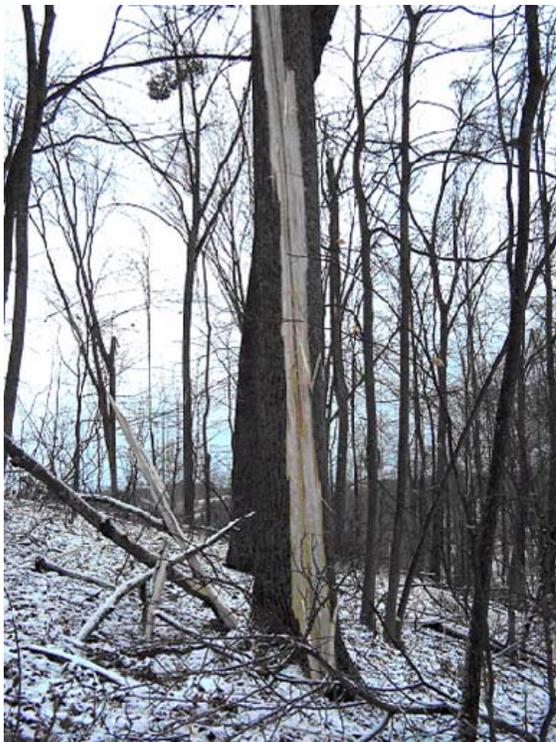
Figure 40 - Damaged Tree

The NLDN recorded two lightning strikes near the mine area at the time of the accident. The first strike occurred at 6:26:35.522 a.m. and reportedly occurred more than one mile south of the mine drift openings. This was a positively charged strike with a magnitude of 38,800 amps. Several unsuccessful attempts were made to locate evidence of a strike in this area. The other lightning strike occurred at 6:26:35.680 a.m. and was about one mile north of the mine drift openings. It was also a positive lightning strike with a magnitude exceeding 100,000 amps. Evidence of this strike hitting a tree was found. The tree had freshly splintered pieces scattered around it. This is shown in Figure 40.

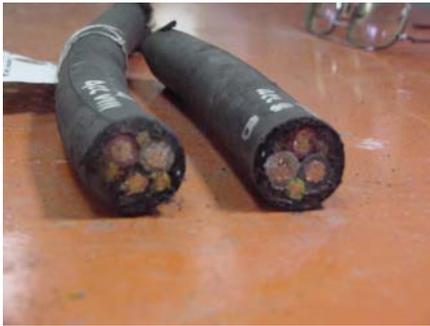
Damaged areas of a cable or its coupler are potential locations where arcs can occur. This cable had numerous damaged areas. Figure 45 is a photograph of two pieces of the cable. Therefore any cuts, nicks, pinholes, or other damage to the cable are potential points where an arc between the red, black, or white conductor and the grounding conductors could occur.
