REPORT OF INVESTIGATION

Surface Nonmetal Mine
(Dimension Sandstone)

Fatal Machinery Accident
March 23, 2015

Kane's Quarry
Kane's Quarry
Montrose, Susquehanna County, Pennsylvania
Mine I.D. No. 36-10136

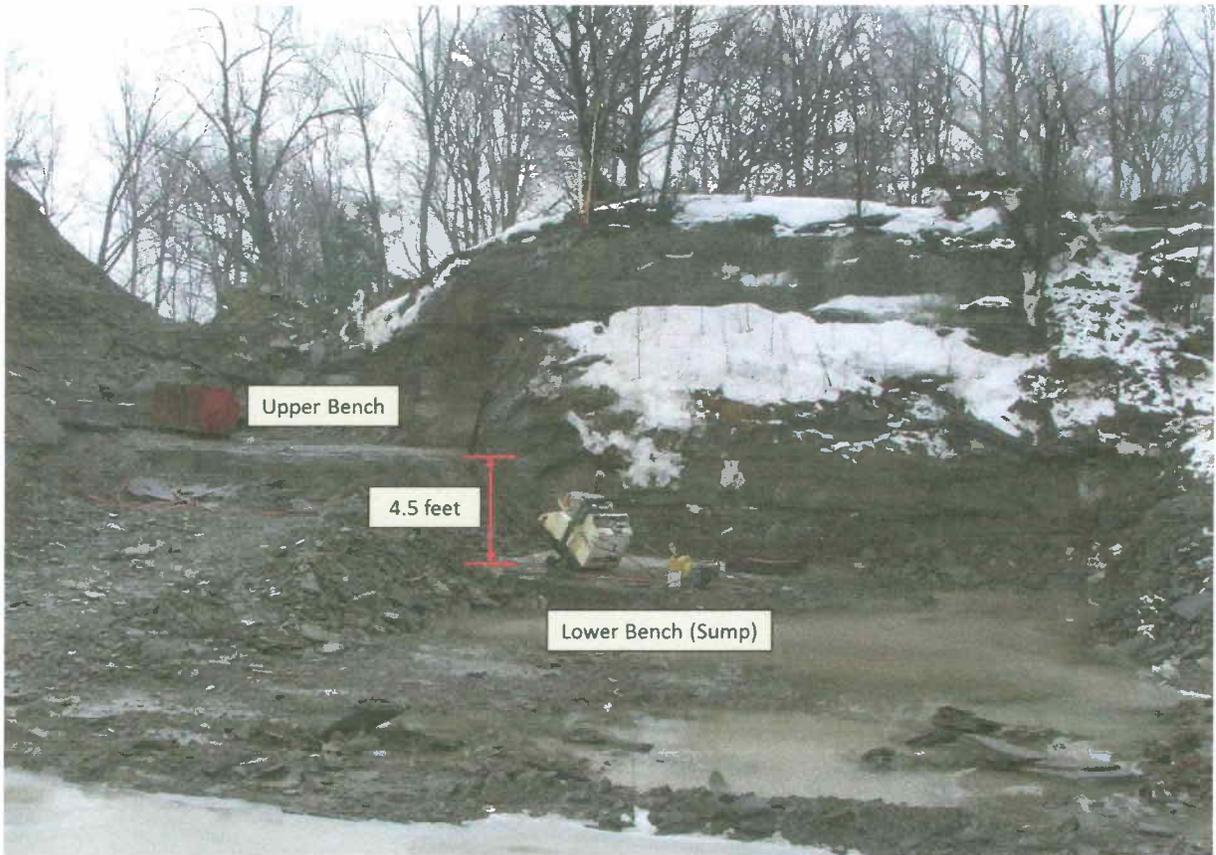
The accident occurred in the center of the quarry pit near the sump area (see Figure 1). A 25-foot-high waste pile of rocks is located to the east of the sump area, and the quarry access road and yard processing area are located to the west of the sump area. The sump area dimensions are approximately 40 feet wide by 80 feet long. Two benches had been created within the bluestone outcrop at the south end of the sump area. The upper bench is approximately 16 feet wide and the lower bench is approximately 18 feet wide. The high-wall above the upper bench is about 15 feet high and the high-wall above the lower bench is approximately 19½ feet high. Therefore, there is a 4½-foot height difference between the two benches. The exposed edge (drop-off) is oriented north to south and is approximately 10 feet long. The drop-off has a slope angle between 45 and 55 degrees. There is no berm or barrier installed along the edge of the upper bench.

Prior to the accident, the victim had made four north-to-south cuts and three west-to-east cuts along the upper bench. At the time of the accident, he was repositioning the saw for a fourth west-to-east cut across the bench. During this repositioning, with his back facing the edge, the victim slipped and fell onto the lower bench.

Root Cause: The victim failed to maintain control of the self-propelled concrete saw that he was operating in reverse gear while repositioning to cut stone. No procedures were in place for persons to safely operate the walk-behind, self-propelled concrete saw on an elevated bench.

Figure 1 – Victim was sawing stone blocks on the upper bench when he fell to the lower bench below (sump area) and the saw fell on top of him.

Corrective Action: The victim was a sole proprietor and; therefore, the business terminated at the time of his death. Consequently, no corrective action was taken.
