REPORT OF INVESTIGATION

Surface Nonmetal Mine  
Crushed, Broken Granite

Fatal Falling Material Accident  
August 3, 2015

Luck Stone Corp - Leesburg  
Leesburg Plant  
Ashburn, Loudoun County, Virginia  
MSHA I.D. No. 44-02964

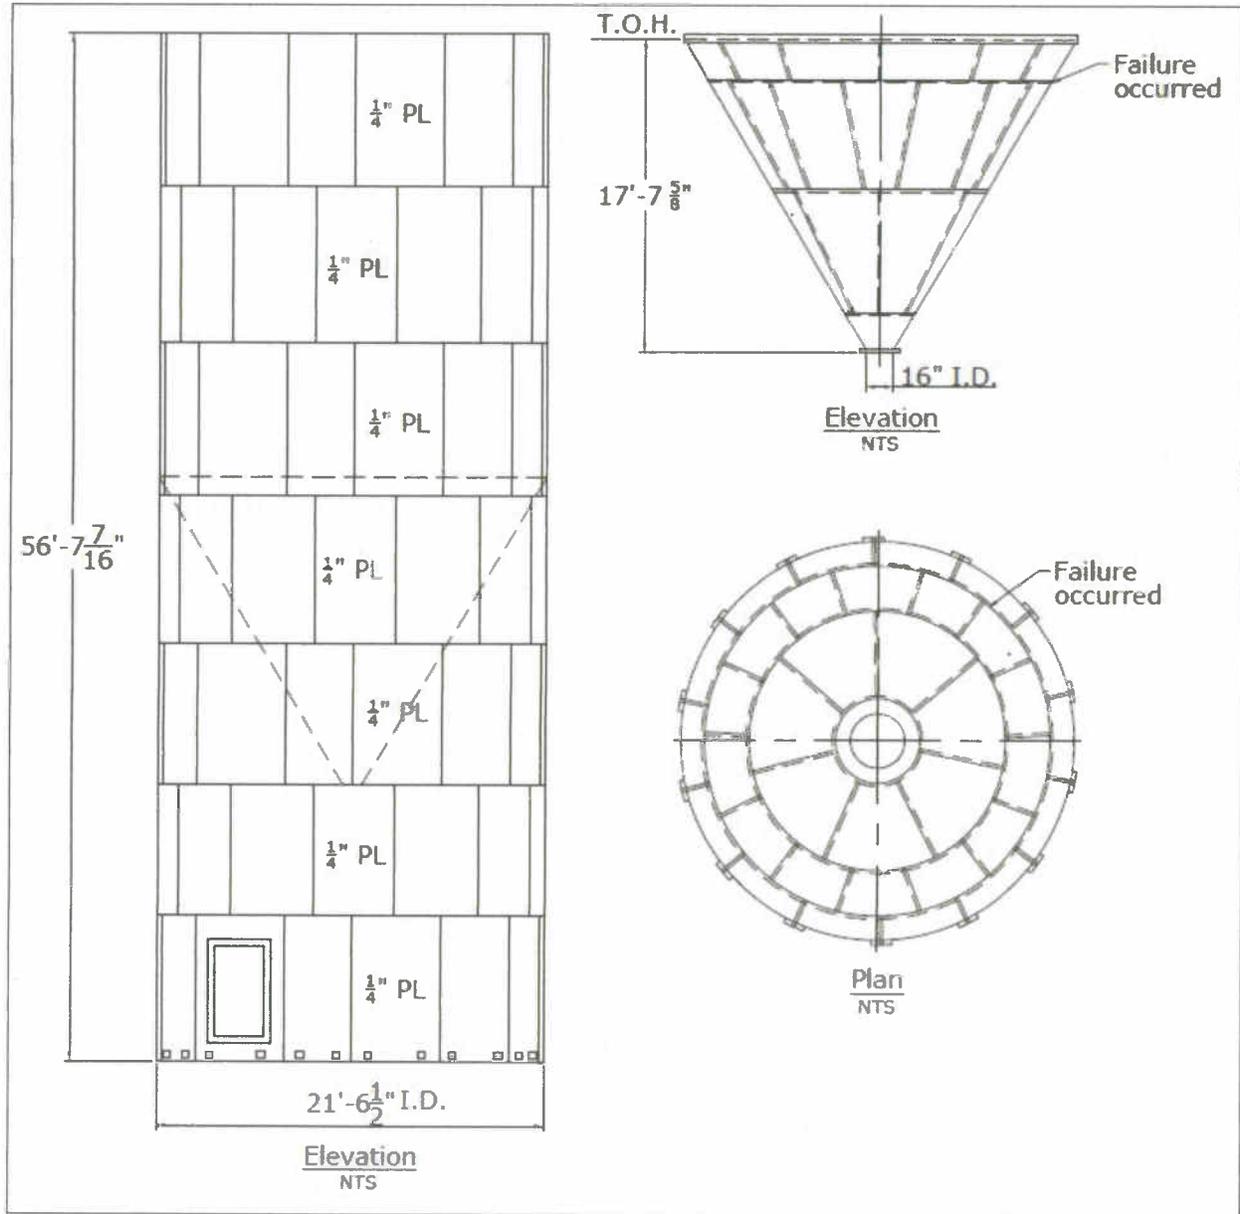
Figure 1 - “Sand Plant Fines” Silo

The “sand plant fines” silo was designed by Peabody TecTank, Incorporated, and was erected in April 1993 by J & L National Construction Corporation. According to design data presented on the construction details drawing, the estimated capacity of the silo was 734 tons. The silo was 21 feet 6.5 inches in diameter and 56 feet 7 inches in height (not including the bag house structure on the roof), and designed to operate under a negative pressure. The silo contained an internally suspended, 60-degree hopper, with an outlet positioned 16 feet 1 inch above the 24-foot-square concrete foundation slab. The 17-foot-8-inch-deep hopper was bolted to the cylinder wall 33 feet 9 inches above the foundation. The hopper had a 16-inch-diameter outlet, and a rotary vane feeder deposited the material onto the SP4 conveyor belt. The cylinder portion had a height of 22 feet 10 inches above the hopper connection (see Figure 1).

Based on observations of the final position of the hopper, it appears that the initial separation occurred at the south side (see Figure 1). This resulted in the hopper swinging to the north before completely detaching. When observed on the concrete pad, the south side of the hopper was lower than the north. When the hopper impacted the ground and the north silo wall, it resulted in a tear in the cylinder wall that measured 17 feet wide (at the base) by 27 feet high. The hopper tore open through the full height of 16 feet and the width of the tear was 14 feet at the base. A large section along the northeast side of the hopper was cut out during the recovery process.

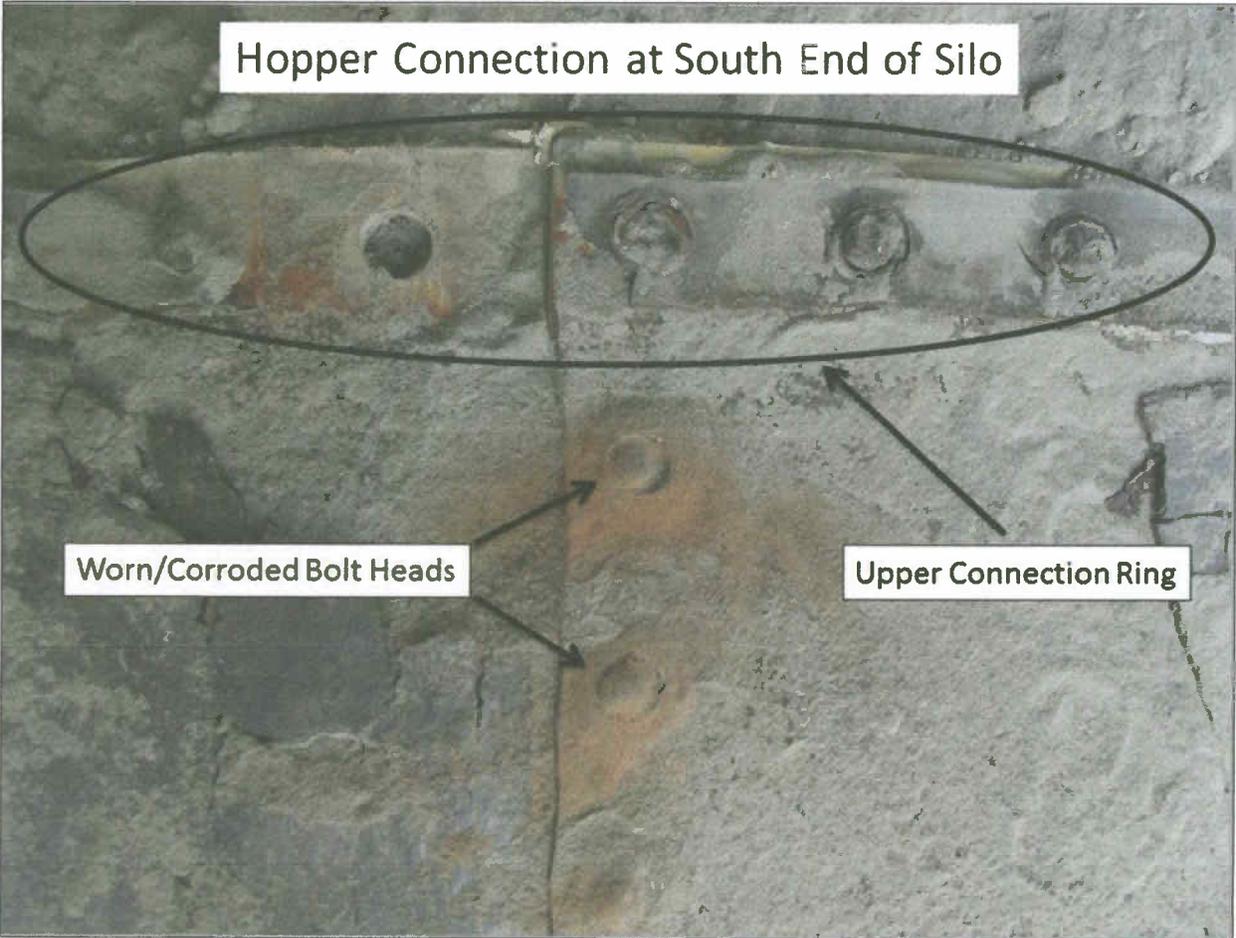
**Figure 2 – Photo showing interior of “Sand Plant Fines” Silo**

- The investigation team observed corrosion of the hopper plates, but the steel was not delaminated. It is likely that material flowing against the hopper continually removed the delaminations.
- The average diameter of the bolt heads abruptly tapered from 0.80 inches at the west side of the hopper to missing at the south side of the hopper. Of the four seams measured in this quadrant, only the first seam on the west side had measurable bolt heads.
- Many of the bolts still remaining in the connection ring had heads that were completely worn and corroded off. Mainly the bolt shafts remained and corrosion was observed on the top of the shaft. An example of the worn/corroded bolts found at the south side interior of the silo is included in Appendix C (see Figure 2).
- Most of the bolt holes on the connection ring exhibited no appreciable elongation.
