Use of an Inertisation Unit during a Coal Mine Fire Recovery Operation

ABSTRACT: On February 13, 2003, a fire occurred in a large underground coal mine located in West Virginia. Firefighting activities were unsuccessful. The mine was sealed at the surface openings on February 14, with the intent of inerting the mine atmosphere naturally. However, the mine operator proposed a novel approach for controlling the mine atmosphere. The Mine Safety and Health Administration worked closely with the mine operator on a plan to recover the mine. Queensland Mine Rescue Service Limited was consulted and contracted to provide technology, equipment and personnel to operate an Inertisation Unit. The primary component of the unit was a jet engine. The engine was capable of producing large quantities of inert gases and forcing the gases into the mine. The unit was installed on the surface at the slope and the injection of inert gases was started on April 4, 2003. After the mine atmosphere was successfully stabilized to a non-explosive condition, re-ventilation of the remainder of the mine was initiated. Mine rescue teams entered the mine and began exploration toward the fire area. The progress of t

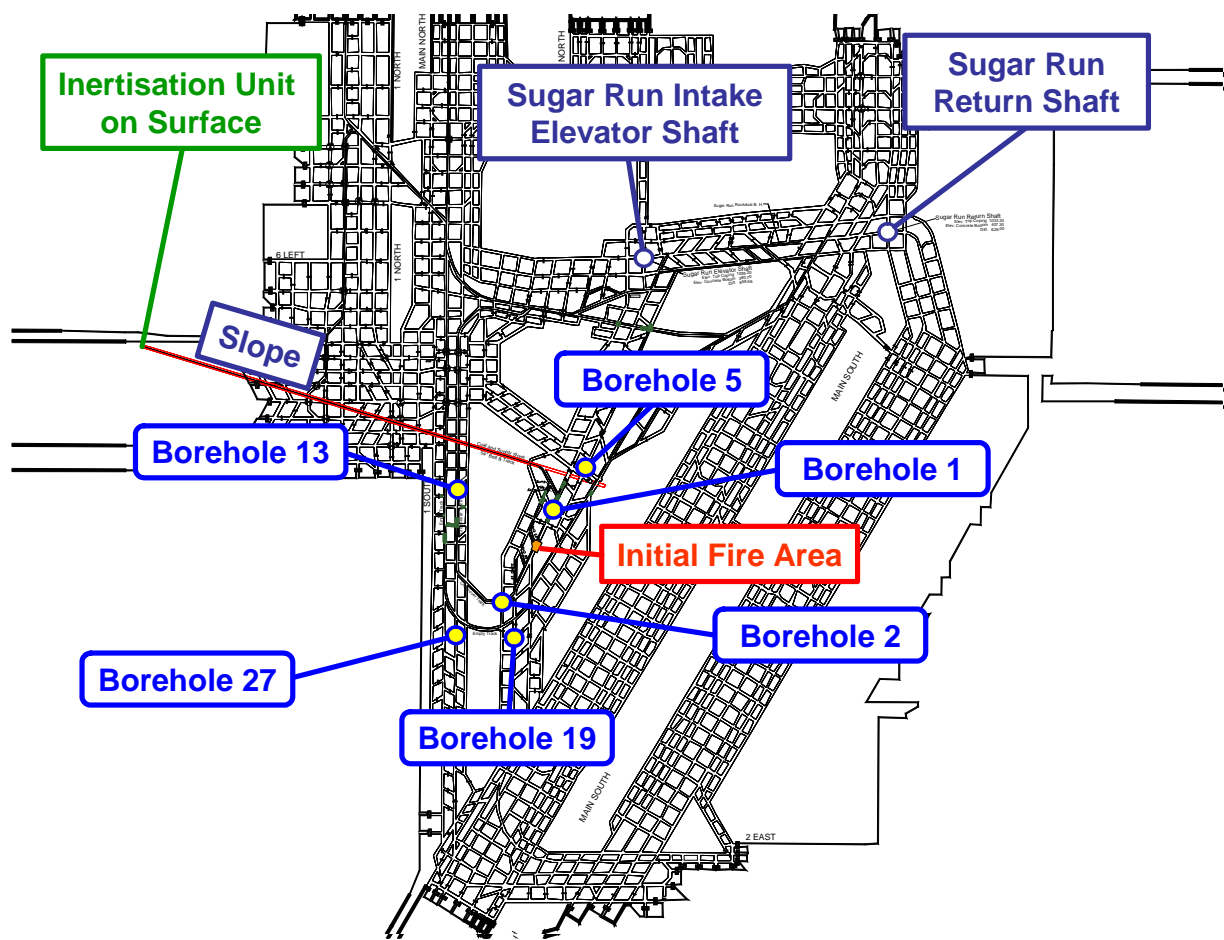
Figure 2. Affected Area and Borehole Locations

Air that entered the mine near the fire area permitted continued combustion and created difficulties with monitoring the mine atmosphere at the surface openings closest to the fire. Additional information was desired to determine the extent and more accurately evaluate the state of the fire. Vertical boreholes were drilled into the mine at locations surrounding the last known extent of the fire. The boreholes were used for injecting water, inserting a borehole camera and temperature probe into the mine to determine the extent of the fire, and sampling the underground atmosphere in close proximity to the fire area. Figure 2 shows a detailed layout of the slope bottom area, the location of the initial fire area, and the locations of the six vertical boreholes.

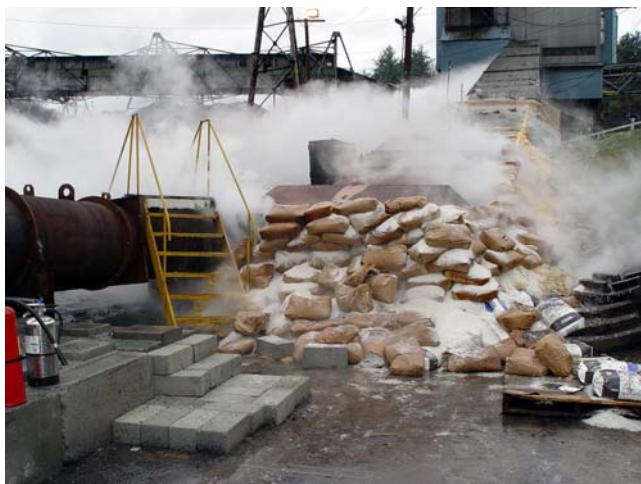
Figure 5. Exhaust Leakage at Slope

Initial startup of the Unit was hindered by brief setbacks. The Unit was started at 7:45 p.m. on April 4, 2003, with the Unit's exhaust vented to the atmosphere. After 15 minutes of operation, the Unit was shut down because of overheating. Work continued on the Unit until 11:45 p.m., when the Unit was restarted. The by-pass gate was closed and the inert gases were directed into the slope. However, pressure from the initial introduction of the exhaust caused damage to the plywood slope seal, resulting in substantial loss of exhaust. After 15 minutes, the Unit was again shut off to repair the slope seal. Leaks in the ductwork attached to the slope were sealed with polyurethane foam and sand bags.
