Equipment Alert – November 4, 2011

2nd Update on Failure of High Pressure Gas Fittings and Valves in Refuge Alternatives

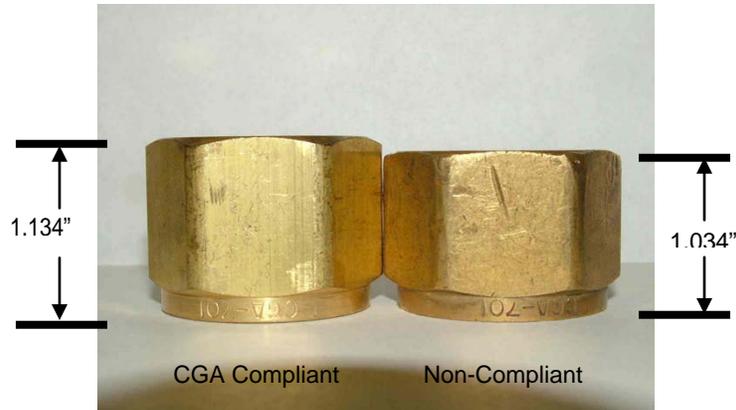
Figure 1 Measured length (shown upright) on CGA compliant and non-compliant high pressure oxygen fitting (nut)

Following the January 9, 2011, failure, MSHA issued the Equipment Alert regarding a catastrophic failure that occurred in an oxygen cylinder fitting in an A. L. Lee refuge alternative in an underground coal mine ([Click here to view January 25, 2011, Alert](#)). The investigation revealed that the failed fitting did not meet the dimensional specifications of the applicable Compressed Gas Association (CGA) standard. (See Figure 1)

1. All refuge alternatives should be physically examined to ensure correct fittings are installed on compressed gas systems. Operators were advised to contact the refuge alternative manufacturer to assist in the examinations. Additionally the operator was advised to ensure that the refuge alternative manufacturer performs all necessary repairs to the refuge alternative. The examination was to include removing access doors, if necessary, to measure and examine each fitting to verify compliance with the applicable CGA standard. The examination may have required removal of fittings to take necessary

measurements. A fitting identified with a CGA standard number does not guarantee that the fitting complies with the CGA standard. MSHA advised that the fittings should be physically examined to verify compliance.

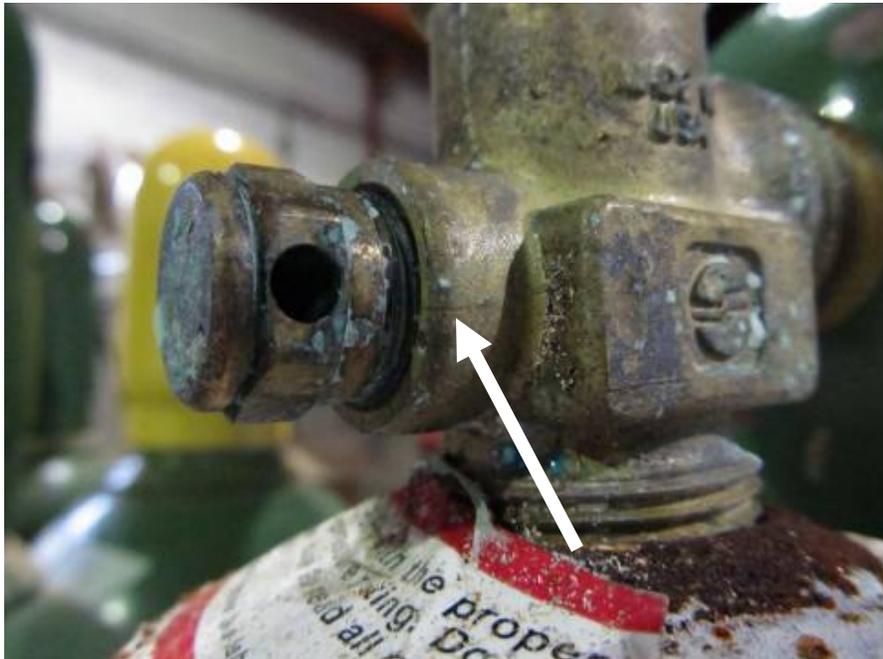
Figure 2 – View of cracked cylinder valve. Arrow points to crack.

Following the second reported failure of a refuge alternative fitting ([Click here to view updated alert of February 10, 2011](#)) MSHA issued an updated Equipment Alert. This fitting met the dimensional specifications of the CGA standard. On February 3, 2011, A. L. Lee reported that cracks had been discovered in both the brass fittings and cylinder valves of a third refuge alternative that had been returned to their shop. (See Figure 2) These fittings also met the dimensional specifications of the CGA standard. These fitting failures demonstrated that the problem extended beyond dimensionally incorrect fittings.

In an effort to determine the mode of failure and possible causes, MSHA sent representative samples to the OSHA Salt Lake City Technical Center (SLTC) laboratory in Salt Lake City, UT. Quoting from the OSHA report, “The analysis performed at the SLTC revealed that the cracks are a result of stress-corrosion cracking (SCC) and the evidence suggests that dezincification is a contributing factor. The stress-corrosion cracks that have formed in the fittings and valves indicate that they are on the path to failure. The demonstrated short and unpredictable service life of the CGA brass valves and fittings is troublesome. The current situation left unchecked represents a safety hazard.”

As part of the updated Equipment Alert of February 10, 2011, MSHA again recommended that mine operators contact their refuge alternative manufacturers and request that the manufacturers conduct a prompt and thorough examination of their units for interior and exterior cracks on fittings and cylinder valves. MSHA advised that, if this examination identified any fittings or valves exhibiting cracking, the refuge alternative should be removed from service until it can be repaired or replaced. These steps are necessary to assure that all refuge alternatives can be safely used in underground coal mines.
