DISTRICT 2 – COAL MINE NEAR MISS

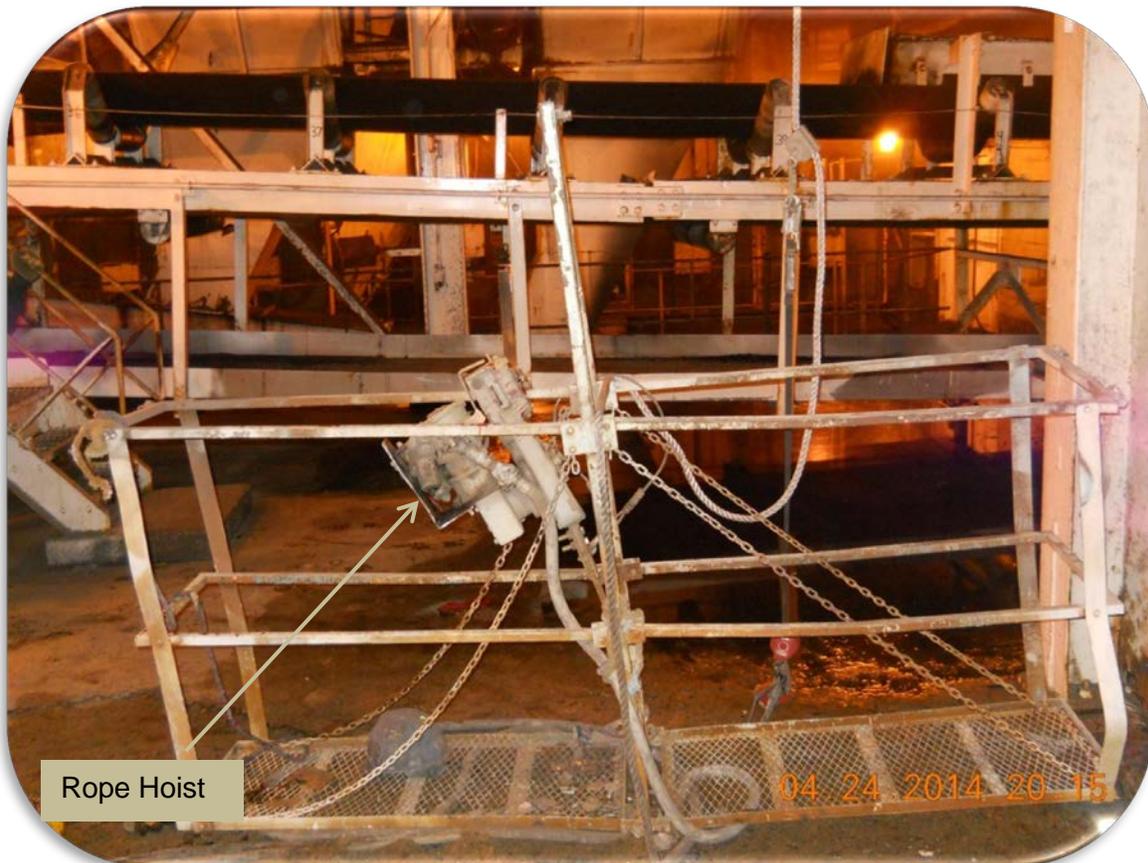
A contractor painter with 10 years of experience received serious head injuries while riding in a self-climbing scaffolding that became separated from the suspending cable. The victim was descending from the second to the first floor when the machine ran off of the end of the suspending wire rope and fell 18 feet to the concrete floor below.

- Fully understand how to properly use equipment prior to beginning your task.
- Wear a properly attached fall arrest system.
- Do not use visibly worn or damaged wire rope.
- If hoist does not appear to work normally, discontinue use immediately until repairs are made.
- Use the proper length of wire rope.
