DISTRICT 2 – COAL MINE NEAR MISS

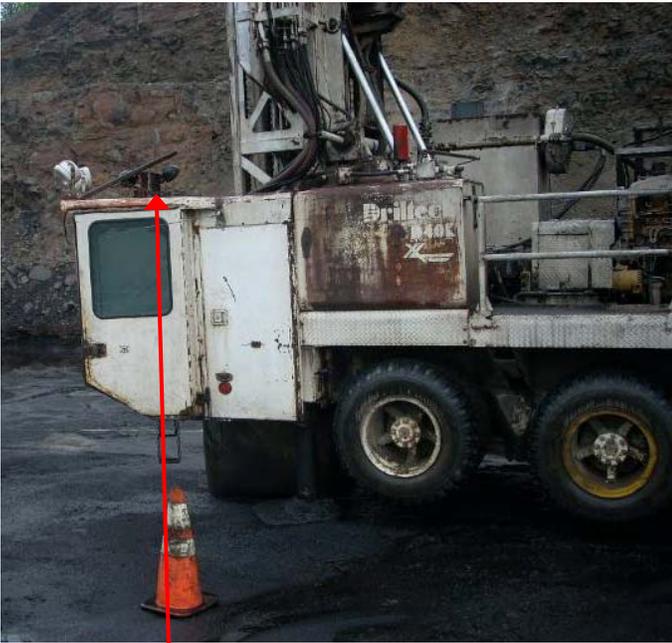
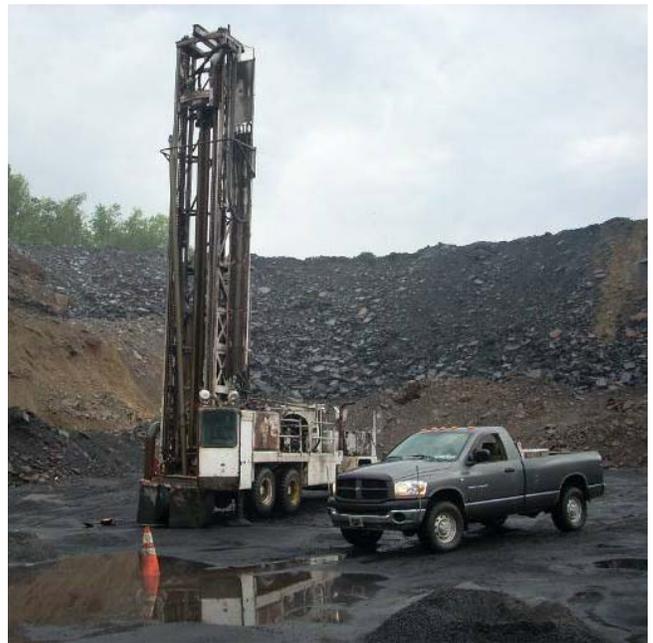
Victim location prior to fall

On May 28, 2010 highwall drill operator, with 25 years experience, received serious injuries when he fell from the top of the cab of the Drilltech D40 K Highwall Drill he was operating. The victim was attempting to replace a detached drill steel into the carousel when he slipped and fell approximately 6 feet to the ground. The drill operator suffered a broken rib, punctured lung, and broken collar bone.

- Conduct a risk assessment before beginning any task; evaluate the work procedures, identify all possible hazards, and take steps to perform the task safely. SLAM it. Stop, Look, Analyze, and Manage.
- Use fall protection and tie off where danger from falling exists
- Install barriers, guardrails, floor penetration covers, signs, handrail, platforms
- Secure/adequate travel ways or walkways
- Ladder use
- Mobile equipment ingress/egress
- Man lifts and boom trucks
