DISTRICT 2 – COAL MINE NEAR MISS

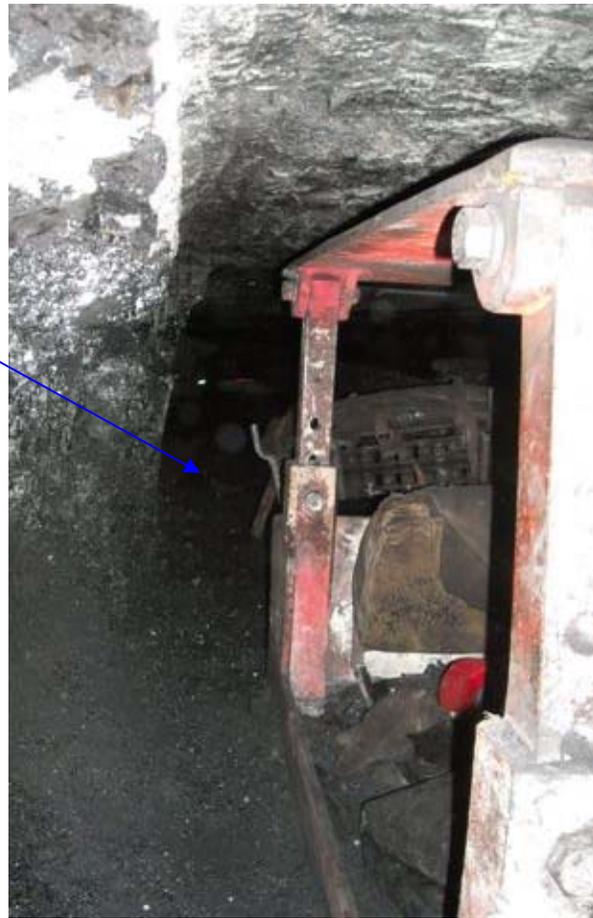
Pinned Victim
Location

On September 2, 2011, a mobile bridge conveyor (MBC) operator sustained serious injuries while exiting the operator's compartment of his MBC. The continuous miner and three MBC's of the continuous haulage system were backing out of a completed cut when the #2 MBC ran over the wash-down hose pulling it apart. The operator was being sprayed with the water and as he abruptly exited the operator's compartment, #3 MBC continued to tram out of the cut pushing the #2 MBC and spinning the machine. When the #3 MBC operator felt tram resistance on the machine he stopped and panicked out shutting the haulage system down. The #2 MBC operator was discovered pinned between the rib and back post of the canopy. The miner suffered 3 broken ribs, a broken bone in his neck, and a bruised rib.

- Installation of a position occupied (dead man) switch. This switch de-energizes the tramming circuit of the entire system, not just a single section, when an operator is out of the cab. Common places to install dead man switches include the seat, arm rest, or cab door where the entire system's tramming circuit remains de-energized until the dead man switch is reactivated upon the return of the operator to the cab.
- Adequate training
