DISTRICT 2 COAL MINE NEAR MISS

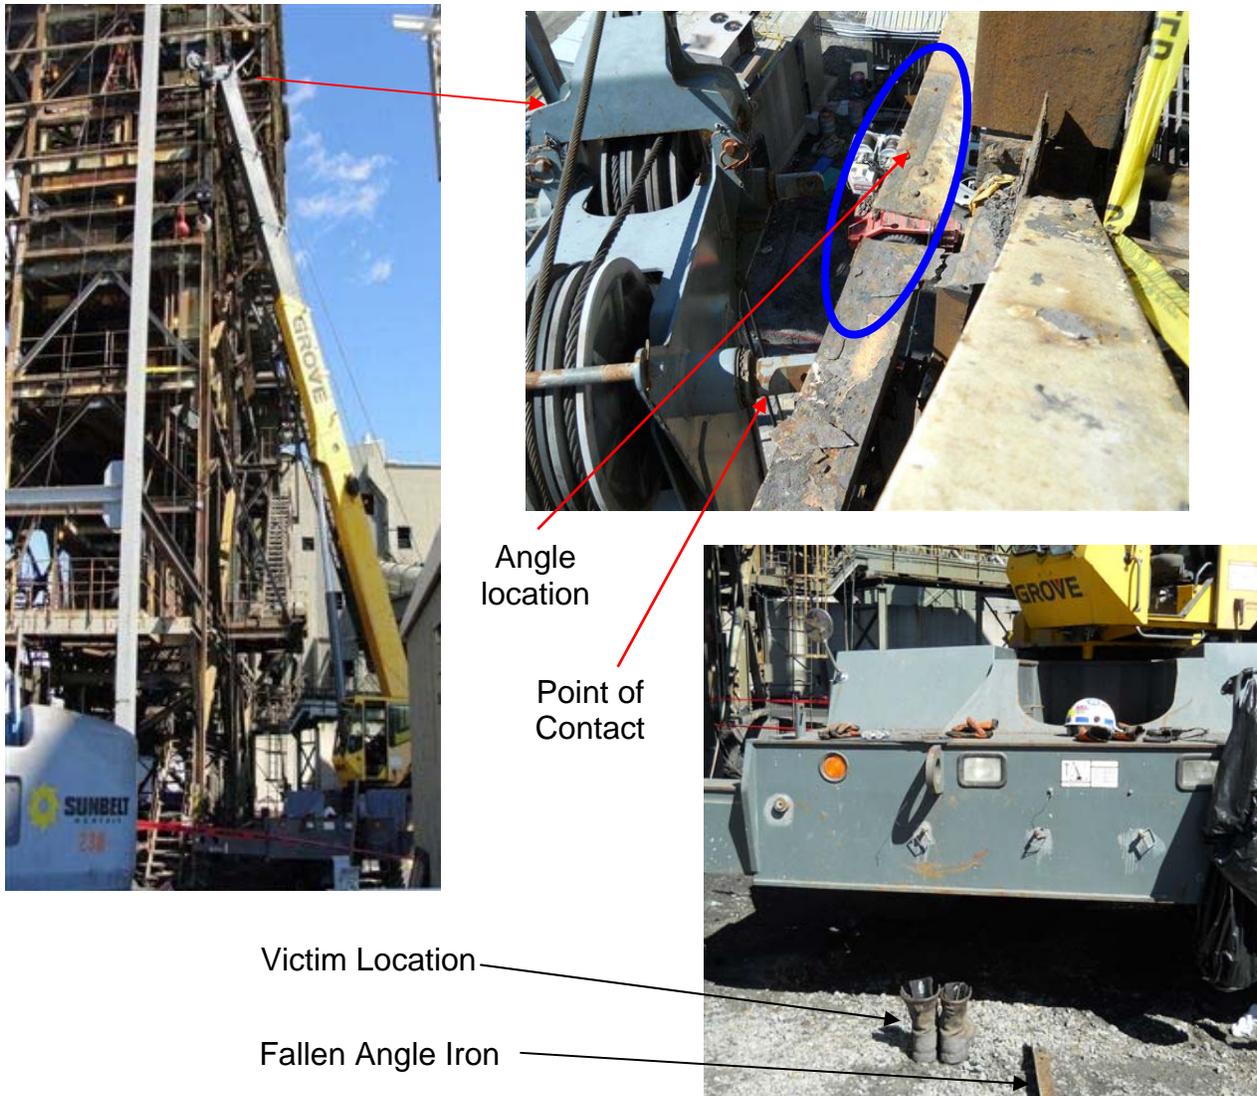
On September 19, 2012 an accident occurred at the Bailey Preparation plant, 36-07230. A contractor crane operator was retracting the boom of the crane he was operating when it came in contact with the prep plant structure. It ripped a 2 inch x 2 inch x 42 inch piece of angle loose, falling and hitting the crane, bouncing off, striking the job foreman who was standing beside the crane. He suffered a broken clavicle as a result of the accident.

- Don't allow booms or loads to touch structures.
- Always use a signalman if the operator can't see the load, loading landing area, path of travel, or when the load is far enough away from the operator to make judgment difficult.
- Respond to standard crane signals from only one person, but a "STOP" signal from anyone.
- Do not distract the crane operator while he is operating the crane.
- Ensure that equipment operators are properly trained.
- NEVER permit people to be in locations where they can contact the crane or load while in operation.
- Ensure that equipment operators communicate with other workers who work in close proximity to their equipment.
