McElroy Mine Shaft Explosion Investigation Summary

Overview

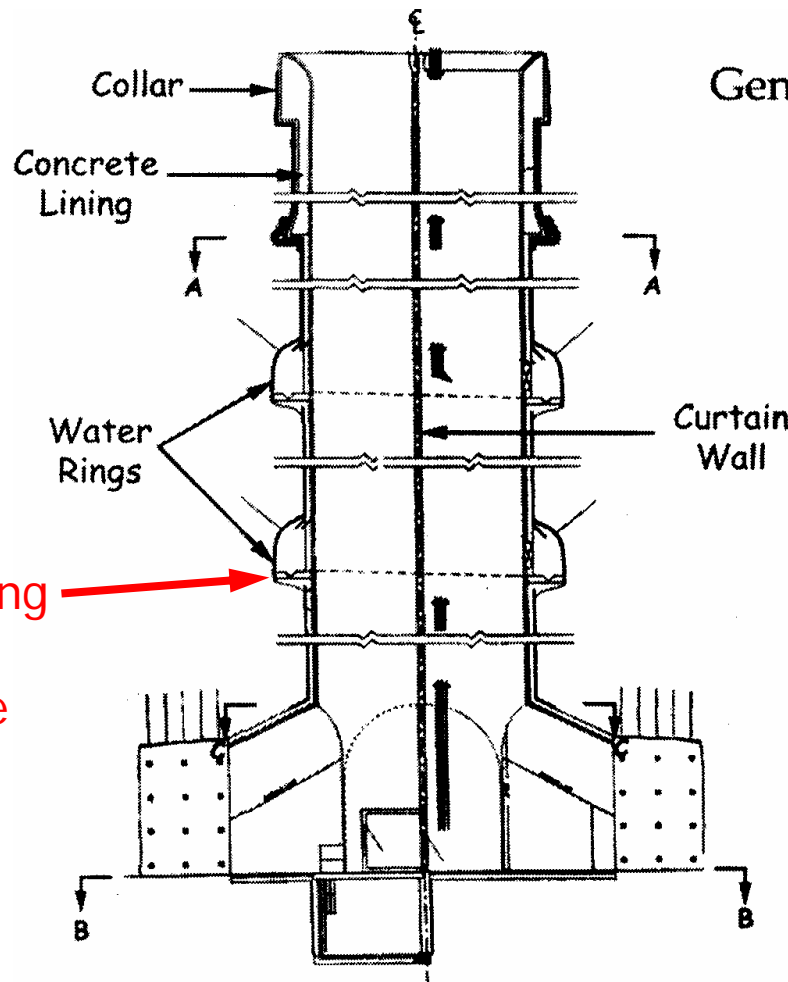
Generic Dual Compartment
Shaft Cross Section

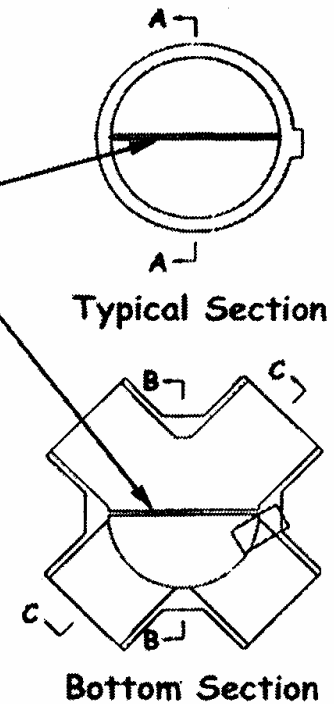
Water ring being
constructed at
the time of the
accident.

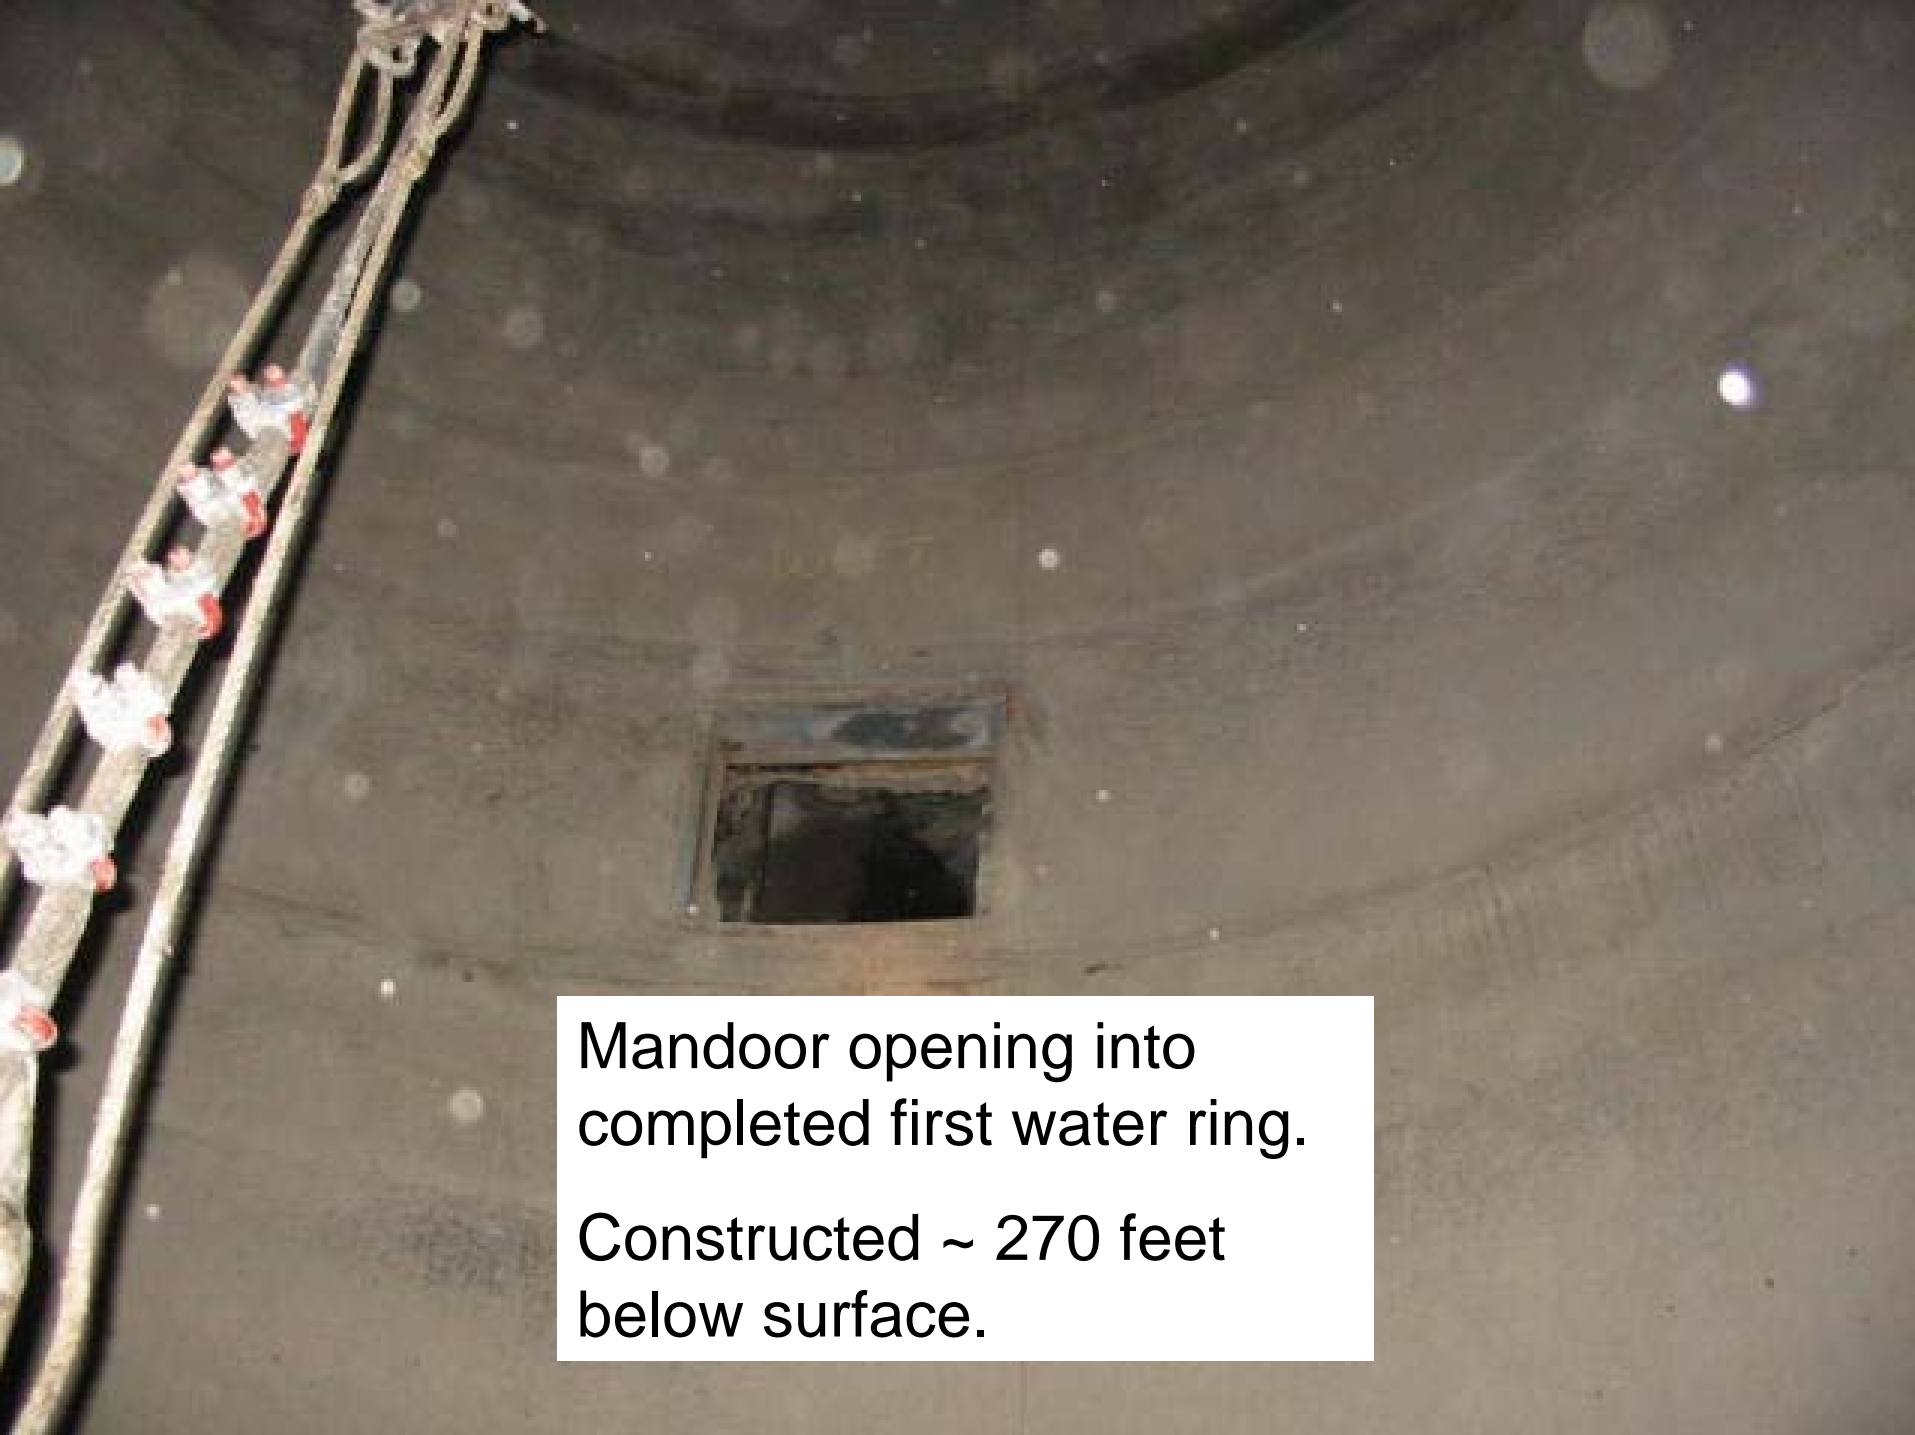
Mandoor opening into
completed first water ring.

Constructed ~ 270 feet
below surface.

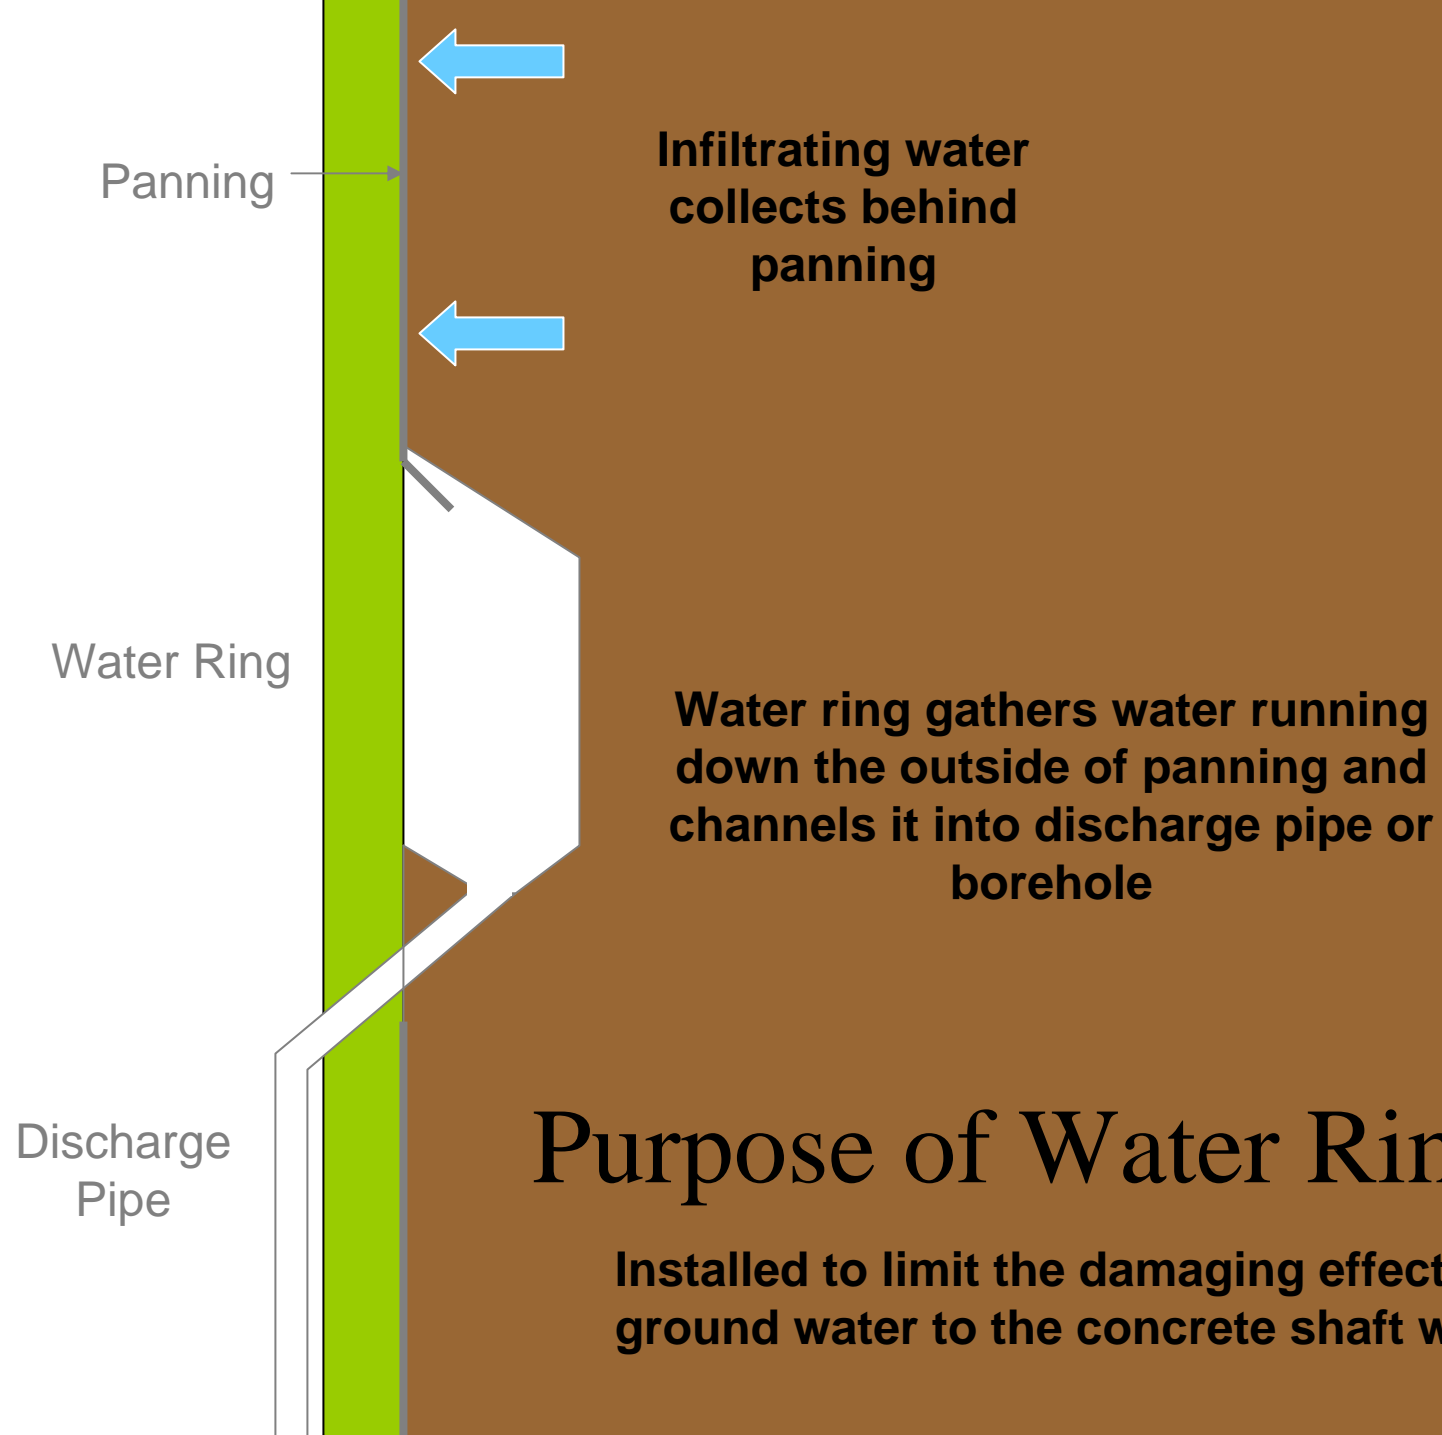
Purpose of Water Rings

Installed to limit the damaging effect of ground water to the concrete shaft wall.

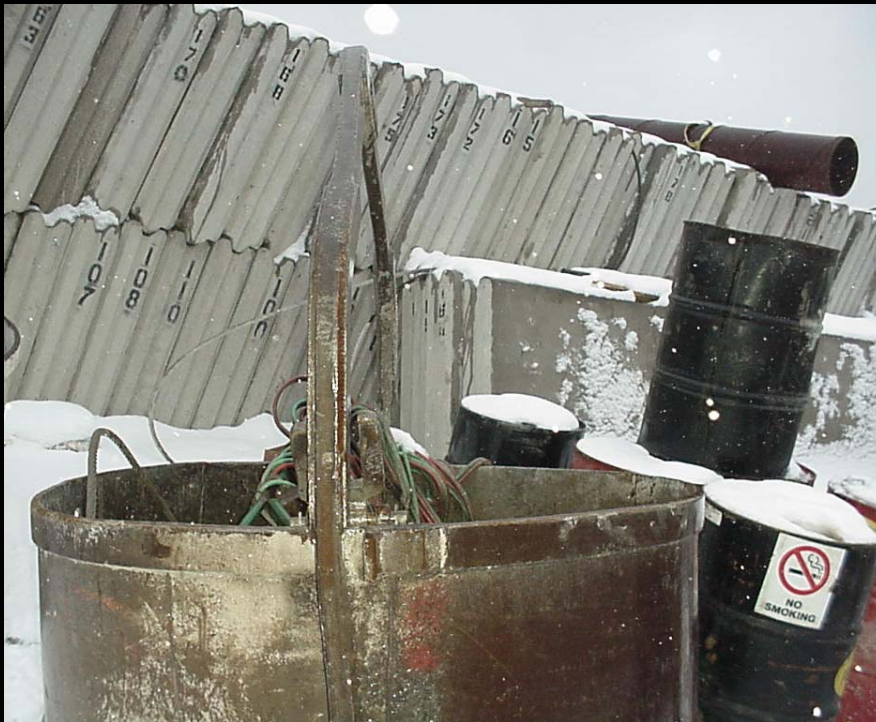
View of bucket containing oxygen-acetylene tanks and hoses which were in shaft at time of explosion

- The examination for methane performed by the night shift foreman prior to the explosion was not adequate. An adequate examination would have required testing for methane in all areas that could have been affected by the use of the cutting torch.
- The water ring was not ventilated to dilute and remove hazardous gases. Proper ventilation of the water ring prior to performing any work would have prevented the accident.
- The water ring construction method created an unventilated area where methane was able to accumulate. The method also required the use of a cutting torch and other potential methane ignition sources.
